GRENFELL TOWER INQUIRY: PHASE 1 REPORT

REPORT of the PUBLIC INQUIRY into the
FIRE at GRENFELL TOWER
on 14 JUNE 2017

Chairman: The Rt Hon Sir Martin Moore-Bick
October 2019

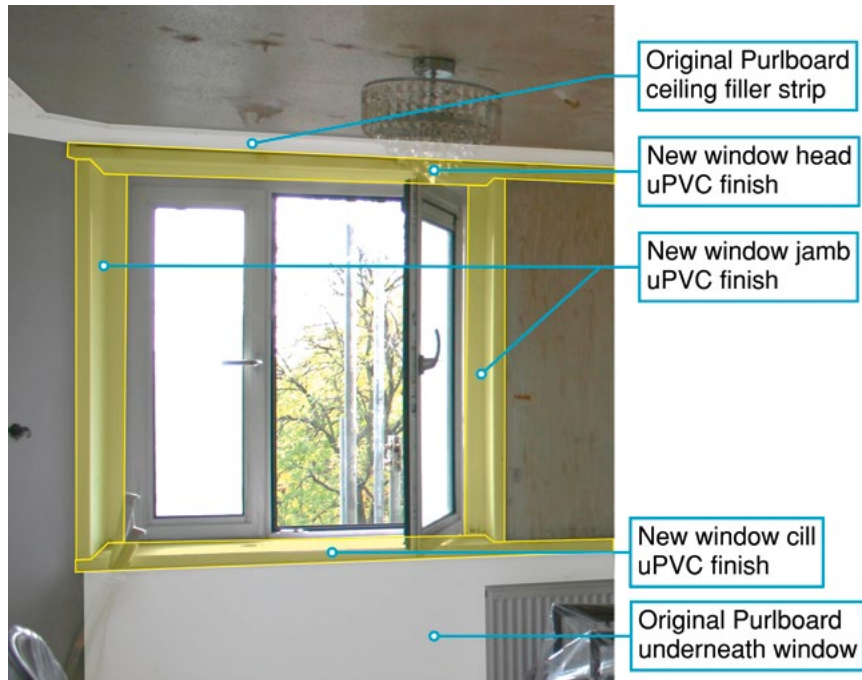
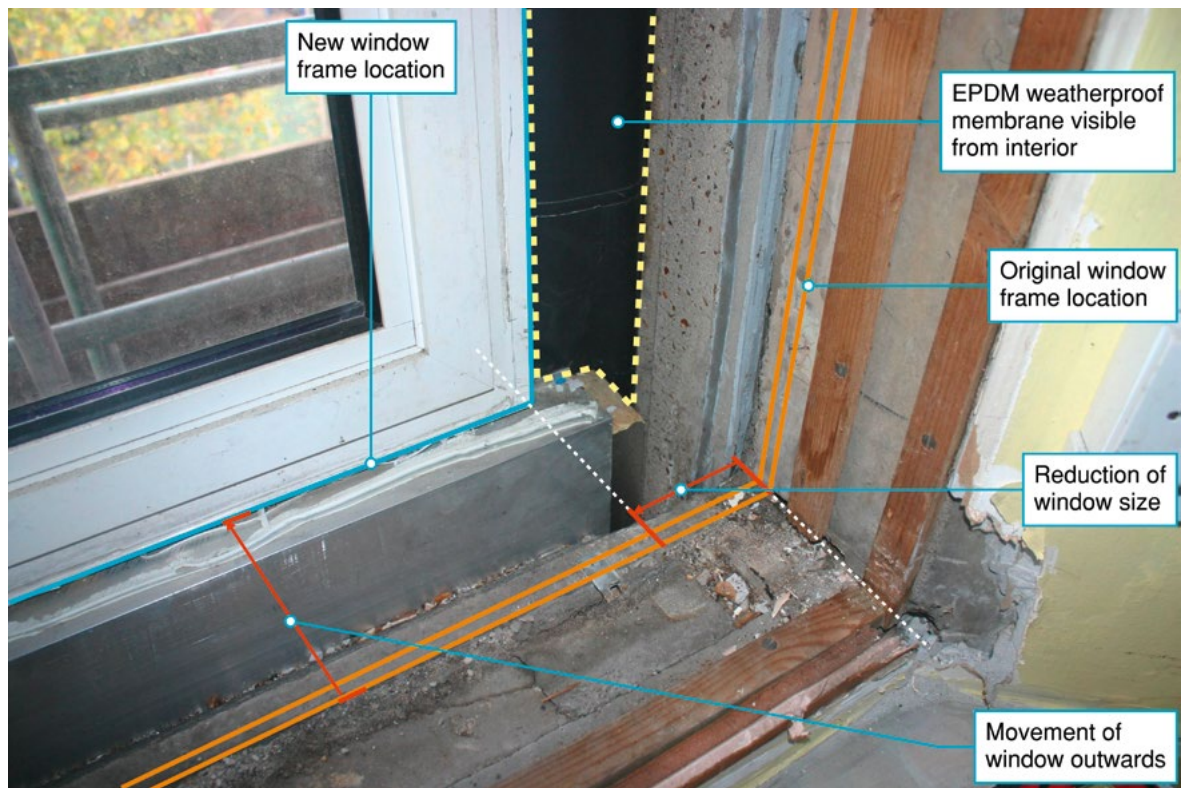
partly to 25mm insulation boards which were used to close off the opening into the cavity in the cladding caused by the repositioning of the windows. No mechanical fixings appear to have been used.⁵⁸ The new window arrangement is illustrated in the following photographs:⁵⁹

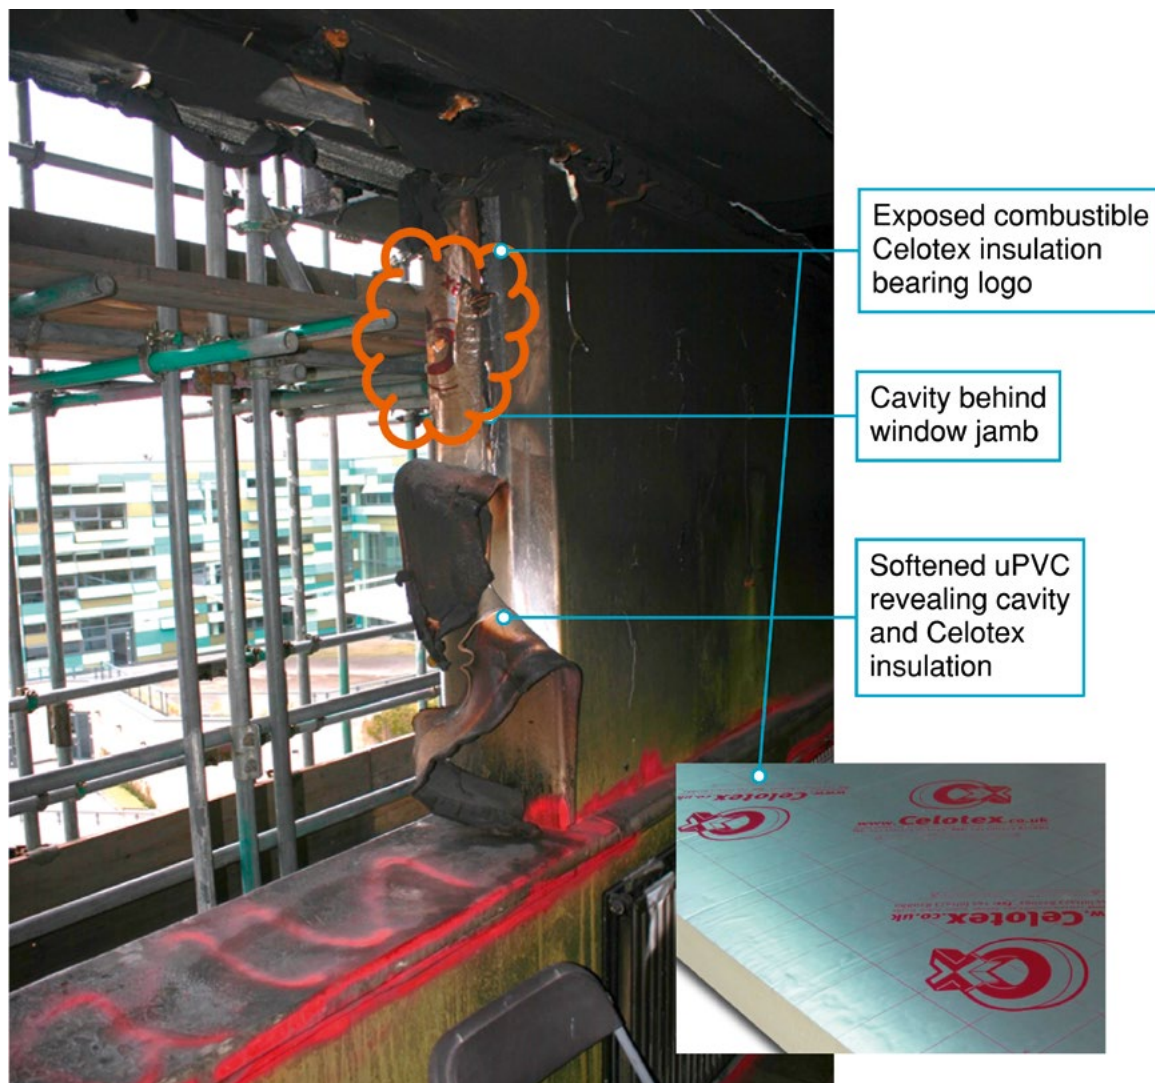
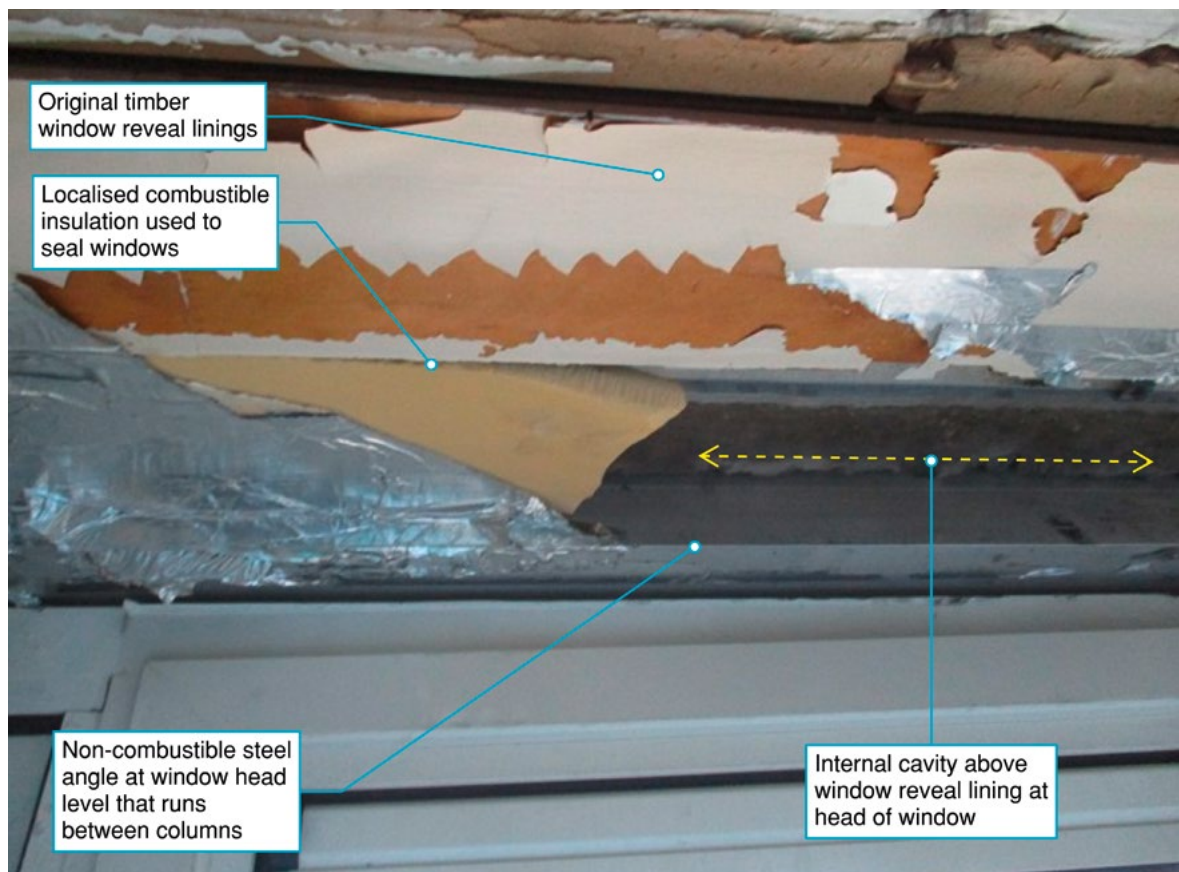
- 6.28 On both jambs and also at the head and sill of the windows, beneath the uPVC, was a 25mm layer of PIR insulation,⁶⁰ either Celotex TB4000 or Kingspan Thermapitch TP. These are both types of PIR insulation, but were much thinner products than those used on the spandrels and the columns. The position of the insulation boards around the windows can be seen from these two photographs:⁶¹

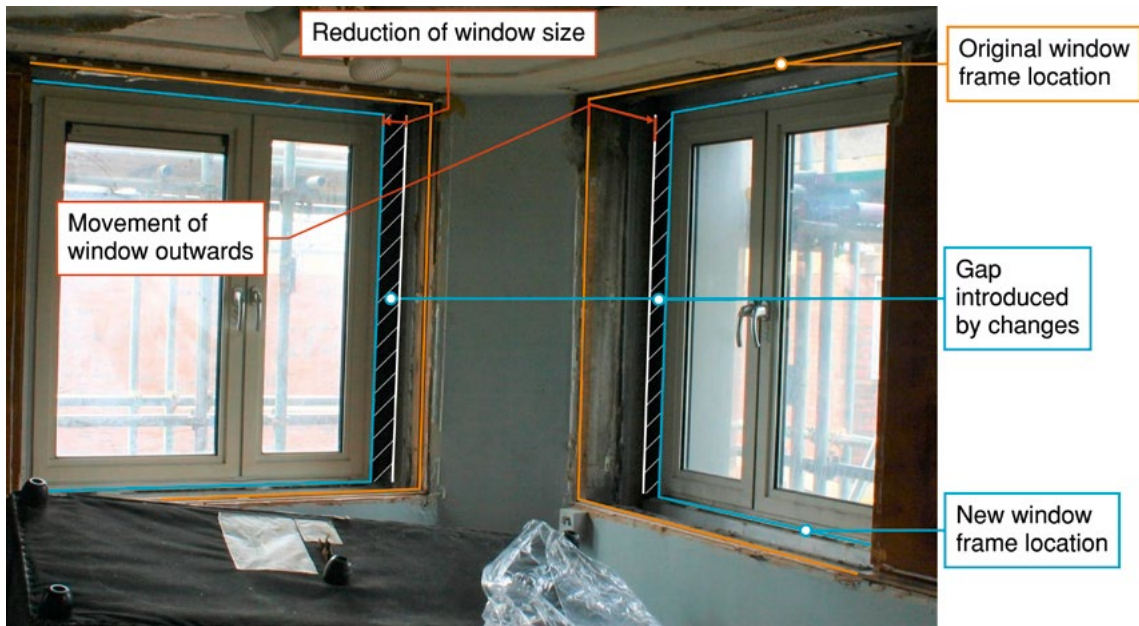
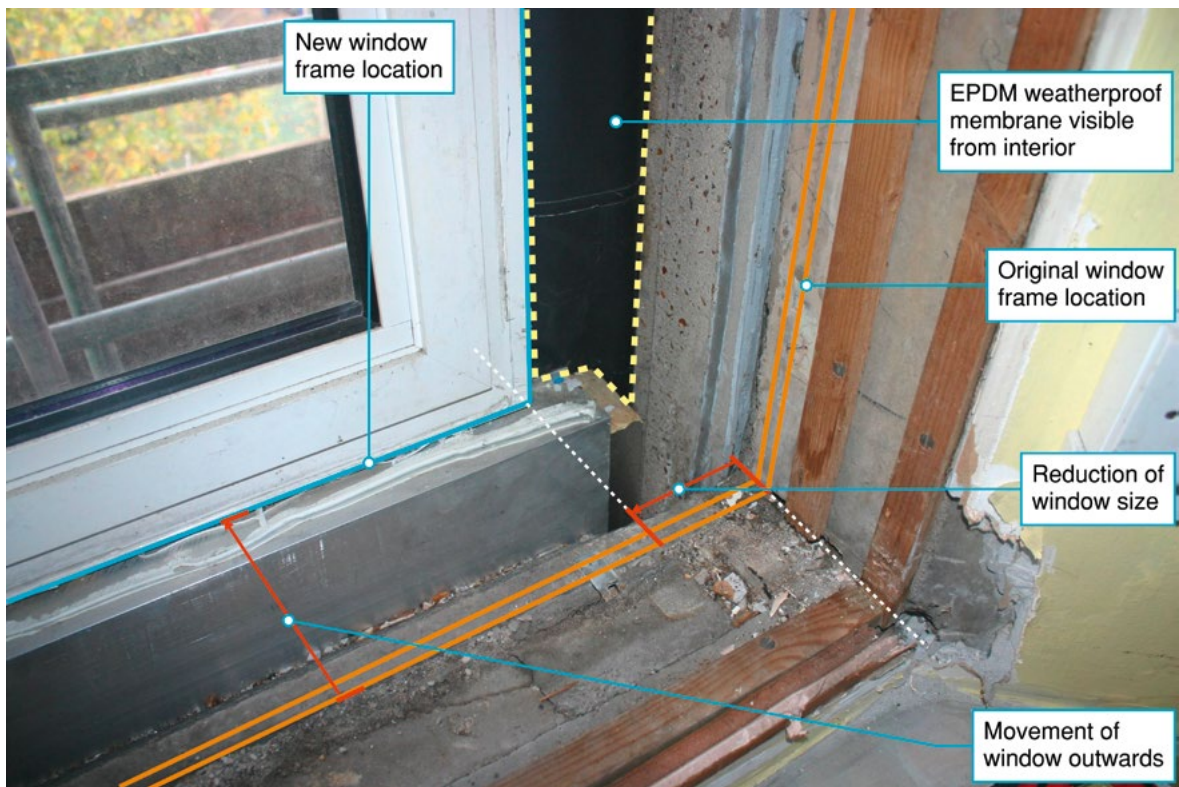
6.34 No cavity barriers were installed around the windows.⁷⁴

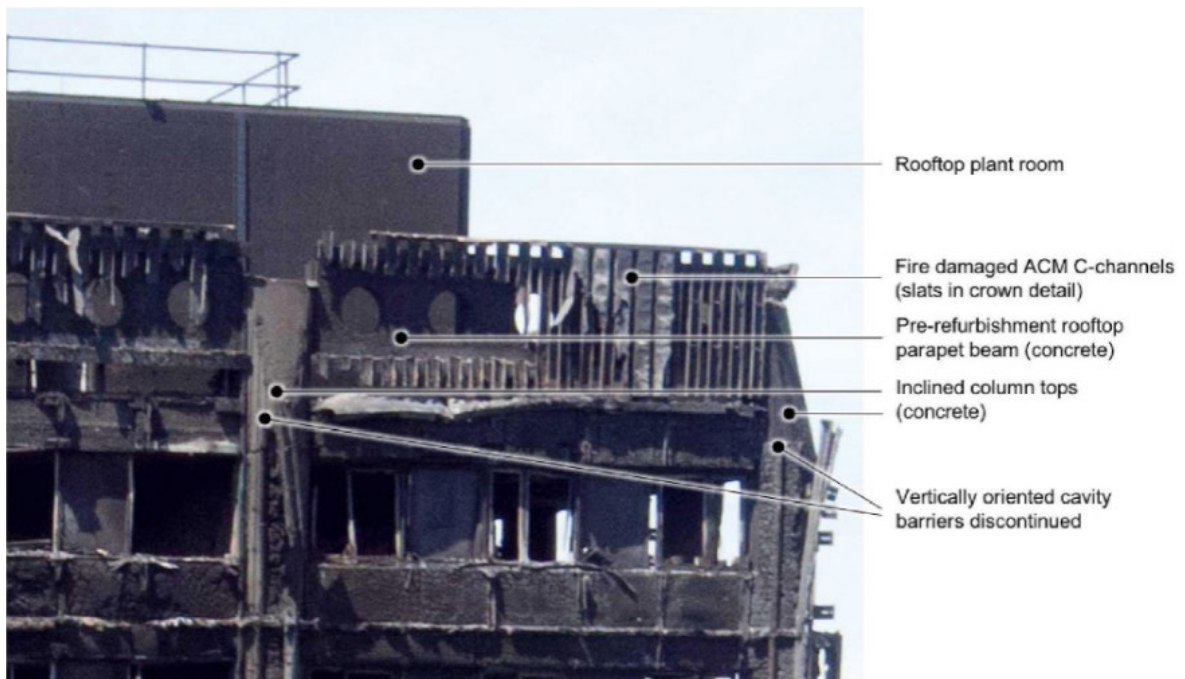
Figure 6.12

- 6.37 In the following picture of the crown taken after the fire it is possible to see the remains of the ACM fins and aluminium rails, together with the original concrete behind.⁷⁷
