Rail Accident Investigation Branch

# Rail Accident Report

## Collision at Aviemore station on the Strathspey Railway 29 September 2023

Report 09/2024  
September 2024

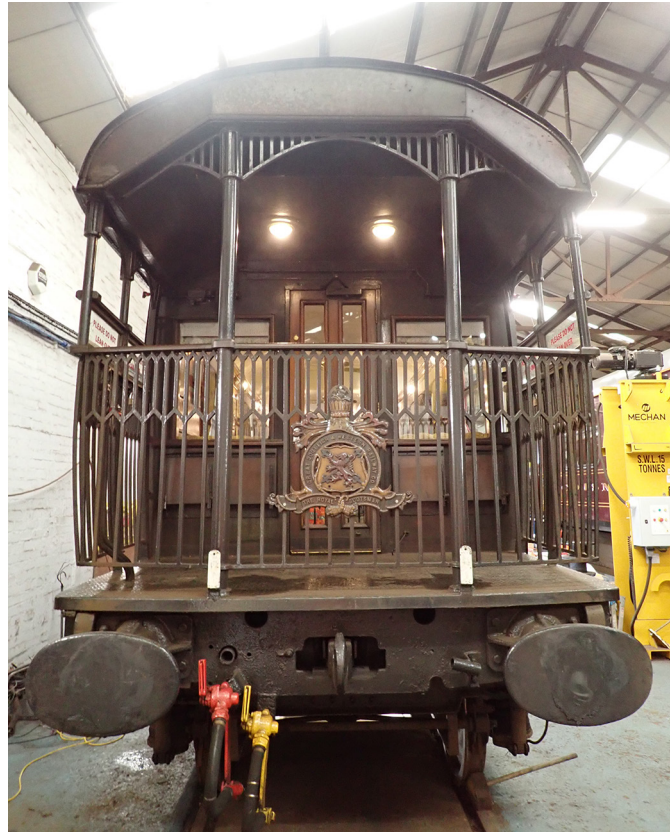
- 20 The coach directly impacted in the collision is known as an 'observation lounge car' (figure 5). This vehicle, number 99965, has a largely open internal space with chairs and sofa-style seating. The leading end of this vehicle, impacted by Flying Scotsman, has a veranda/observation area. Although covered, this area is open to the environment.

Figure 5: The observation lounge car.

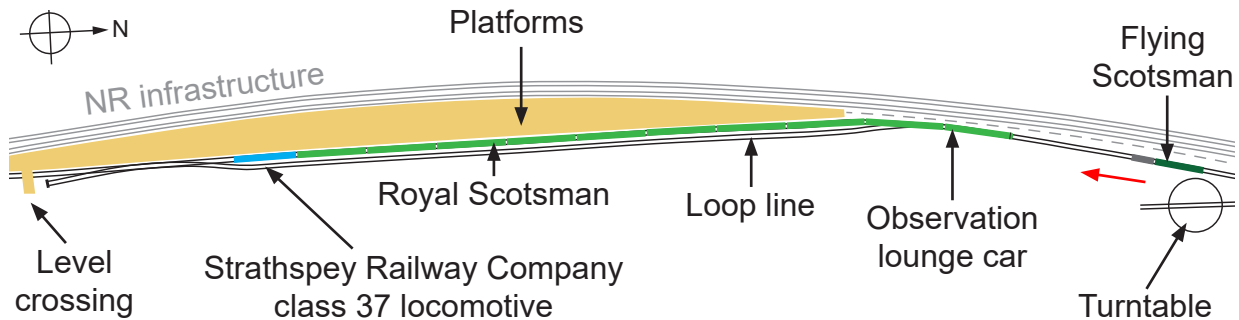
Figure 6: Position of Royal Scotsman coaches at Aviemore at the time of the collision.

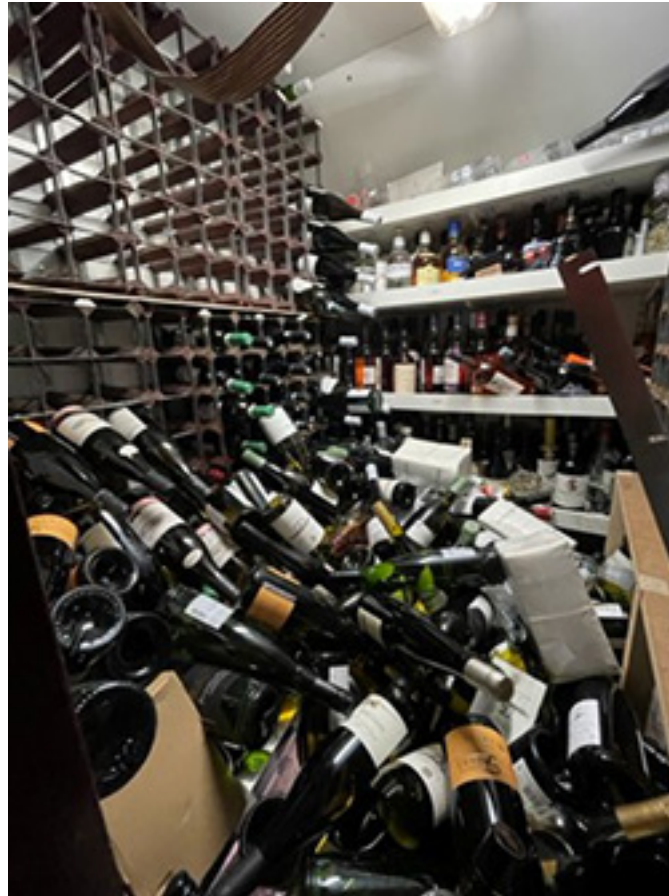
- 59 The impact caused at least one person on the veranda of the observation coach to fall to the floor. A passenger standing inside the observation coach also clashed heads with another passenger. Numerous wine bottles fell from a large wine rack and some glass bottles containing spirits were dislodged from a shelf in a kitchen area (figure 7). These areas were not accessible to passengers but were used by staff, although none were in the vicinity at the time.

*Figure 7: Wine bottles dislodged during the accident (courtesy of the Strathspey Railway Company).*

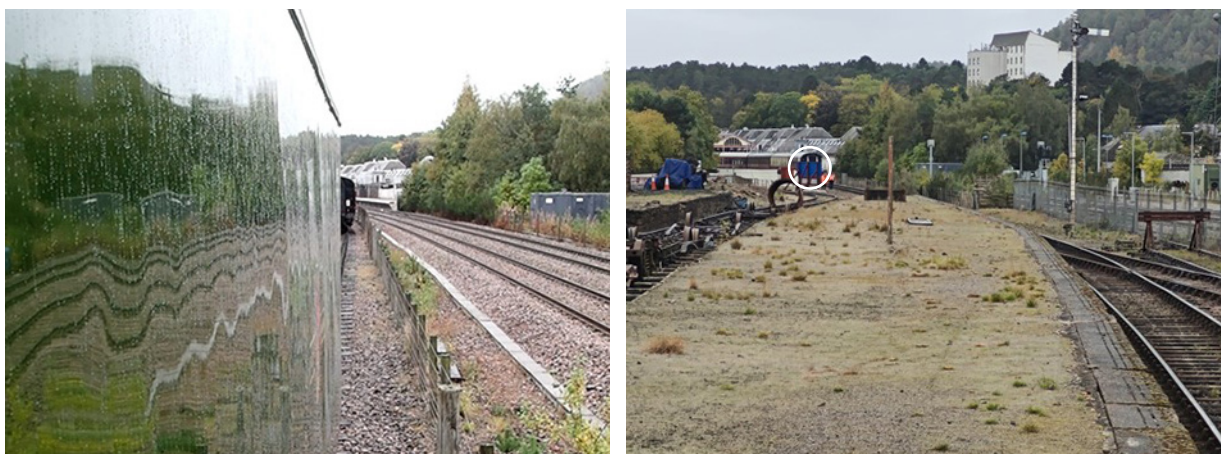
- 73 RAIB observed that, from the driver's side of the cab, the end of the coaches closest to the locomotive first became partially visible when the locomotive was around 81 metres from them. It was not until that distance was reduced to around 62 metres that RAIB considers that the presence of the coaches would be fully apparent to a person looking out from the driver's side of the locomotive cab (figure 8). For a person looking out from the fireman's side of the cab, while obstructions may have impeded the view of the Royal Scotsman coaches during the initial part of the movement from Speyside to Aviemore station, an unimpeded view of the nearest part of the rake was available for more than 230 metres on the approach (see paragraph 93, figures 8 and 11).

Figure 8: The view along the driver's side of the tender when the locomotive is 62 metres from the coaches (left) contrasting with the view along the fireman's side at Speyside (right) with the position of coach end (circled).

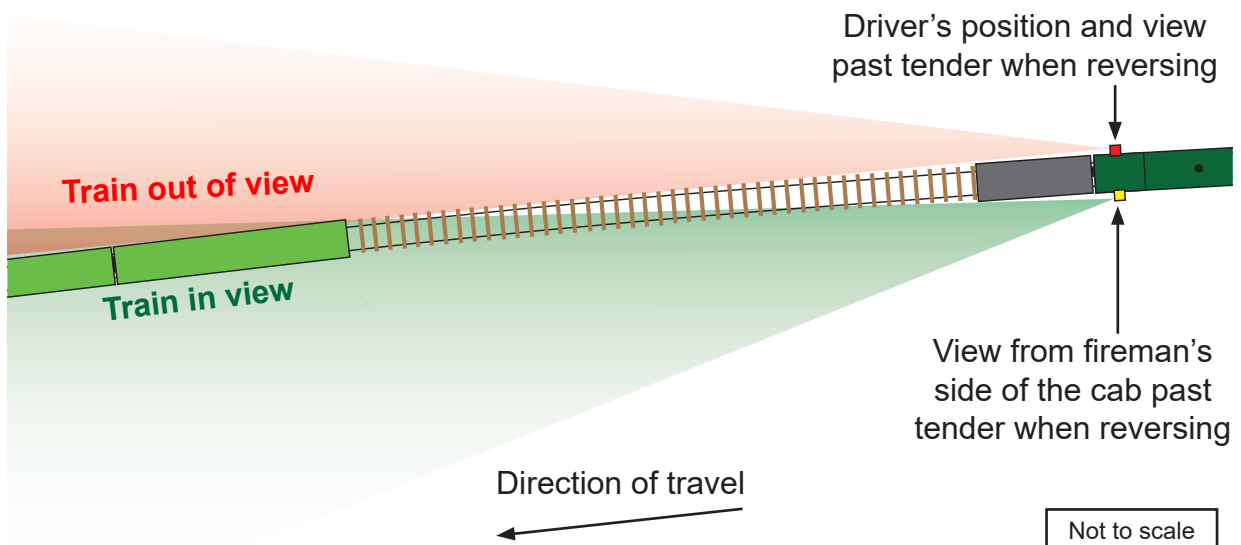
75 At the time of the accident, the locomotive was moving in the reverse direction, with the tender leading. This meant that the driver needed to turn to look behind them to see the line ahead, while using the driving controls. The reconstruction undertaken by RAIB (paragraph 73 and figure 8) showed that the tender restricts the driver’s view ahead when the locomotive is operating with the tender leading and approaching a left-hand curve.

Figure 11: Representation of the view from each side of the locomotive cab when reversing on a left-hand curve in the direction of travel.

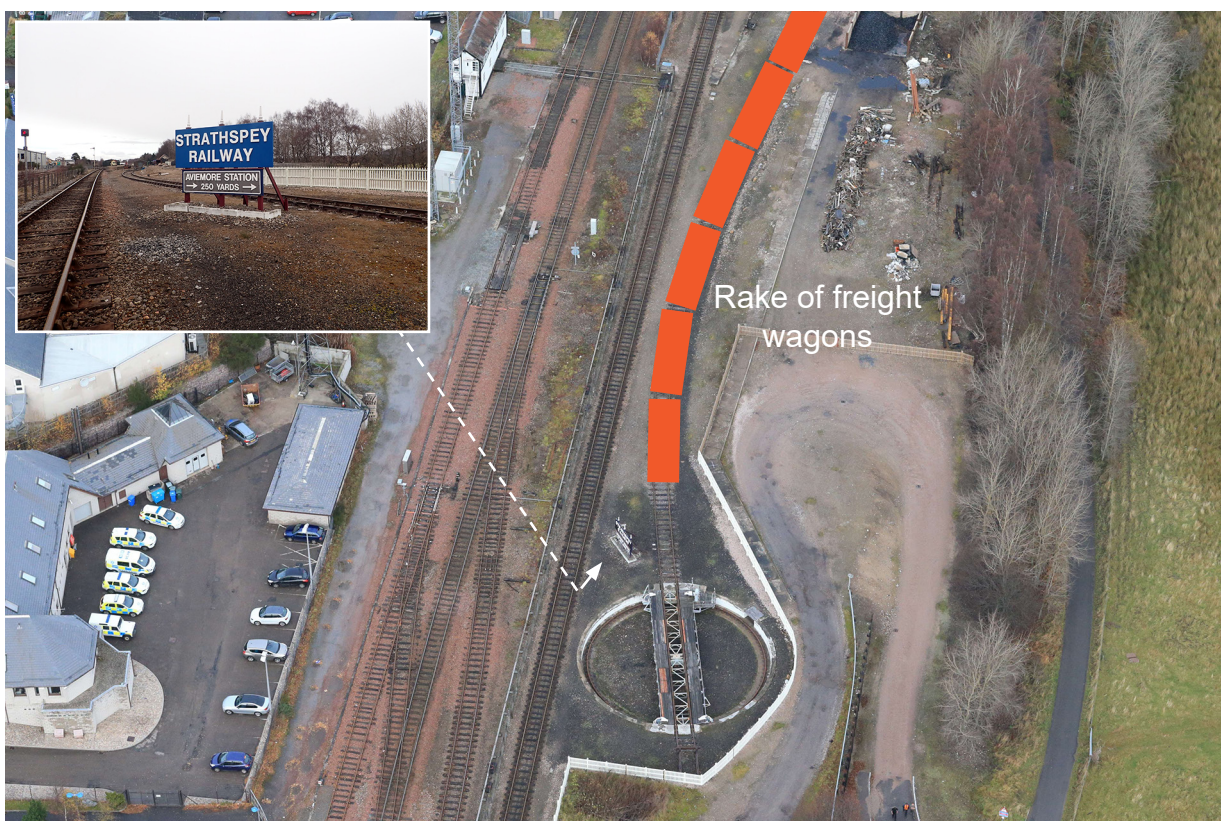
- 91 Evidence from witnesses, corroborated by a video taken by a passenger onboard the Royal Scotsman, shows there was a rake of freight wagons stabled in the line that leads to the turntable (figure 12). These wagons were not in position when RAIB undertook its reconstruction on 5 October 2023.

- 92 The turntable lies to the north of Aviemore station with its centre approximately 125 metres from the north end of platform 3. Adjacent to the north-west corner of the turntable is a large blue sign (figure 12) advertising the Strathspey Railway. The sign is 3.8 metres wide by 1.3 metres tall with the bottom edge approximately 1.5 metres from the ground. Below that sign, attached to the same posts, is a smaller sign which fills most of the gap underneath the main blue sign.

- 93 RAIB investigated the possible effect that the presence of the freight wagons and the sign could have had on the view from the locomotive. RAIB concluded that the presence of the freight wagons and blue sign may have obstructed the view of the Royal Scotsman coaches from the fireman's side of the cab while at Speyside platform and when leaving it. However, by the time Flying Scotsman reached a point 230 metres from the Royal Scotsman, there would have been an unobstructed view of the coaches from the fireman's side of the locomotive.

Figure 12: The turntable with inset of Strathspey Railway sign (main image courtesy of Network Rail with RAIB annotations).

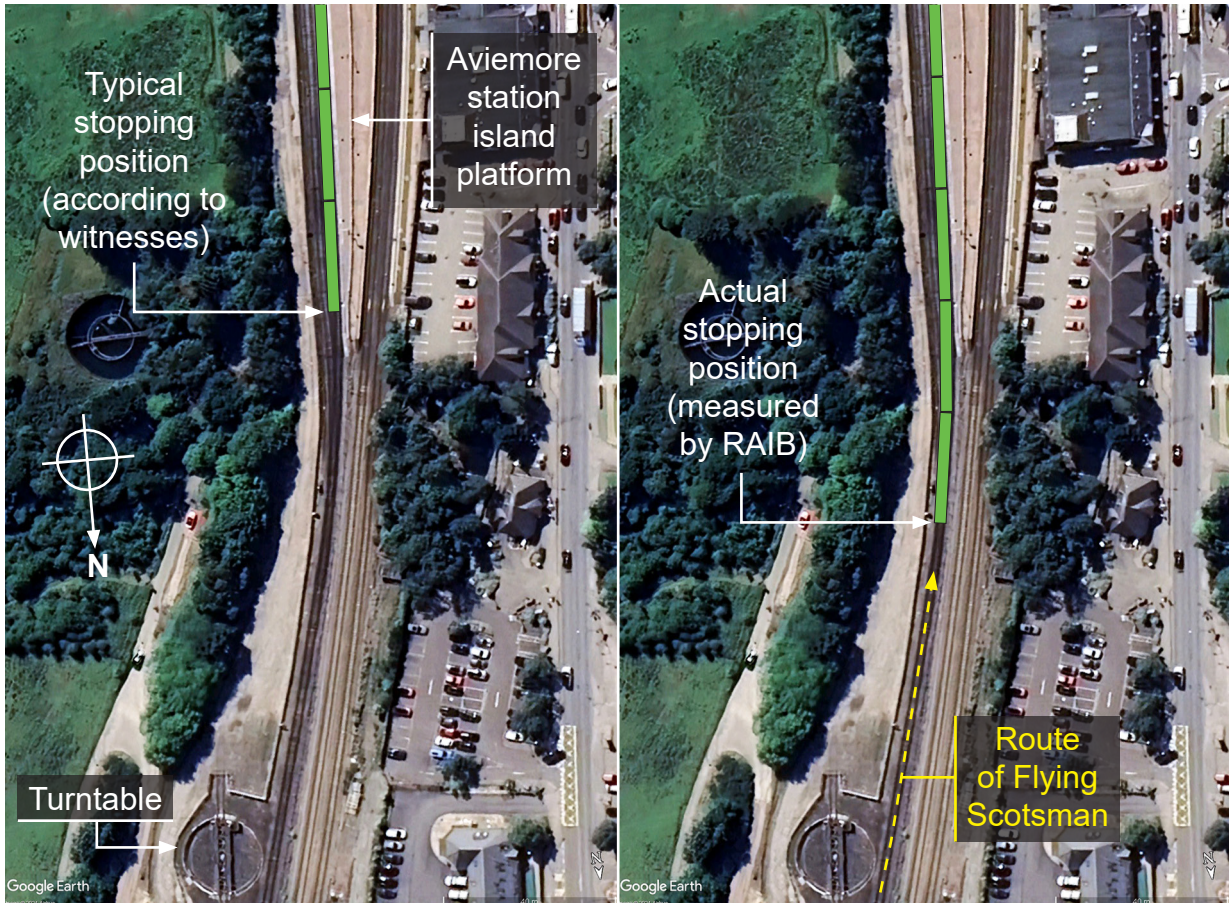
102 Although accounts described some variation in the position of the Royal Scotsman train in normal circumstances, the need to couple the class 37 locomotive to the rear meant that, on the day of the accident, the Royal Scotsman coaches were two to three coach lengths further north than would usually be the case (figure 13). The driver's expectation, based on their previous experience of similar movements, was that the Royal Scotsman coaches would be further south than they actually were.

Figure 13: Positions of Royal Scotsman coaches on the day of the accident (right) compared with a normal day (courtesy of Google with RAIB annotations).

103 The driver, therefore, saw no need to further reduce Flying Scotsman's speed (or stop) on approach, believing that the locomotive was still some distance from the Royal Scotsman coaches. The driver's belief that the coaches were further south than they actually were also removed any concern at the absence of any direction or warning from the custodian's representative (who the driver believed was observing) about the proximity of the coaches.
