Fatal man overboard from the sail training vessel *Pelican of London* at Sharpness, England on 2 October 2023

SUMMARY

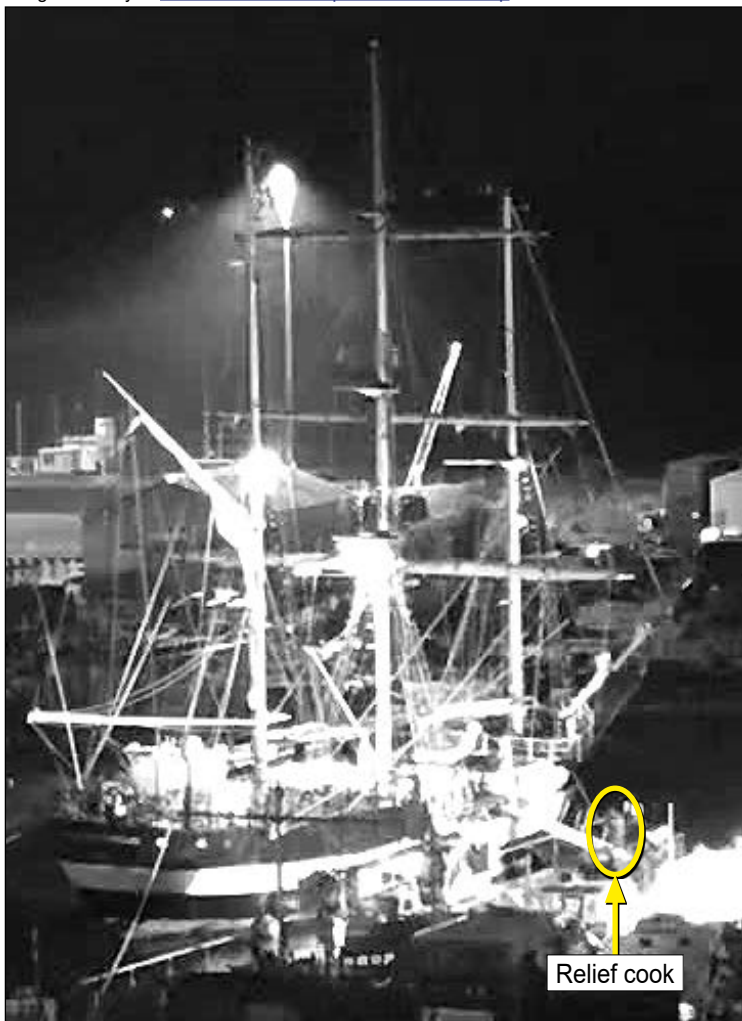
Figure 2: CCTV image of the relief cook ascending the gangway

At 2009 on 2 October, the relief cook joined his *Pelican of London* colleagues at the local bar where, over the next 2 hours and 42 minutes, he drank at least nine double whiskies and ice. The relief cook was the last customer in the bar when he left at 2251, walking back to *Pelican of London* alone. Arriving at the ship at 2307, the relief cook slowly ascended the gangway (Figure 2) and then paused for a few seconds to step down towards the deck via the bulwark ladder.

At 2308, the relief cook fell from the left-hand (aft) side of the top of the gangway, landing with a splash into the dock. The chief engineer (C/E) heard the noise and ran up from their cabin to the well deck, arriving within 7 seconds. The C/E looked

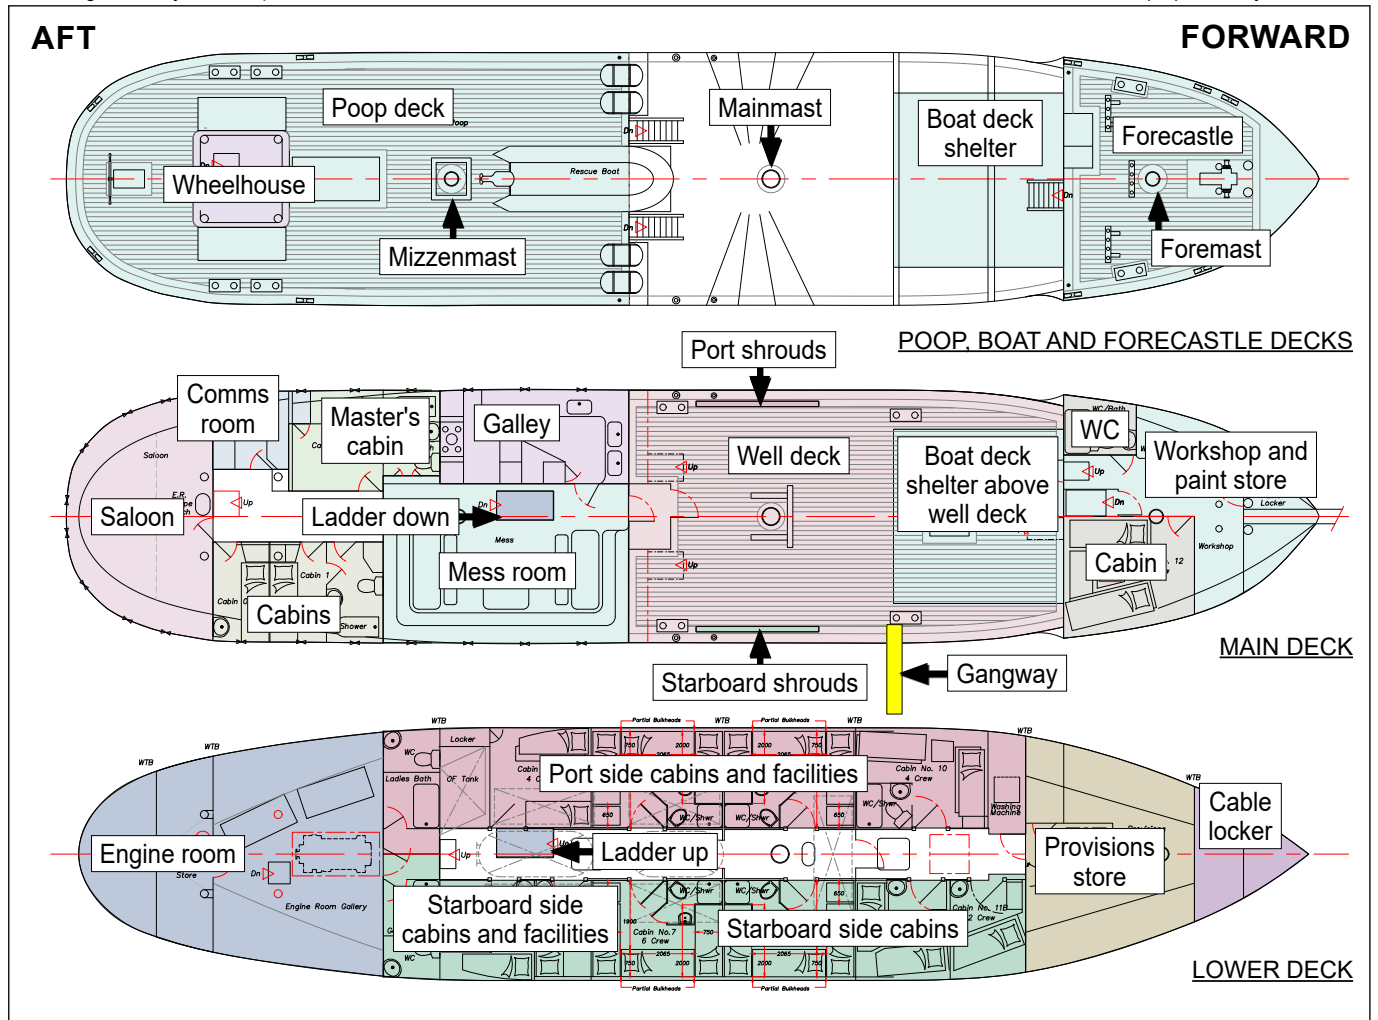
Figure 3: Pelican of London general arrangement

The three decks on *Pelican of London* comprised a lower deck, a main working deck and an upper deck, which was split into forecabin, well deck and poop deck areas (**Figure 3**).

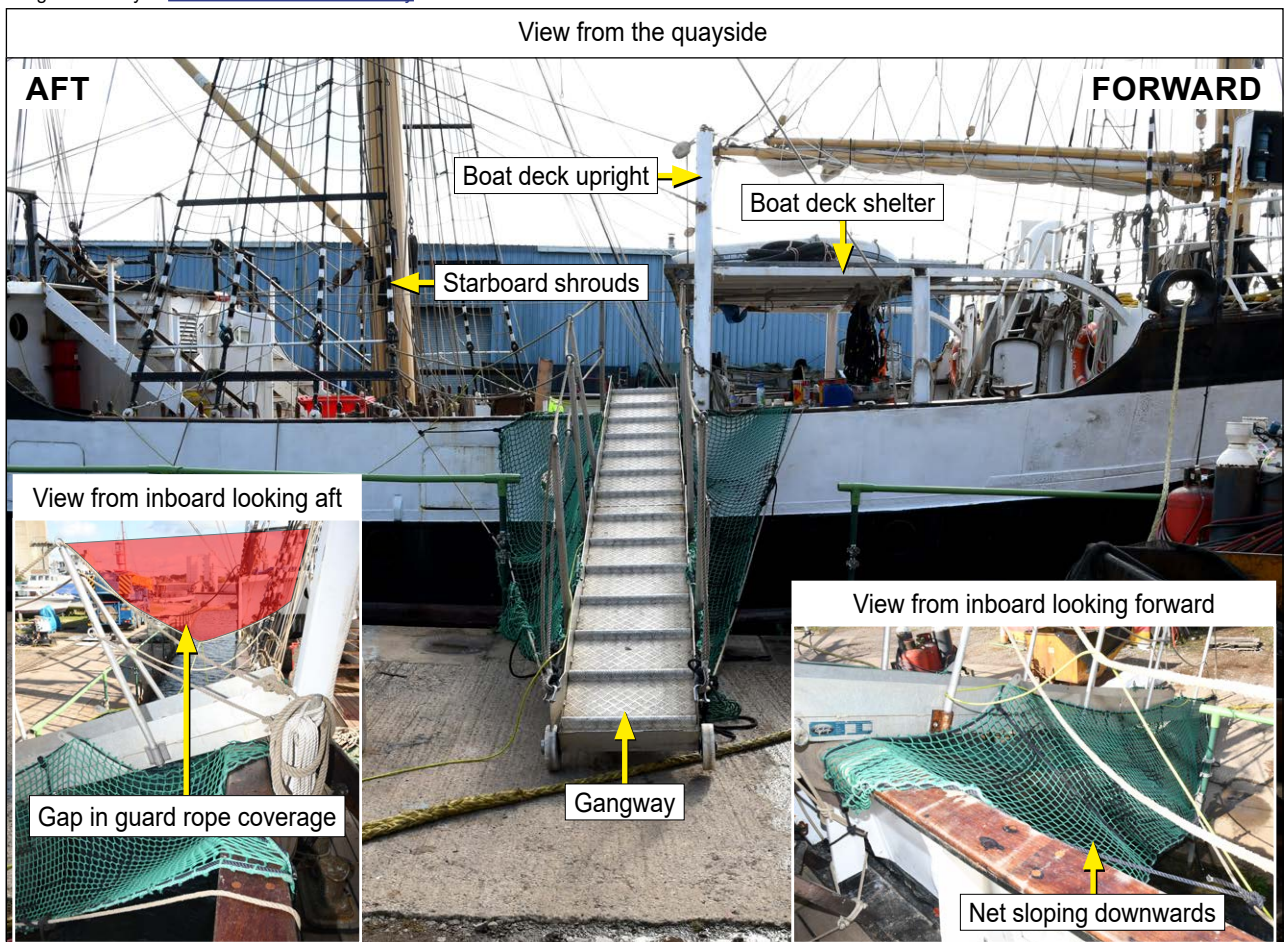
Figure 4: The gangway

At the top end of the gangway the aft side's guard ropes had been tied off slack on the forward shroud line at a height of approximately 0.5m above the top of the bulwark. An electric cable had been run over the top of the aft guard ropes and along the aft side of the gangway to a position on the quay. The electric cable served to depress the guard ropes such that they were roughly 0.3m high at their lowest point. The guard ropes at the inboard end of the forward side of the gangway had been tied off on a cleat on the aft upright of the boat deck (approximately 0.25m above the bulwark top) and at the base of the same upright.

The gangway net was rigged in two rectangular sections (approximately 1m x 5m). Each rectangular net section was arranged with its long edge lashed to the edge of the gangway; one forward and one aft. The outer long edges of the gangway net sections were lashed to lines run from the shore end of the gangway to points on board. On the forward side, this line was secured to the base of a bulwark stanchion about 2m forward of the gangway. Aft, this line was secured to the base of the forward starboard shroud. This meant that, on either side of the gangway, the nets sloped downwards away from the gangway edges by approximately 30° from the horizontal.

When the gangway was rerigged on 27 September the guard ropes from the stanchions on the inboard end of the gangway were tied off aft on the shrouds near the top of the bulwark, and forward low down on the starboard aft boat deck upright. This left significant gaps in the effective fencing between the top of the bulwark ladder and the inboard end of the gangway on both sides. These gaps were worsened by the electric cable that ran across the guard ropes and did not provide a sufficient barrier to prevent anyone from falling overboard from the top of the gangway.

The safety net, which should have arrested the fall of anyone toppling from the gangway, was rigged without a spreader bar. With the net's outer edges tied low onto the shrouds aft, and onto the bulwark forward, the net sloped downwards away from the gangway, creating a chute that did nothing to arrest the relief cook's fall.

- 2024/130** Review and amend fleet policy, procedures and training for rigging and approving the gangway arrangement to include guard ropes to prevent falls and gangway nets to arrest the fall of a person.
- 2024/131** Review and amend the onboard risk assessment procedure, as guided by the COSWP Annex 1.4, such that:
- operational risks can be mitigated to a level that is as low as reasonably practicable
 - local work instructions are produced that control the hazards.
- 2024/132** Review and amend the fleet policy and procedure on drugs and alcohol to include specific consideration of:
- individual responsibilities
 - alcohol testing
 - returning on board from recreational time ashore.
