Serious Incident

Aircraft Type and Registration:	Fan Jet Falcon Series D, G-FRAK	
No & Type of Engines:	2 General Electric Co CF700-2D-2 turbofan engines	
Year of Manufacture:	1969 (Serial no: 213)	
Date & Time (UTC):	14 November 2023 at 0930 hrs	
Location:	In-flight over South-West England	
Type of Flight:	Aerial work	
Persons on Board:	Crew - 2	Passengers - None
Injuries:	Crew - None	Passengers - N/A
Nature of Damage:	None	
Commander's Licence:	Airline Transport Pilot's Licence	
Commander's Age:	56 years	
Commander's Flying Experience:	7,000 hours (of which 6,000 were on type) Last 90 days - 38 hours Last 28 days - 17 hours	
Information Source:	Aircraft Accident Report Form submitted by the pilot and an investigation conducted by the operator in conjunction with the aircraft manufacturer

Synopsis

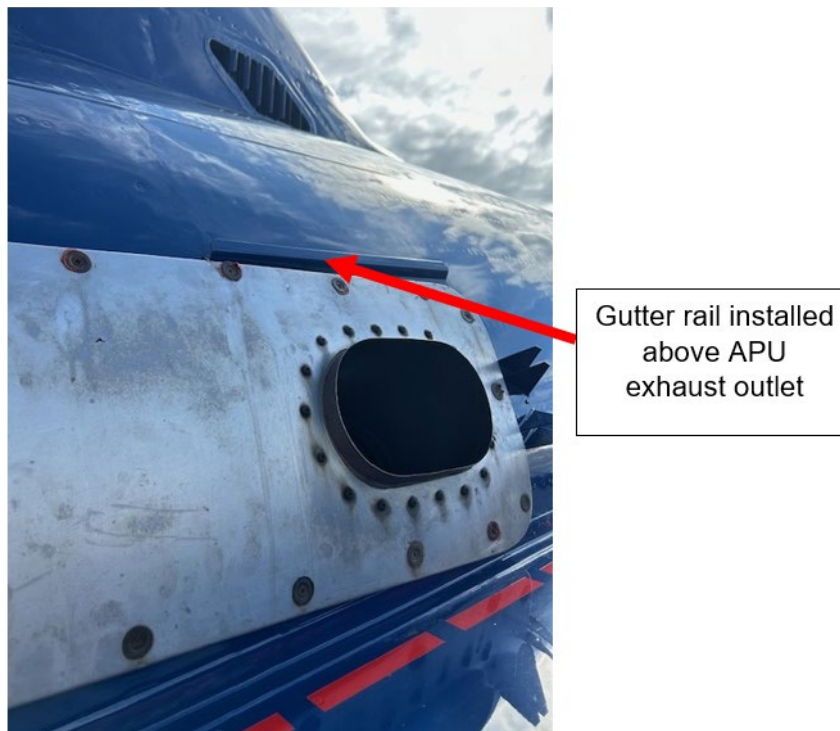
Figure 3

Gutter rail installation
(Image used with permission)

To reduce rainwater ingress, a 'gutter rail' has incorporated above the APU exhaust to direct rainwater away from it (Figure 3).
