Accident

Aircraft Type and Registration:	Beagle B121 Series 2 Pup, G-AZCZ	
No & Type of Engines:	1 Lycoming O-320-A2B piston engine	
Year of Manufacture:	1970 (Serial no: B121-167)	
Date & Time (UTC):	3 March 2024 at 1630 hrs	
Location:	Near Cardiff Airport	
Type of Flight:	Private	
Persons on Board:	Crew - 1	Passengers - 1
Injuries:	Crew - None	Passengers - 1 (Minor)
Nature of Damage:	Damaged beyond economic repair	
Commander's Licence:	Private Pilot's Licence	
Commander's Age:	28 years	
Commander's Flying Experience:	83 hours (of which 8 were on type) Last 90 days - 4 hours Last 28 days - 4 hours	
Information Source:	Aircraft Accident Report Form submitted by the pilot

Synopsis

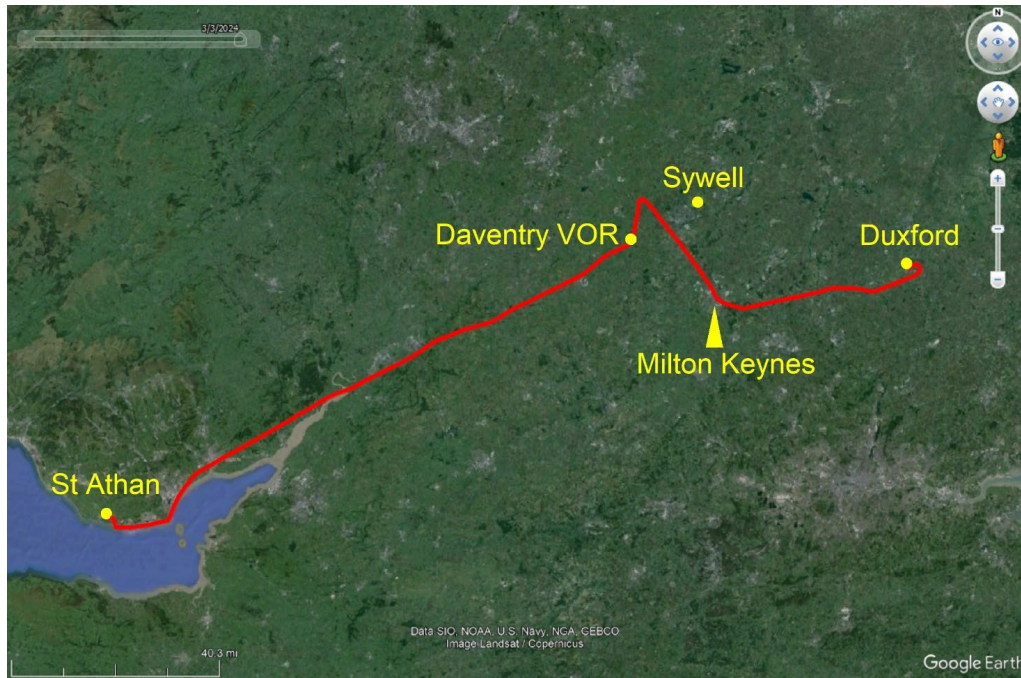
G-AZCZ commenced taxiing at 1100 hrs and took off 13 minutes later. Figure 1 provides the track of the aircraft during the flight. The aircraft climbed to 5,000 ft amsl and, as it approached Cravens Gorse hang glider site located to the east of Gloucestershire Airport, it climbed to 5,500 ft amsl. After passing Cravens Gorse, the aircraft descended to 3,800 ft and levelled off. When it was overhead the Daventry VOR the pilot altered course towards the north and contacted Sywell. The weather had not improved as anticipated and the pilot subsequently altered course towards the south, flying over Milton Keynes before turning east to Duxford, where it landed at 1248 hrs. The flight time was 1 hour 35 minutes, and the flight distance was 170 nm. During the flight the pilot stated that he had leaned the engine mixture and alternated regularly between the left and right fuel tanks; he did not operate the aircraft with the tanks set to both.

GNSS flight track from St Athan to Duxford
 (©SIO NOAA U.S Navy, NGA GEBCO, Image Landsat / Copernicus)

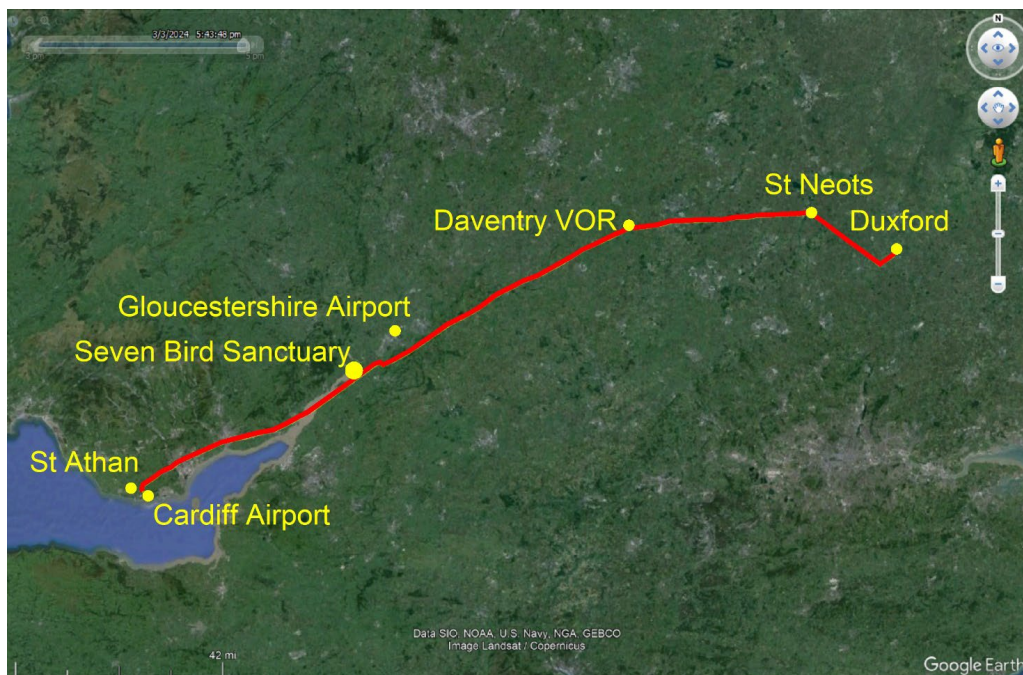
The aircraft started to taxi at 1453 hrs and took off at 1500 hrs, initially climbing to 2,500 ft amsl followed by a further climb to 3,500 ft amsl as it passed St Neots. Figure 2 provides the track of the aircraft during the flight. As the aircraft approached Gloucestershire Airport, the pilot changed from the left to the right fuel tank. Between five to ten seconds later the engine started to lose power. The pilot checked the instruments and saw that the fuel pressure was low, following which he identified that the fuel selector was not correctly positioned into the detent for the right tank. Having corrected this, engine power was restored. The pilot advised that he had initially considered diverting to Gloucestershire Airport but, satisfied that he had identified the problem, decided to continue to St Athan.

As the aircraft approached the Severn Bird Sanctuary the pilot climbed the aircraft to 5,000 ft amsl before then starting a gradual stepped descent to 1,500 ft amsl. The aircraft was subsequently cleared for a straight in approach to land on Runway 25 at St Athan. The pilot stated his normal practice was to change fuel tanks during the approach checks and recalled changing from the right to the left tank, for which he reported that he had checked the cockpit gauge which showed 2 imp gal in the left and 4 imp gal in the right tank. The aircraft was now at a height of about 1,100 ft agl and about 2.4 nm from St Athan and 1.5 nm from Cardiff Airport.

Approximately five to ten seconds after selecting the left fuel tank the engine started to lose power. The pilot saw that the fuel pressure was indicating zero and so checked that the electric fuel pump was ON; which it was. He recalled that he had then possibly changed back and forth several times between the left and right tank, but the engine did not regain power. The pilot declared a MAYDAY and, being aware that he was closer to Cardiff Airport, turned towards Runway 12. As the aircraft descended, the pilot was not certain that it would make the runway and so decided to land in a field. During the landing roll the nosewheel dug into the soft ground and the aircraft tipped over. The pilot was uninjured, but his passenger suffered an injury to her shoulder. The emergency services and a SAR helicopter arrived on site shortly after and provided medical assistance.

GNSS flight track from Duxford to St Athan
(©SIO NOAA U.S Navy, NGA GEBCO, Image Landsat / Copernicus)
