## Accident

<b>Aircraft Type and Registration:</b>	UAS DJI Mavic 2 Enterprise Advanced	
<b>No &amp; Type of Engines:</b>	4 Electric motors	
<b>Year of Manufacture:</b>	2021 (Serial no: 4GCCJ5RR0A0C41)	
<b>Date &amp; Time (UTC):</b>	9 February 2024 at 0255 hrs	
<b>Location:</b>	Weybridge, Surrey	
<b>Type of Flight:</b>	Emergency Services Operations	
<b>Persons on Board:</b>	Crew - None	Passengers - None
<b>Injuries:</b>	Crew - N/A	Passengers - N/A
<b>Nature of Damage:</b>	Damage to all four propellers, body, legs and battery pack.	
<b>Commander's Licence:</b>	Other	
<b>Commander's Age:</b>	33 years	
<b>Commander's Flying Experience:</b>	11 hours (of which 4 were on type) Last 90 days - 3 hours Last 28 days - 1 hour	
<b>Information Source:</b>	Aircraft Accident Report Form submitted by the pilot

## Synopsis

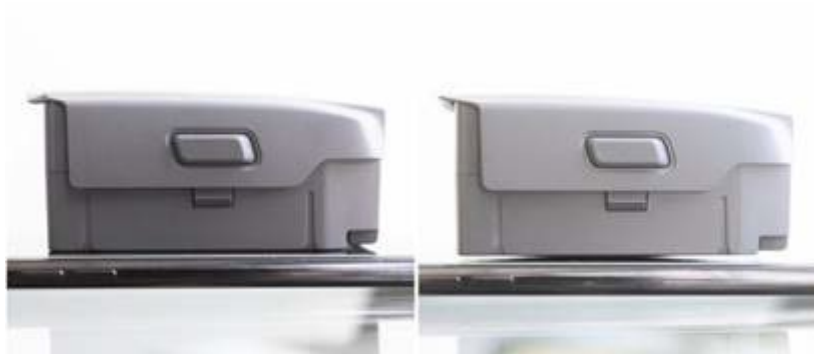
**Figure 2**

An online search found examples where the same model of battery pack had swelled, and this had compromised the ability of the battery to be securely attached to the UA. An examination of the battery pack after the accident showed that the casing was split, probably as a result of the impact with the ground, but also that there was some evidence of swelling. However, it was not possible to determine whether this swelling was present prior to the accident.

If a battery has swollen and has a curved underside surface, this can impede or prevent secure retention of the battery by the latching mechanism.

Battery without swelling with a flat underside (left) compared with one with swelling evident (right). (Used with permission).
