AAIB Bulletin

9/2024

Boeing 767-332(ER)	N197DN	10-Feb-23	3
--------------------	--------	-----------	---

Aircraft Type and Registration:	Boeing 767-332(ER), N197DN	
No & Type of Engines:	2 Pratt & Whitney PW4060 turbofan engines	
Year of Manufacture:	1997 (Serial no: 28454 LN: 683)	
Date & Time (UTC):	10 February 2023 at 1130 hrs	
Location:	Prestwick Airport	
Type of Flight:	Commercial Air Transport (Passenger)	
Persons on Board:	Crew - 10	Passengers - 211
Injuries:	Crew - None	Passengers - None
Nature of Damage:	Contained engine failure, fractured water drain tube	
Commander's Licence:	Airline Transport Pilot's Licence	
Commander's Age:	62 Years	
Commander's Flying Experience:	21,000 hours (of which 12,000 were on type) Last 90 days - 180 hours Last 28 days - 50 hours	
Information Source:	AAIB Field Investigation

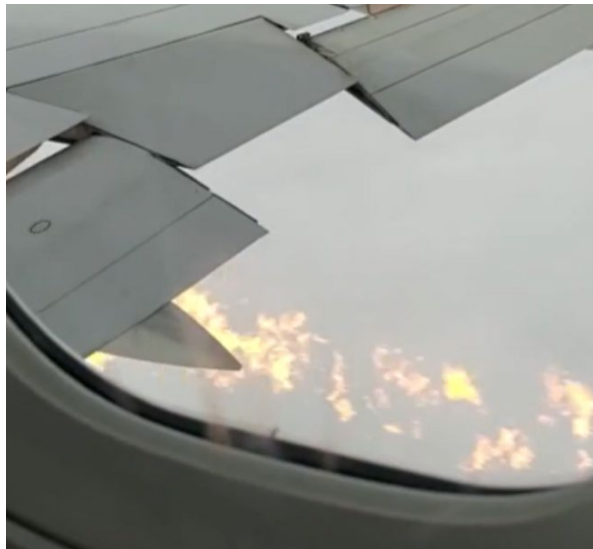
Figure 2

Image from passenger video

The recorded engine fire parameters did not indicate a fire at any point during the flight or taxi. The passenger video (Figure 2) shows fire evident in flight. This was recorded approximately 8 minutes before landing, as the aircraft was levelling from a left turn with flaps deploying. No evidence of fire was found after this time.

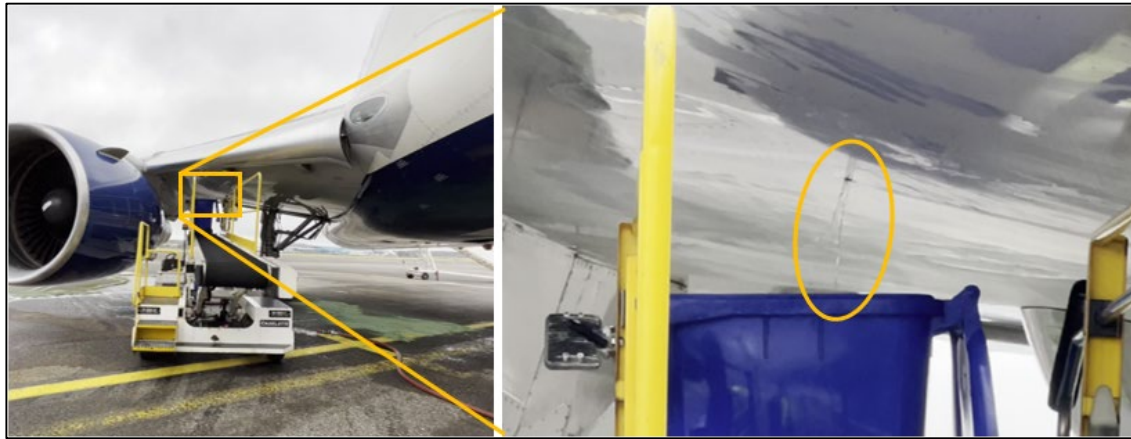
Figure 4

Fuel leaking from the right wing

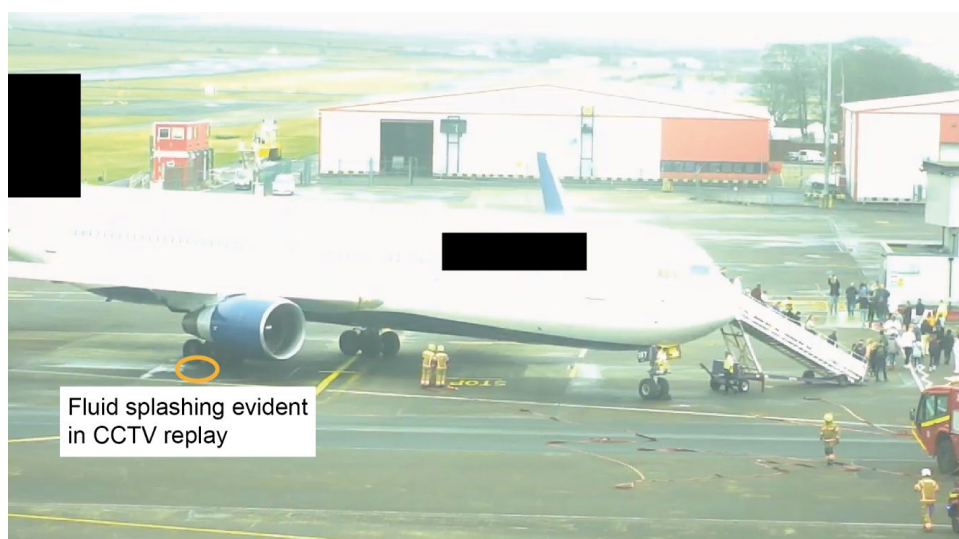
CCTV snapshot showing fuel leak location, disembarkation and AFS attendance

The presence of the fuel leak can be identified when a CCTV camera was zoomed in to the relevant location after the aircraft came to a halt. The first passengers started disembarking via steps at the front left door within 5 minutes of the aircraft coming to a stop, and the last less than 6 minutes later. Figure 7 shows a snapshot from one of the CCTV recordings.

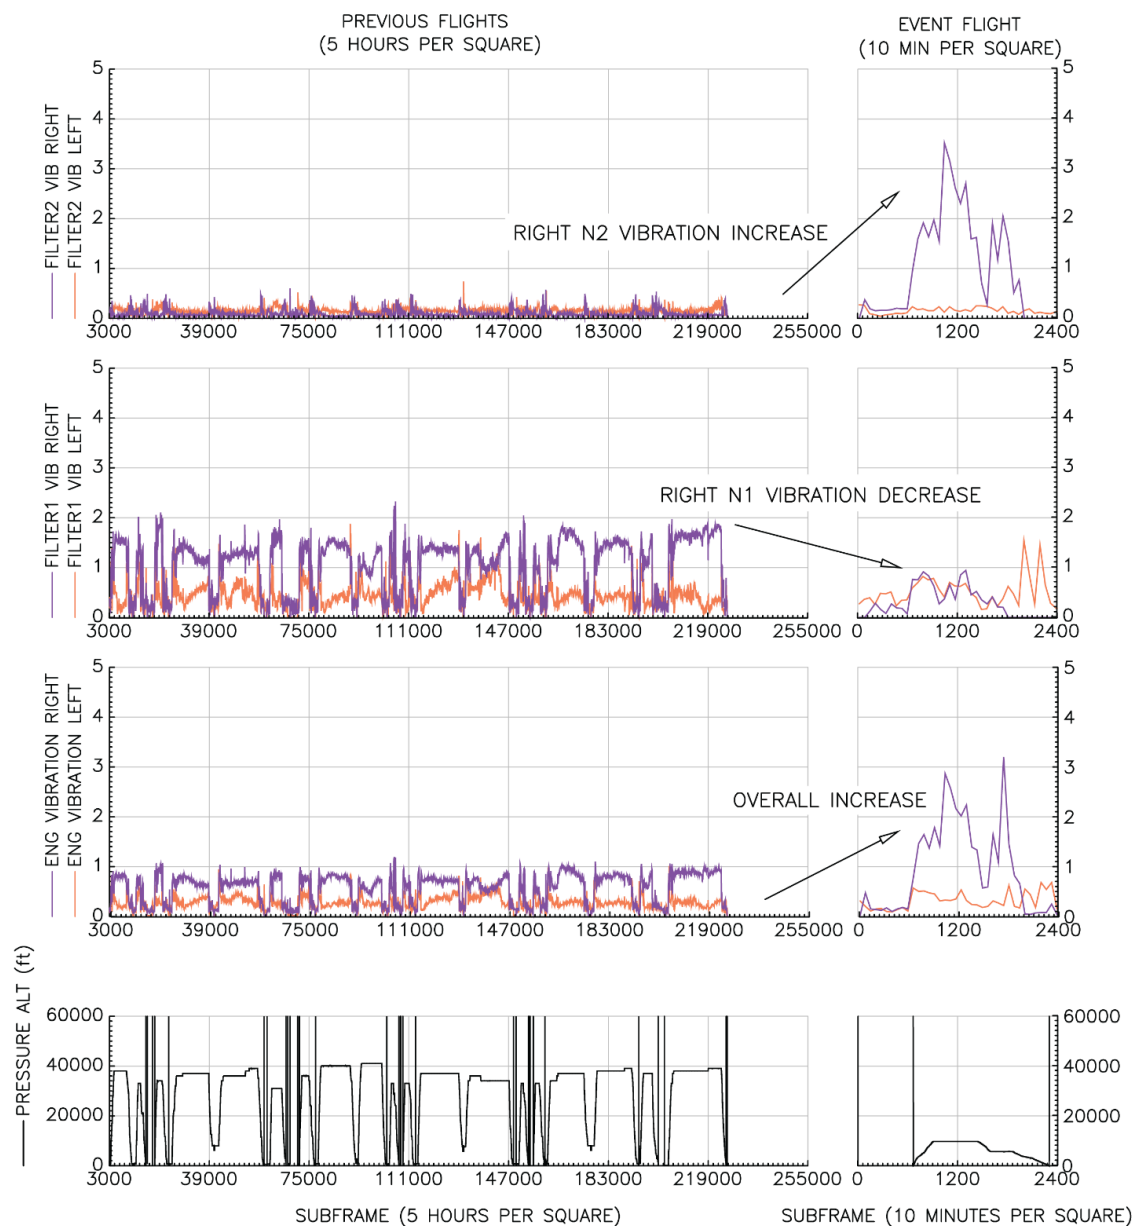
Figure 8 shows the vibration levels of both engines for the most recent flights, including the event flight. The values are not calibrated or in specific units but serve to highlight large changes in vibration levels. The difference between left and right engine vibration values before the event flight were not considered relevant to the investigation. The plot shows that the overall and N2 vibration levels dramatically increased at the start of the event flight. The N1 vibration values decreased.

Figure 8
Vibration data trends

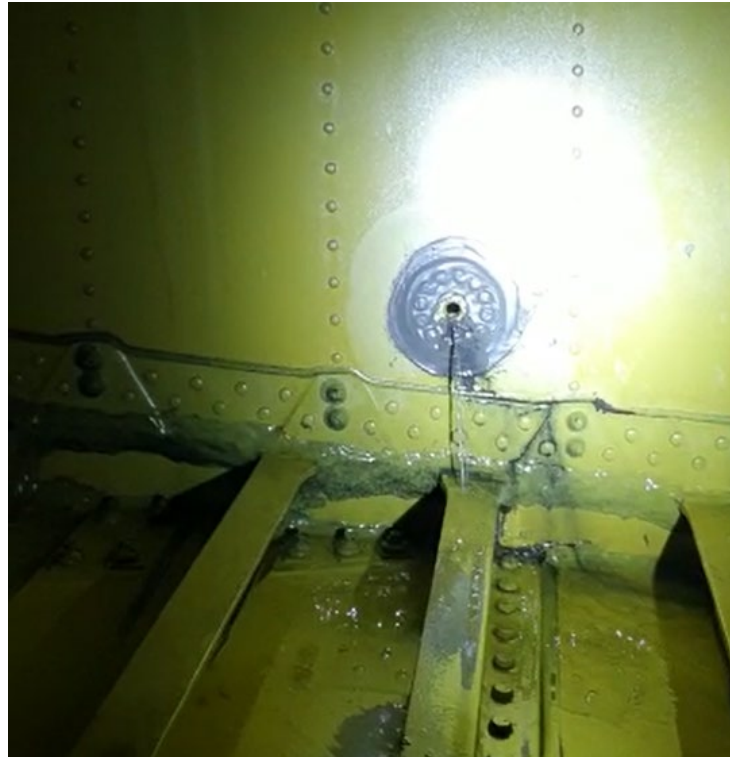
Figure 13

The aircraft was inspected by the AAIB at Prestwick Airport with support from the operator's maintenance personnel and a detailed visual inspection of the dry bay confirmed that it was structurally intact, with no evidence of fuel leaks through joints or sealant. The components of the fuel system which passed through the dry bay were confirmed to be satisfactory with no leaks present. It was noted that after the event the leak was stopped by moving fuel out of the right wing tank into the centre fuel tank. A test was undertaken where fuel was transferred back to the wing tank, and during the transfer the dry bay was monitored for fuel leaks. When the fuel quantity reached approximately 17,000 lb in the wing tank, fuel was seen coming through a fitting on Rib 9 (Figure 13). The flow rate was estimated at approximately 1.5 gallons per minute.

Fuel coming through the fitting on Rib 9. View from inside the dry bay looking outboard.

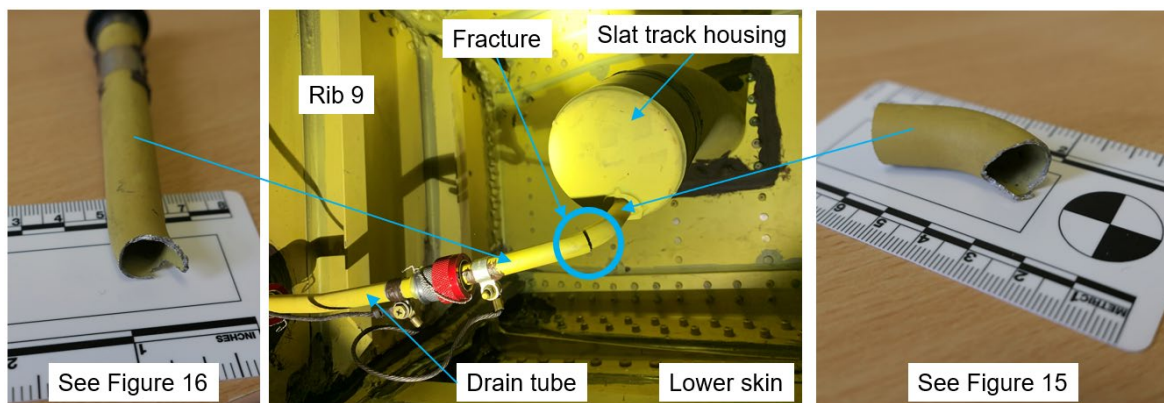
Figure 14

The wing fuel tank was drained, and a qualified mechanic inspected the area outboard of Rib 9. The inspection revealed that the drain tube from the slat track housing to the rib had fractured and had allowed fuel to enter the drain tube (Figure 14). The two pieces of the upstream drain tube section were removed from the aircraft for further examination.

View looking forward of the slat track can showing the drain line fracture (centre)

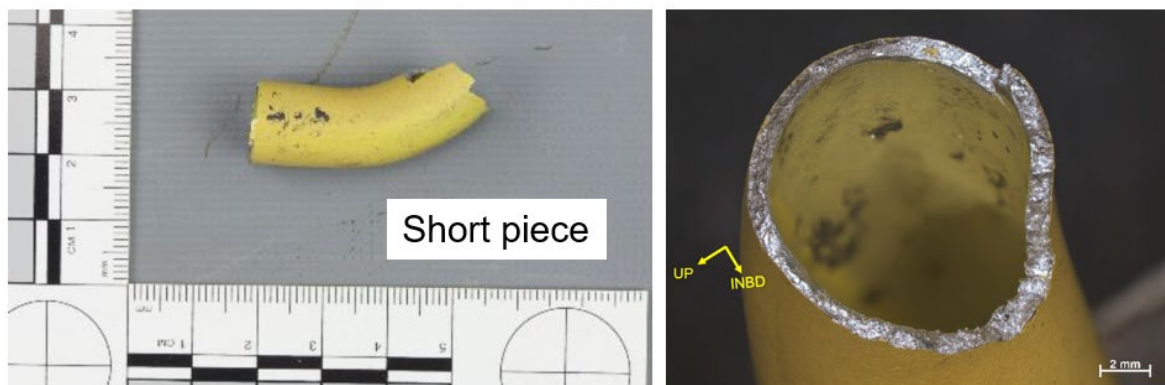
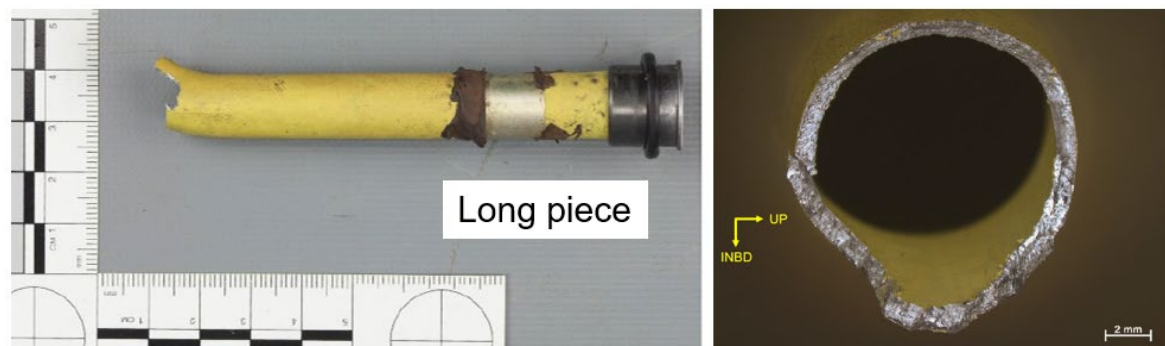
The two pieces of the upstream drain tube (Figure 15 and 16) were examined at a specialist forensic laboratory using an optical microscope and a Scanning Electron Microscope (SEM). Initial examination of the fracture surfaces identified extensive mechanical damage consistent with rubbing between the opposing halves of the fracture. Areas of the fracture surface also exhibited deposits which masked the underlying fracture surface. Energy Dispersive X-ray (EDX) analysis of the deposit found that it was consistent with the primer paint on the inner and outer surfaces. It appeared that once the crack had developed, fragments of paint from the surface had migrated into the crack and had been ground between the opposing fracture faces.

Short piece of drain tube (adjacent to slat track housing)

Long piece of drain tube (adjacent to the coupling)

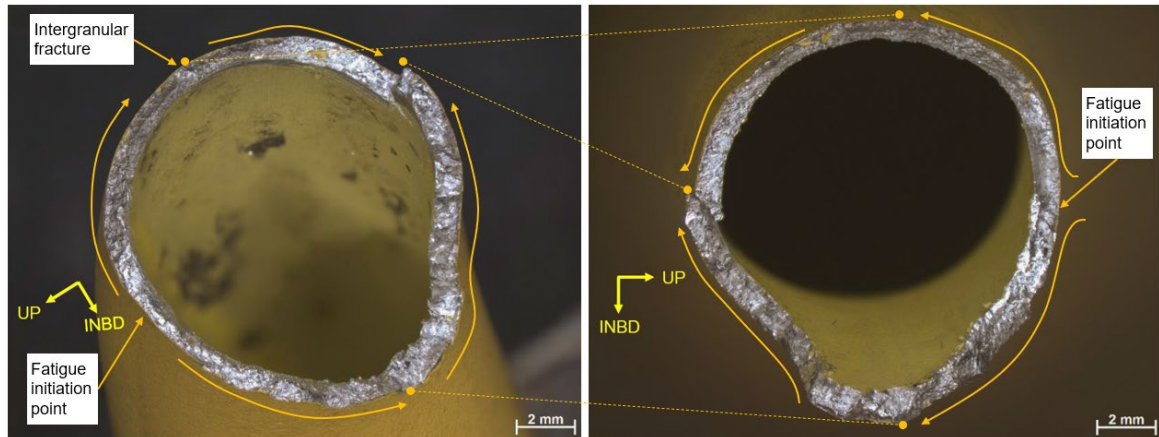
Figure 17

Striations were visible at discrete areas across most of the fracture surface indicating that crack growth was the result of fatigue. The orientation of the striations suggested that fatigue cracks had initiated on the upper surface of the tube and propagated in both directions around the circumference (Figure 17). Although the main crack growth suggested initiation in an area at the top of the tube, it was apparent that multiple cracks had initiated at both the inner and outer surfaces of the tube ahead of the main crack front. These secondary cracks propagated for short distances before joining the main crack. Towards the

inboard edge, the fracture turned downstream towards Rib 9 and propagated for approximately 7 mm in an axial direction before returning to a circumferential orientation. At the bottom of the tube, the two converging crack fronts were on different planes approximately 1.7 mm apart. At this point an overload crack propagated between the two cracks causing the two pieces of the tube to separate.

Left - Short piece fracture face showing crack propagation direction
Right - Long piece fracture face showing crack propagation direction

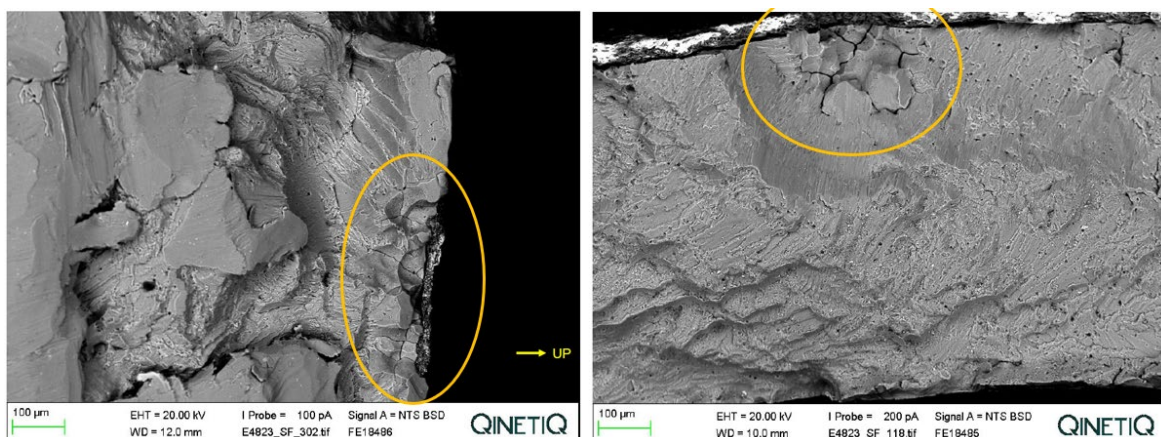
It was noted at the fatigue initiation point on the outer edge at the top of the tube, that an area of intergranular fracture approximately 100 μm deep was present (Figure 18 left). Further instances of intergranular fracture were observed on the fracture surface at both the inner and outer edges. At the outboard side of the fracture an area of intergranular fracture was observed on the outside edge which extended approximately 180 μm in from the outboard edge (location identified in Figure 17 left, shown in Figure 18 right).

Left - Intergranular fracture at the initiation point
Right - Intergranular fracture at the outboard edge of the fracture

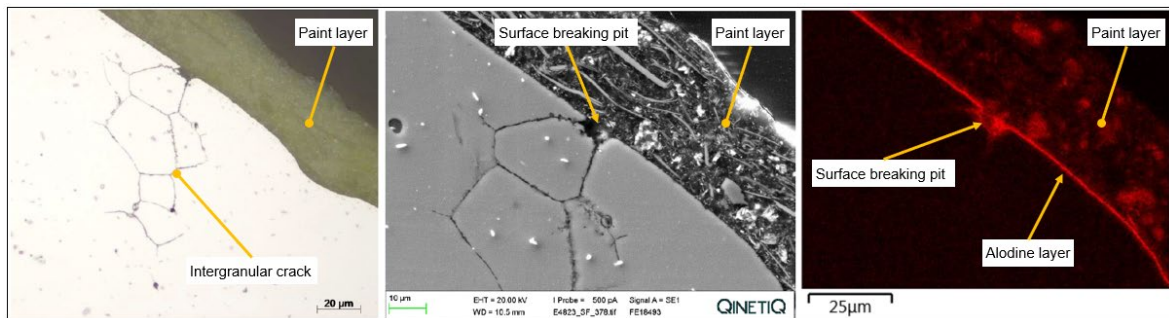
Figure 19

A series of micro-sections were removed from both pieces of the tube away from the fracture face. All the sections highlighted further intergranular cracking present on both the inside and outside of the tube, although it was more prevalent on the outer surface. In some cases, the micro-section showed the intergranular fracture breaking onto the surface (Figure 19), and it appeared to have initiated from a small pit approximately 5 µm deep on the surface of the tube. Further analysis using EDX mapping (Figure 19 right) showed that the surface breaking feature was covered with a chromium rich layer consistent with the Alodine process applied during manufacturing.

Example surface breaking intergranular fracture

It was observed that the chromium rich layer had formed around the bottom of the pit and had partially extended along the grain boundaries which indicated the pitting and intergranular cracking was present before the application of the chromate conversion coating. It also showed that it was present before the part was painted. The pitting and intergranular cracking was therefore not a result of in-service degradation and had been present since the drain tube was manufactured.

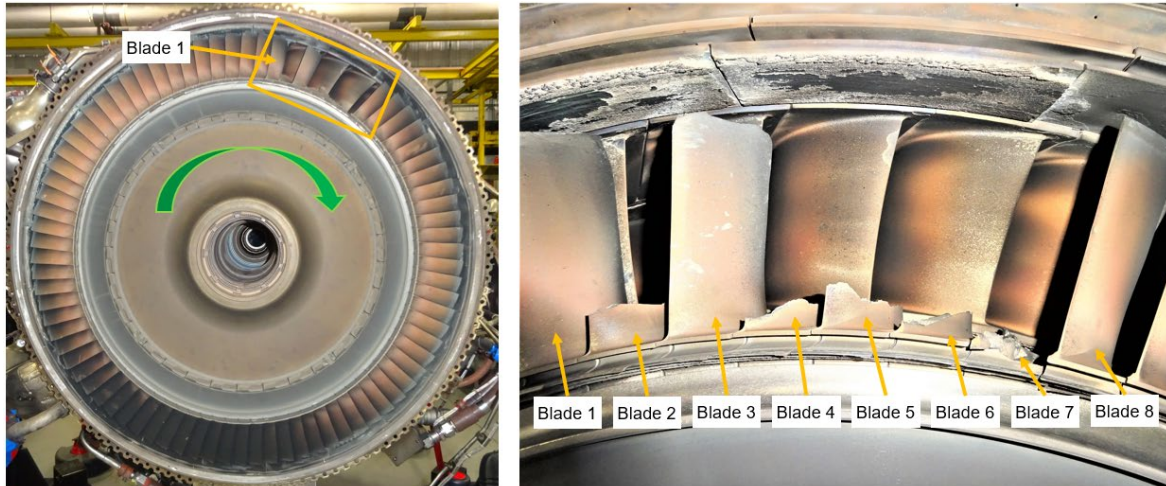
Figure 20

The engine was subsequently stripped at the operator's engine maintenance facility, and it was found that six blades on the HPT 2 disk exhibited transverse fractures (Figure 20). These blades were identified as Blades 2 through 7. Further damage was noted to the turbine section downstream of the HPT 2 disk consistent with turbine blade loss.

Left - View on HPT 2 disk looking forward showing rotation direction

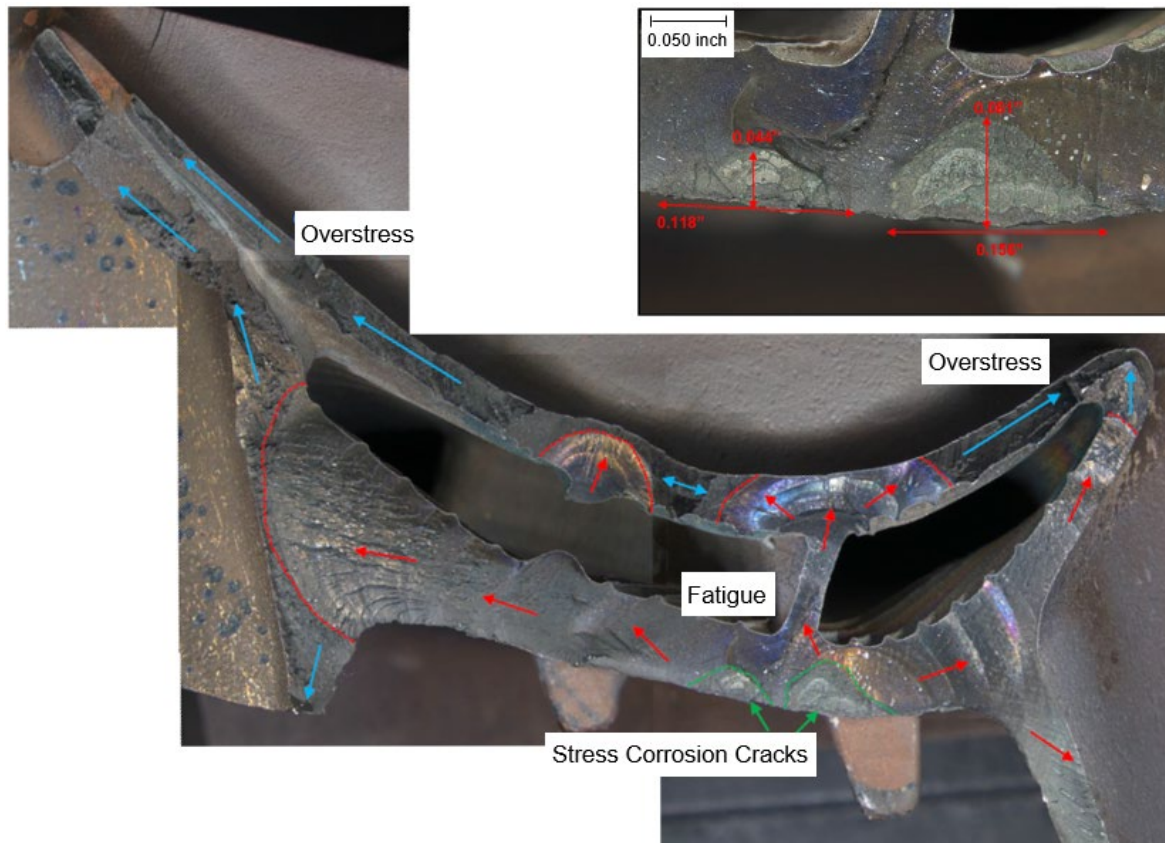
Figure 21

The blade set was examined by the engine manufacturer which revealed that the fracture face of Blades 2 to 6 exhibited jagged non-directional fracture features indicative of rapid tensile overstress due to secondary impact. Blade 7 exhibited fracture features consistent with fatigue, indicating that it was the first blade to detach (Figure 21). The level of imbalance in the subject event exceeded the level of imbalance observed in two prior B767 events that resulted in the fracture of the slat track housing drain tube.

Detailed examination indicated that the fracture initiated from two Stress Corrosion Cracks (SCC) at the forward rib external convex wall (identified in green in Figure 21), which measured 3.96 mm (0.156 inch) wide by 2.06 mm (0.081 inch) deep and 3.00 mm (0.118 inch) wide by 1.12 mm (0.044 inch) deep. SEM examination of these areas revealed these cracks extended from multiple origins along the external convex wall surface, but the exact origins could not be determined due to oxide scale and rubbing damage. EDX mapping of the fracture surface and exterior convex wall surface revealed it was composed primarily of mixed nickel-based alloy oxides and aluminium-platinum based coating oxides. The regions of pitting and oxide scale also exhibited silicon, which could have originated from dirt ingested during engine operation. EDX mapping of the crack attack front of a pit, paired with Wavelength Dispersive Spectroscopy revealed the presence of sulphur, indicative of sulphation attack, otherwise known as hot corrosion. Further evaluation of the fracture surface found evidence of fatigue on both the convex and concave side walls. The fatigue progressed from the extremity of the cracks (identified in red in Figure 21) and exhibited arrest features indicative of high cycle fatigue. Final blade fracture was by overload stress, identified in blue in Figure 21.

Detail of the Blade 7 fracture face (Used with permission)

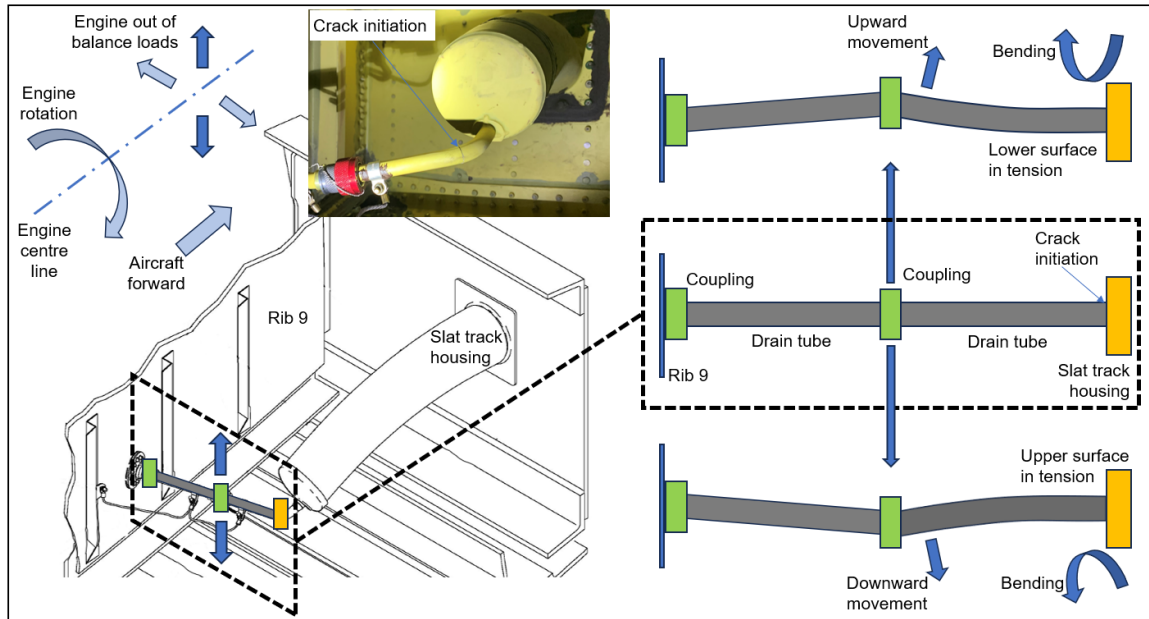
Figure 22

Drain line fracture mechanism

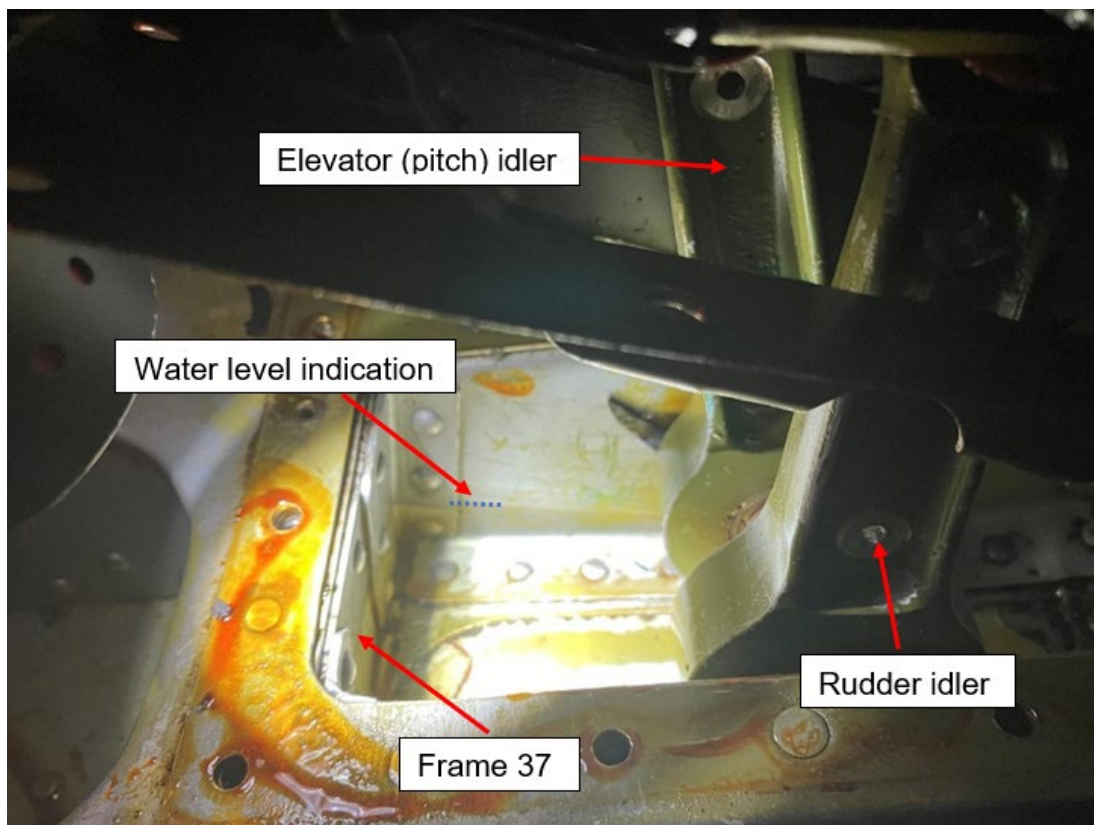
Figure 1

Examination of the aircraft by the operator found evidence of trapped water in the control box compartment, at frame 37 in the rear fuselage, under the elevator (pitch) control idler (Figure 1). No other anomalies were found with the pitch control system or its components.

Control box area in rear fuselage
(Image used with permission)

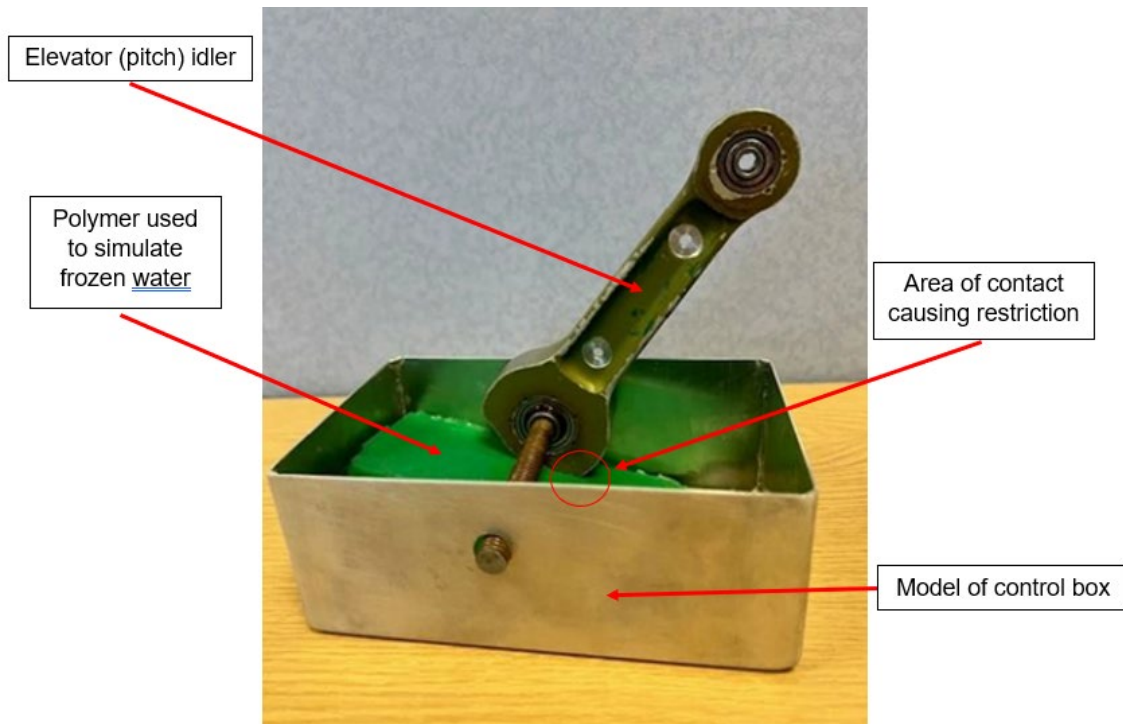
Figure 2

Testing using a model of the control box and a polymer to simulate the water level, showed that if this water froze into ice, it could restrict pitch control movement (Figure 2). The area of contact with the ice was a flat section of the idler that had been shaped to allow clearance with the aircraft skin.

Test model showing how frozen trapped water could restrict control movement
(Image used with permission)

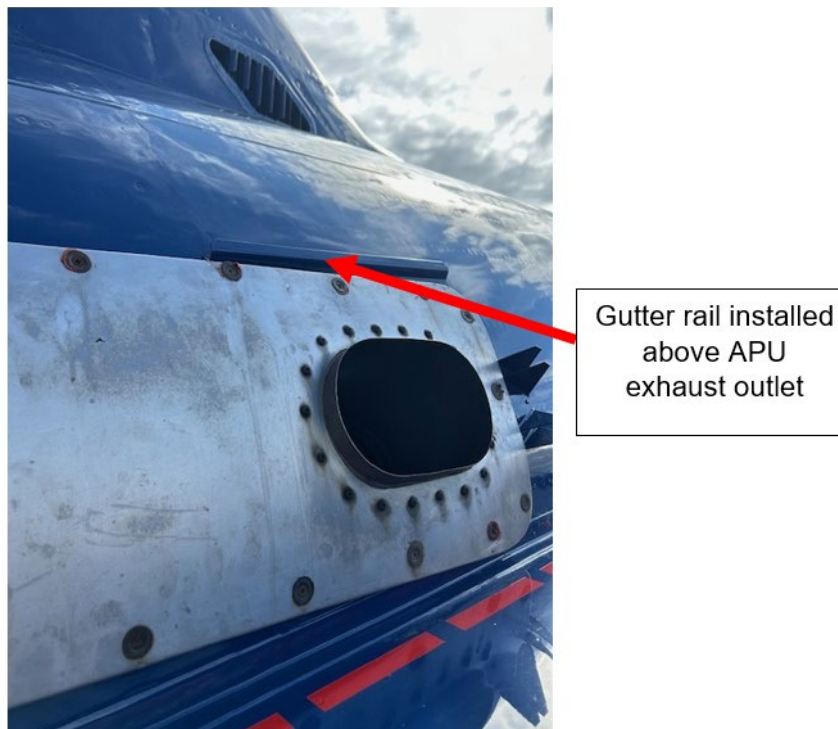
Figure 3

Gutter rail installation
(Image used with permission)

To reduce rainwater ingress, a 'gutter rail' has incorporated above the APU exhaust to direct rainwater away from it (Figure 3).

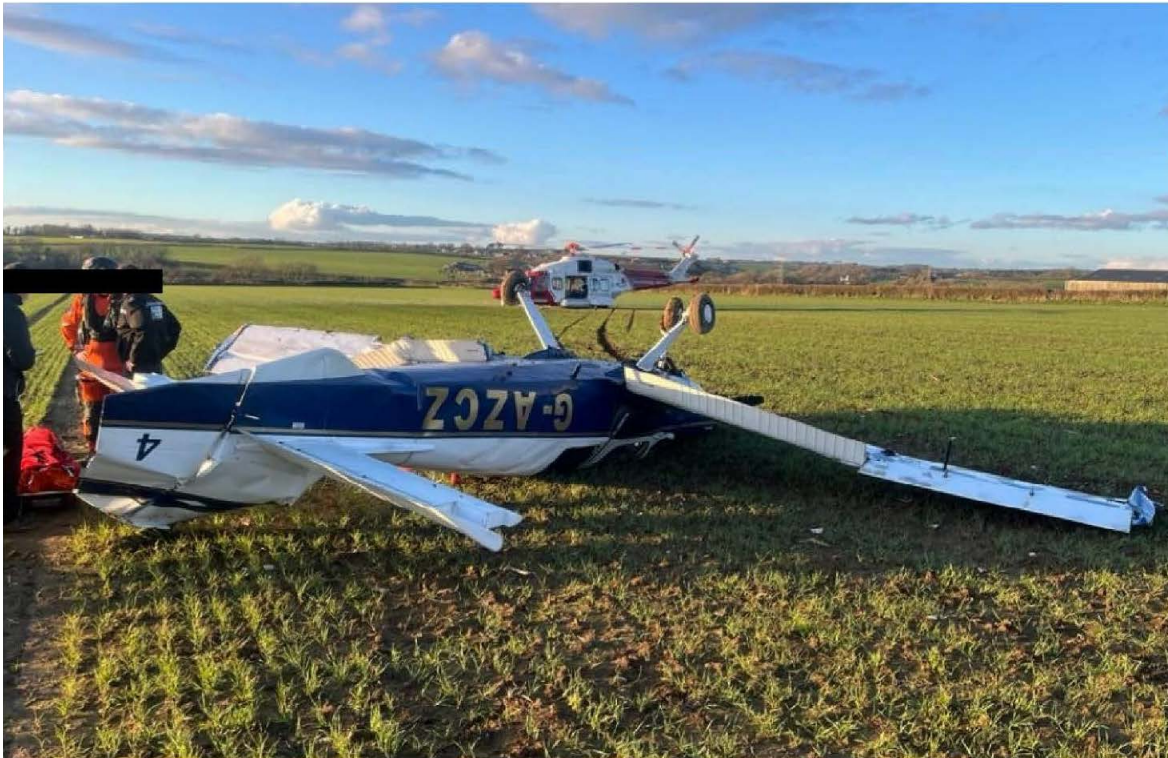
The aircraft (Figure 3) was recovered to St Athan the day after the accident. This was performed with the assistance of staff from the maintenance organisation that had maintained the aircraft. It was reported that the aircraft's fuel tanks were intact and both fuel tank filler caps were fitted and secure. There was no smell of fuel or evidence of fuel contamination of the surrounding soil. When the fuel tanks were inspected prior to removing the wings, they were found to be empty of fuel.

Figure 3
Accident site

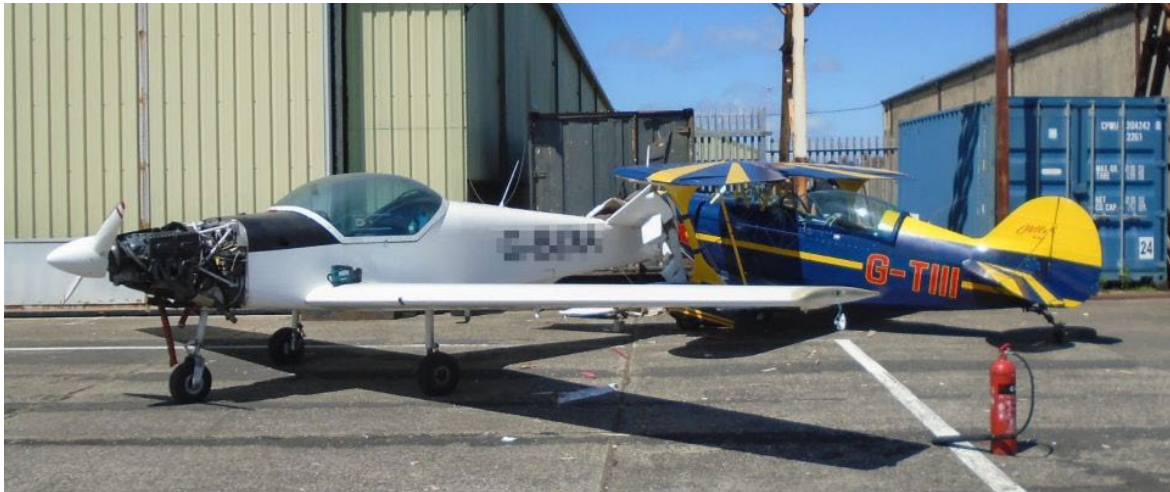
Figure 1

The aircraft after the collision

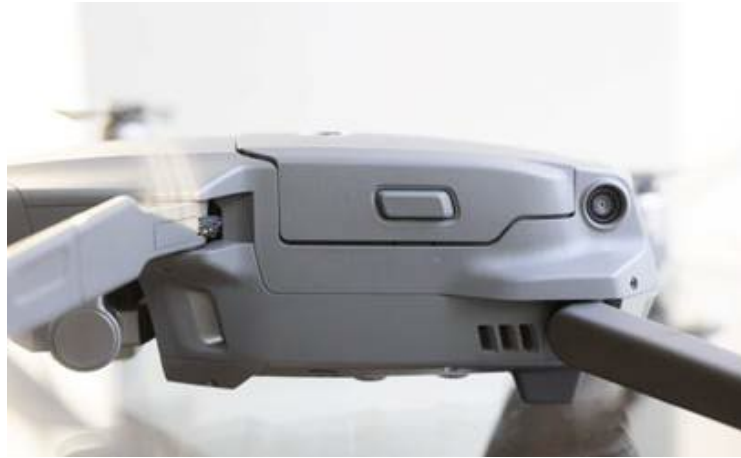
Figure 1

Battery not properly secured, but with button positions that could indicate it was if viewed from above. (Used with permission).

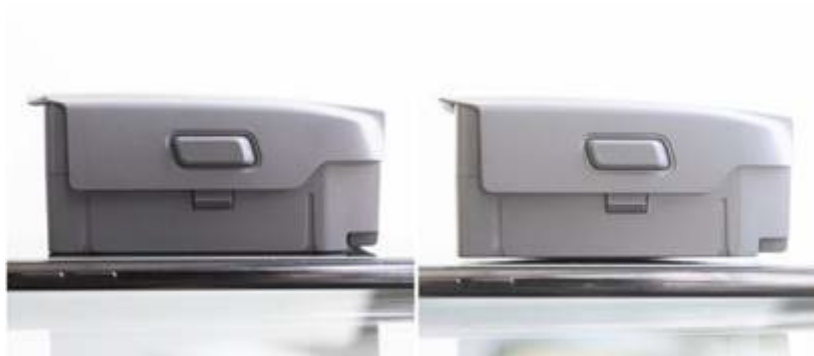
Figure 2

Battery without swelling with a flat underside (left) compared with one with swelling evident (right). (Used with permission).
