Rail Accident Investigation Branch

Rail Accident Report

Overspeed at Spital Junction, Peterborough 4 May 2023

Report 10/2024
September 2024

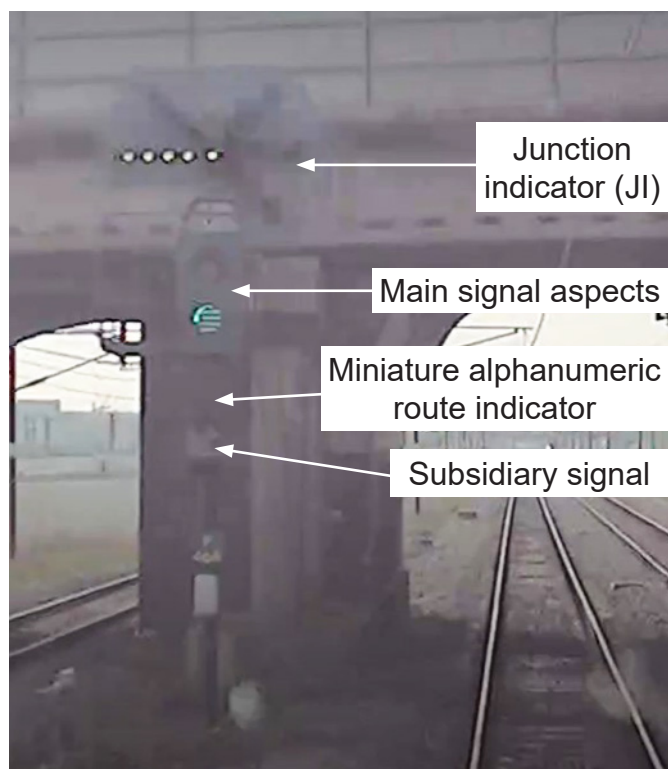
Figure 5: Annotated image of P468 signal.

- 14 Trains approaching on the Up Fast line are signalled from P468 signal across the junction. The signal is located around 700 metres on the approach to the point of divergence towards the Up Slow No 1 and Up Slow No 2 lines which lead to platforms 1 and 2 respectively. P468 signal is a four-aspect colour light signal with a position light junction indicator (referred to as a junction indicator (JI) in this report) (figure 5). P468 signal can display red, yellow (caution) and green aspects in the lower aperture and an additional yellow in the top aperture when required to display double yellow (preliminary caution) aspects.

- 15 The JI on P468 signal can show five different indications, meaning a train can be signalled to go in one of six different ways beyond the signal (the JI is not illuminated for trains going straight ahead on the Up Fast line). Figure 6 shows where a train can go to from this signal and what the associated JI indication will be for that route. The signal is also fitted with a subsidiary signal and a miniature alphanumeric route indicator. These are for occasions when a train is signalled into a platform at Peterborough station that is already occupied by another train and are not relevant to this incident.

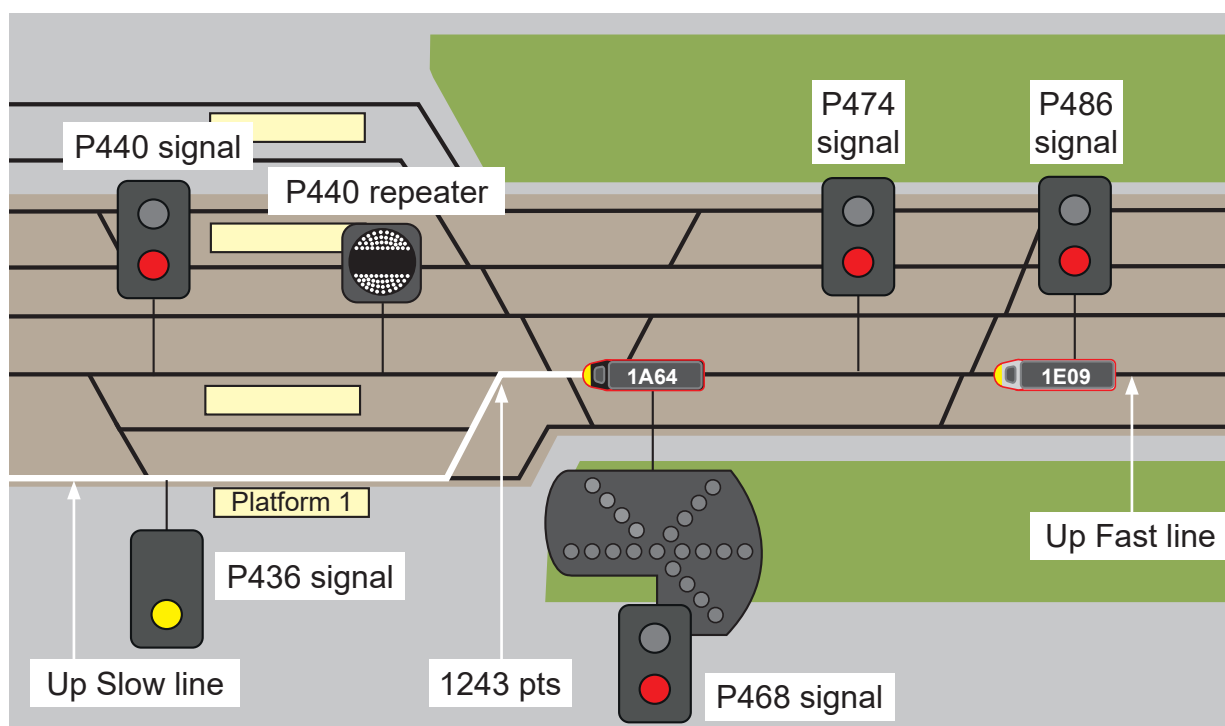
Figure 19: Train 1A64 passes P468 signal travelling at 50 mph (80km/h) still accelerating.

- 64 At 12:59:27 hrs, when the train was approximately 680 metres from the signal, the driver applied full power.
- 65 At 13:00:14 hrs, train 1A64 passed P468 signal travelling at 50 mph (80 km/h) and still accelerating under full power. P468 signal had at this point been displaying its green aspect and JI lights to the driver for 63 seconds (figure 19).

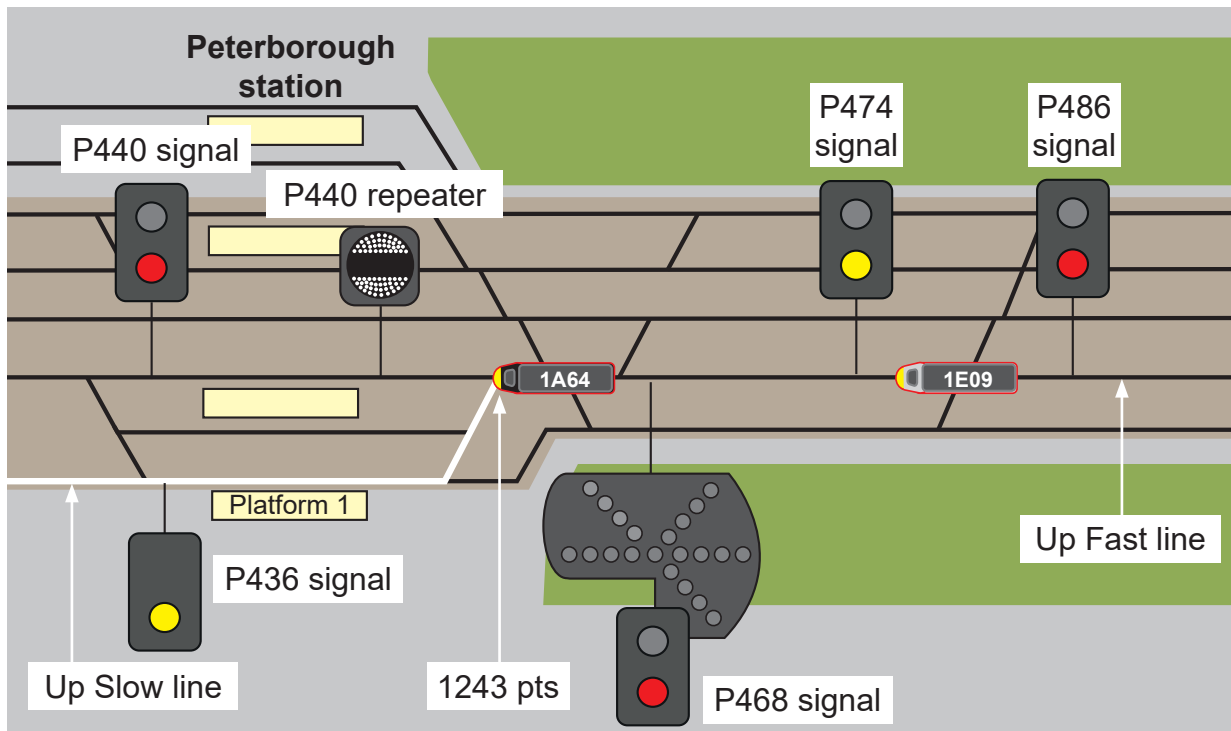
Figure 20: Train 1A64 reaches the point of divergence at the junction travelling at 66 mph (106 km/h) and still accelerating.

66 At 13:00:42 hrs, train 1A64 reached the divergence at the junction, still accelerating and travelling at 66 mph (106 km/h). Responding immediately to the train lurching at the first set of points, the driver moved the power brake controller from full power to command full emergency braking (figure 20).

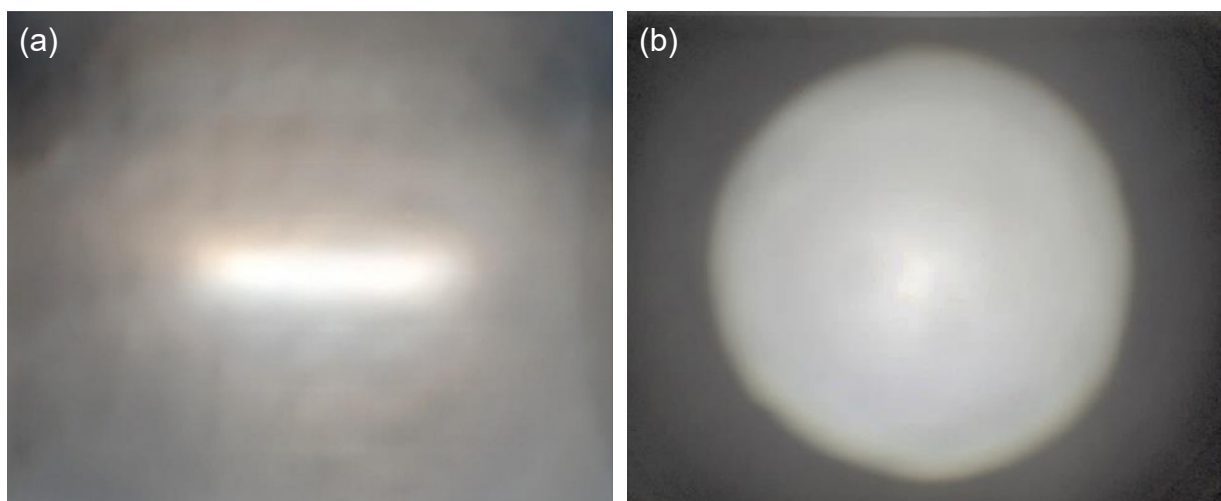
Figure 26: JI projected beam characteristic from filament indicator (a) and LED module (b).

- 136 The LED JI light modules were found to be at different alignments within the JI housing, ranging between -0.4 and -2.7 degrees error relative to the designed position within the housing. The pivot light was also found to be installed upside down. These issues are likely to be a consequence of the sample JI having been supplied from one of Network Rail's training centres and is unlikely to be representative of the LED JIs in use. To account for the misalignment, the luminous intensity of all modules was tested 'on-axis' and relative to the light module itself, and not to its position within its housing.

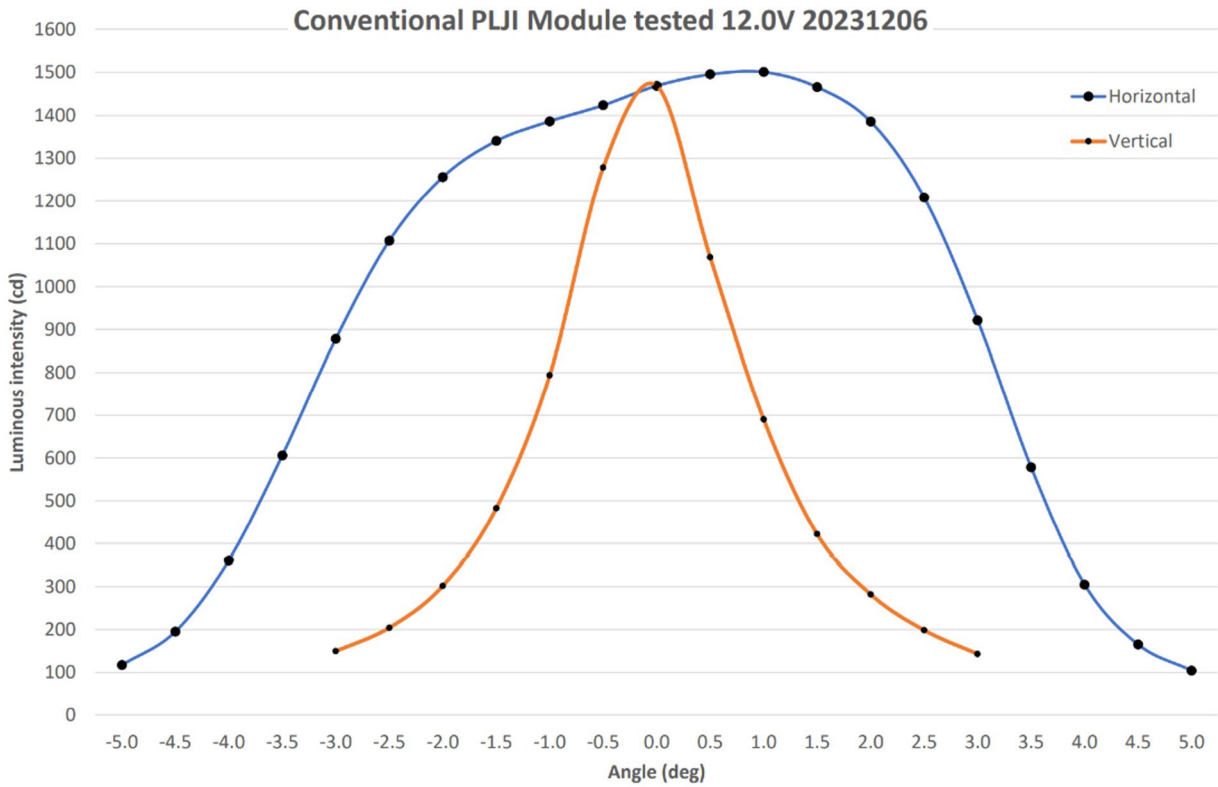
Figure 27: Measured luminous intensity from a filament JI module.

- 138 The measured on-axis luminous intensity of the LED JI modules was significantly lower than the output measured for the BRS SE 156/1 filament bulb module, which was approximately 1,450 cd (figure 27). Although the product acceptance testing verified that an LED JI was readable at the required distance of 800 metres, the testing shows that the output of the LED JI module is significantly lower than the output of the example filament JI module it was intended to replace.

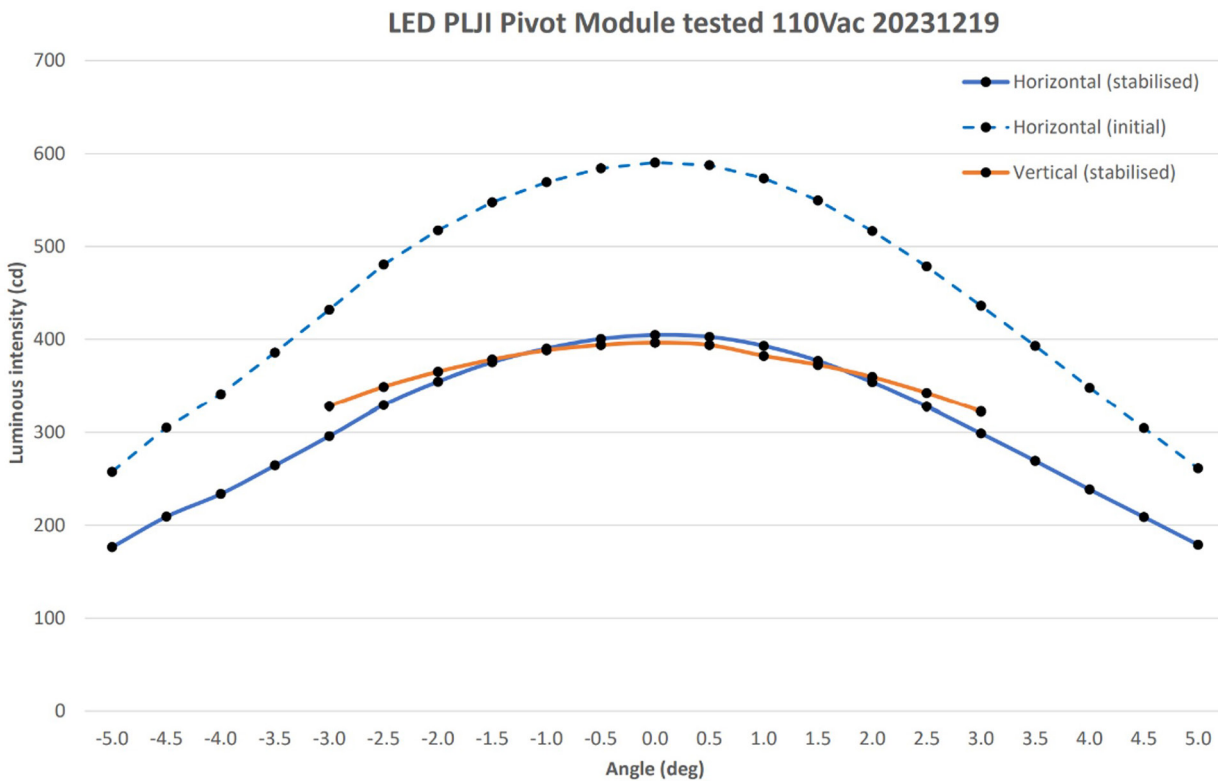
Figure 28: Measured luminous intensity from an LED JI module.

- 137 During testing, the LED JI modules were found to emit a greater luminous intensity when initially illuminated. The luminous intensity reduced as the modules became warmer. Although it is unlikely that the LED JI modules fitted to P468 signal would create sufficient heat to affect the light output during the time they were illuminated for an approaching train, it was necessary to allow the modules to stabilise to enable the testing to take place. When tested, the LED JI pivot light module produced the highest output of 591 cd¹³ initially, which reduced to 403 cd once it had stabilised after 40 minutes (figure 28). The other LED JI light modules produced a light output of between 255 cd and 314 cd when stabilised.

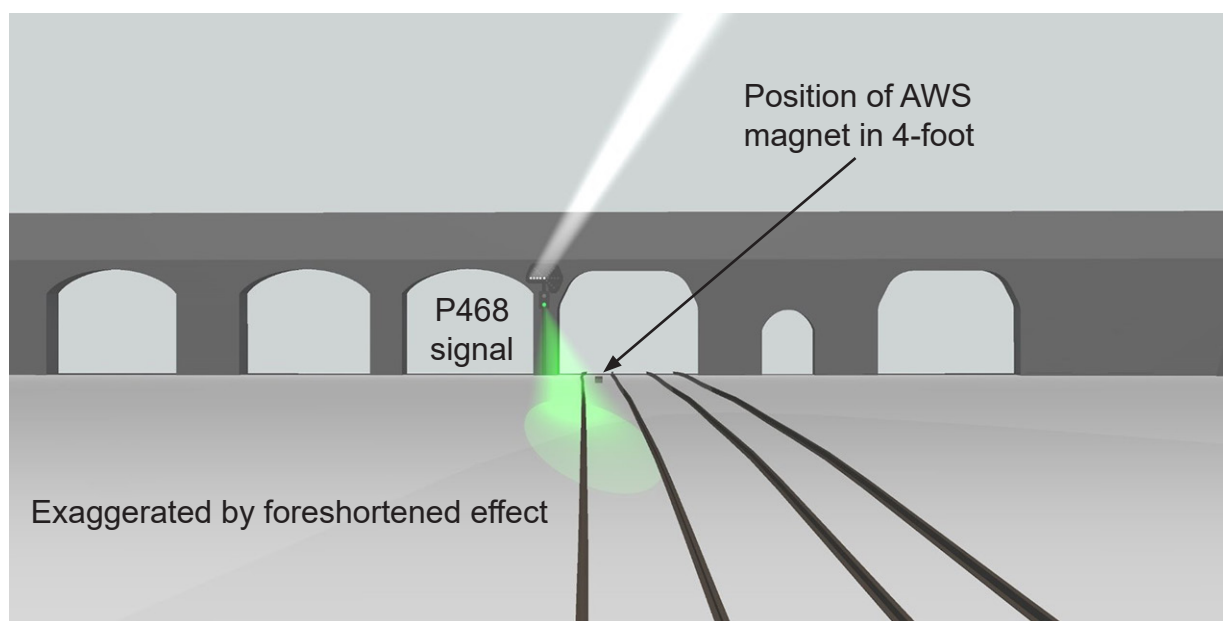
Figure 29: Alignment of green aspect and JI when viewed at 800 metres from P468 signal.

- 142 When a beam drawn from the green aspect and JI of P468 signal is overlaid on the topographical survey of the Up Fast line, the centre line of the green main aspect was found to be pointing down towards the track, and the JI pointing upwards (figure 29). This downwards alignment of the main aspect is in line with signal sighting guidance to aim the main signal towards driver's eye level at the AWS magnet associated with the signal. Figure 30 places an approaching train at 100 metres (110 yards) from P468 signal. At this distance, the centre of the green aspect beam is to the left and at a height approximating that of a driver's eye line. In contrast, the top of the windscreen of an approaching train is approximately 5 degrees below the centre of the beam projected by the JI.

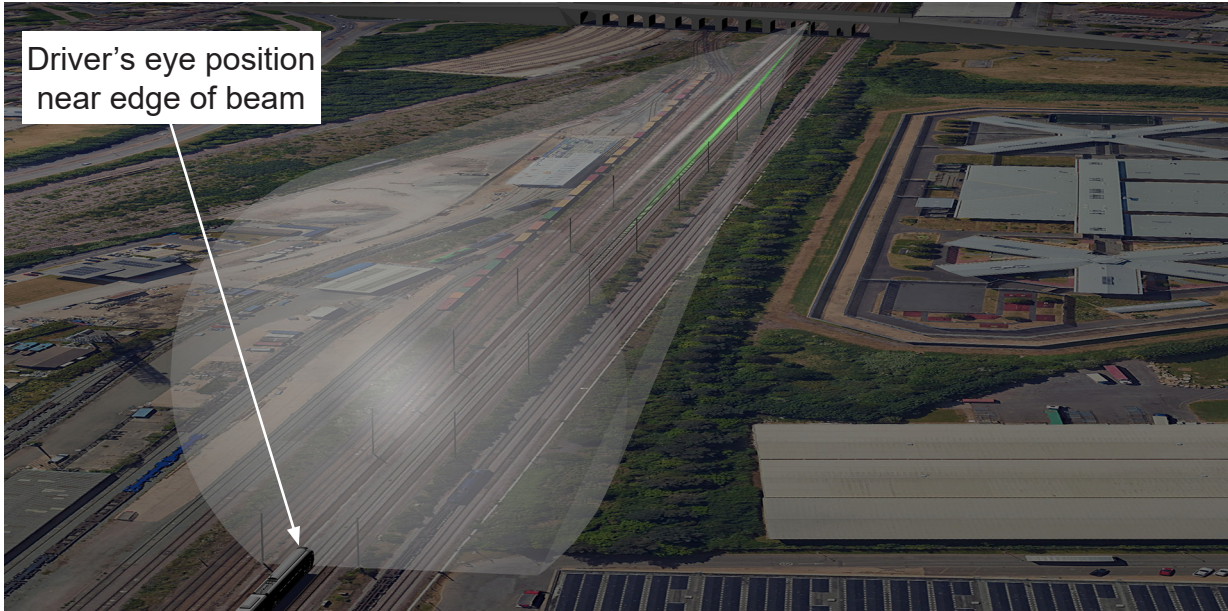
Figure 31: Illustration of the JI beam projected by a 5-degree cone out to a distance of 800 metres.

143 When these beams are projected to 800 metres (875 yards) from P468 signal, the centre of the green aspect beam remains closer to the driver's eye level, although below the windscreen level of an approaching train. However, the centre of the JI is much further from the driver's eye line (figure 31).

144 It is likely, therefore, that the conspicuity of the route indication was reduced compared to that of the green main aspect because:
