## Serious injury to a crew member on board the survey and supply vessel *Kommandor Orca* at Portland, England on 16 August 2022

### SUMMARY

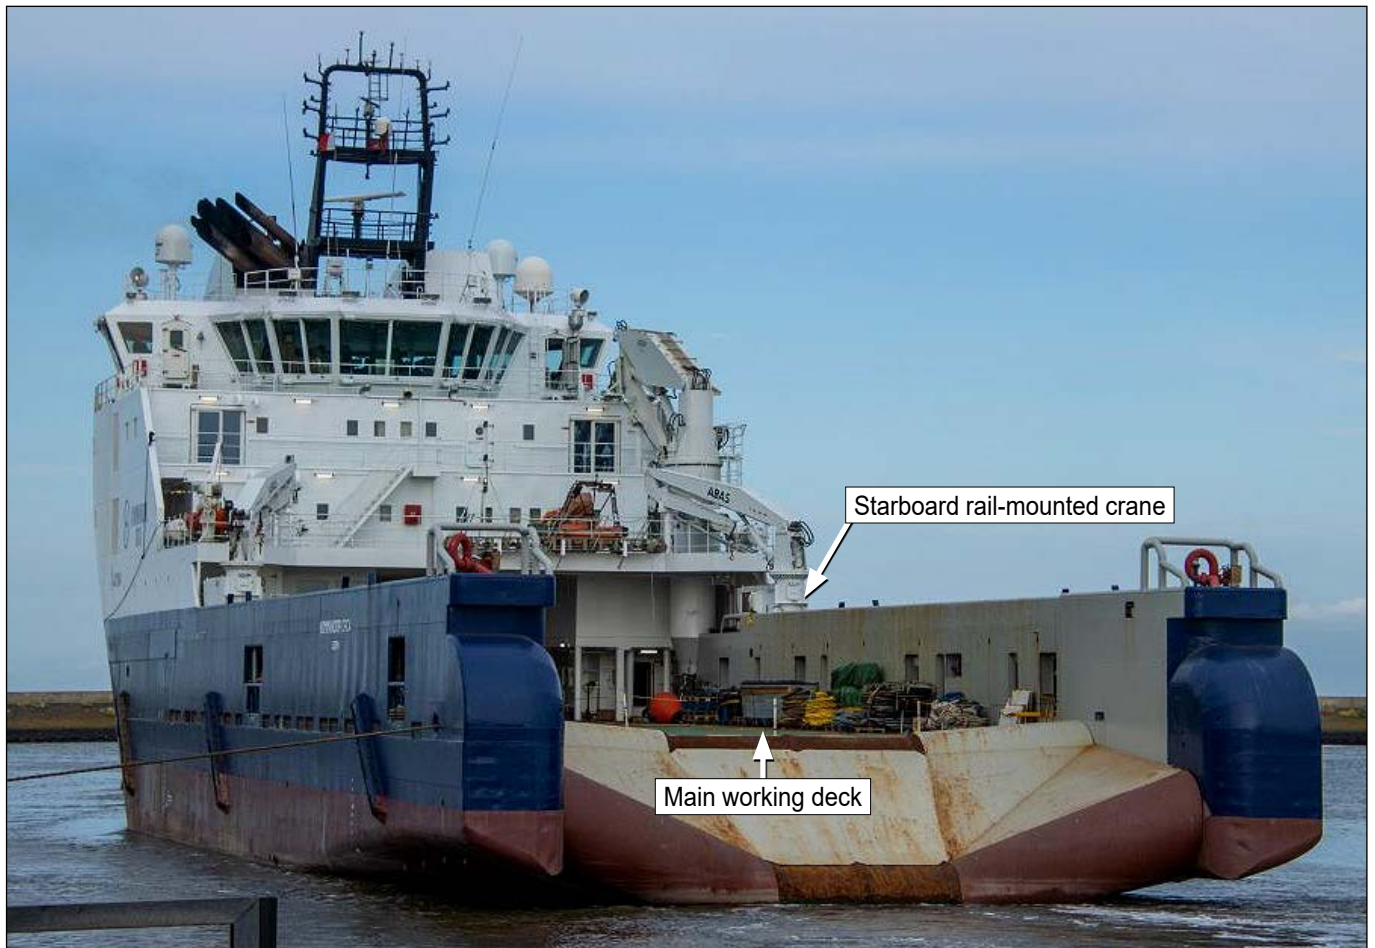
**Figure 1:** *Kommandor Orca*'s deck arrangement

At 0800<sup>1</sup> on 16 August 2022, *Kommandor Orca* was alongside at Portland, England preparing for a contract. The vessel's chief officer (C/O) held a toolbox talk with the vessel's second officer (2/O), fitter and a deck rating to plan the day's work. During the toolbox talk the C/O also completed the lifting plan and permit to work for moving several items of deck gear and machinery. The C/O returned to the bridge after the toolbox talk, while the 2/O and the fitter used a pallet truck to move equipment on the vessel's main deck. They decided to move heavier items using the starboard rail-mounted crane (**Figure 1**).

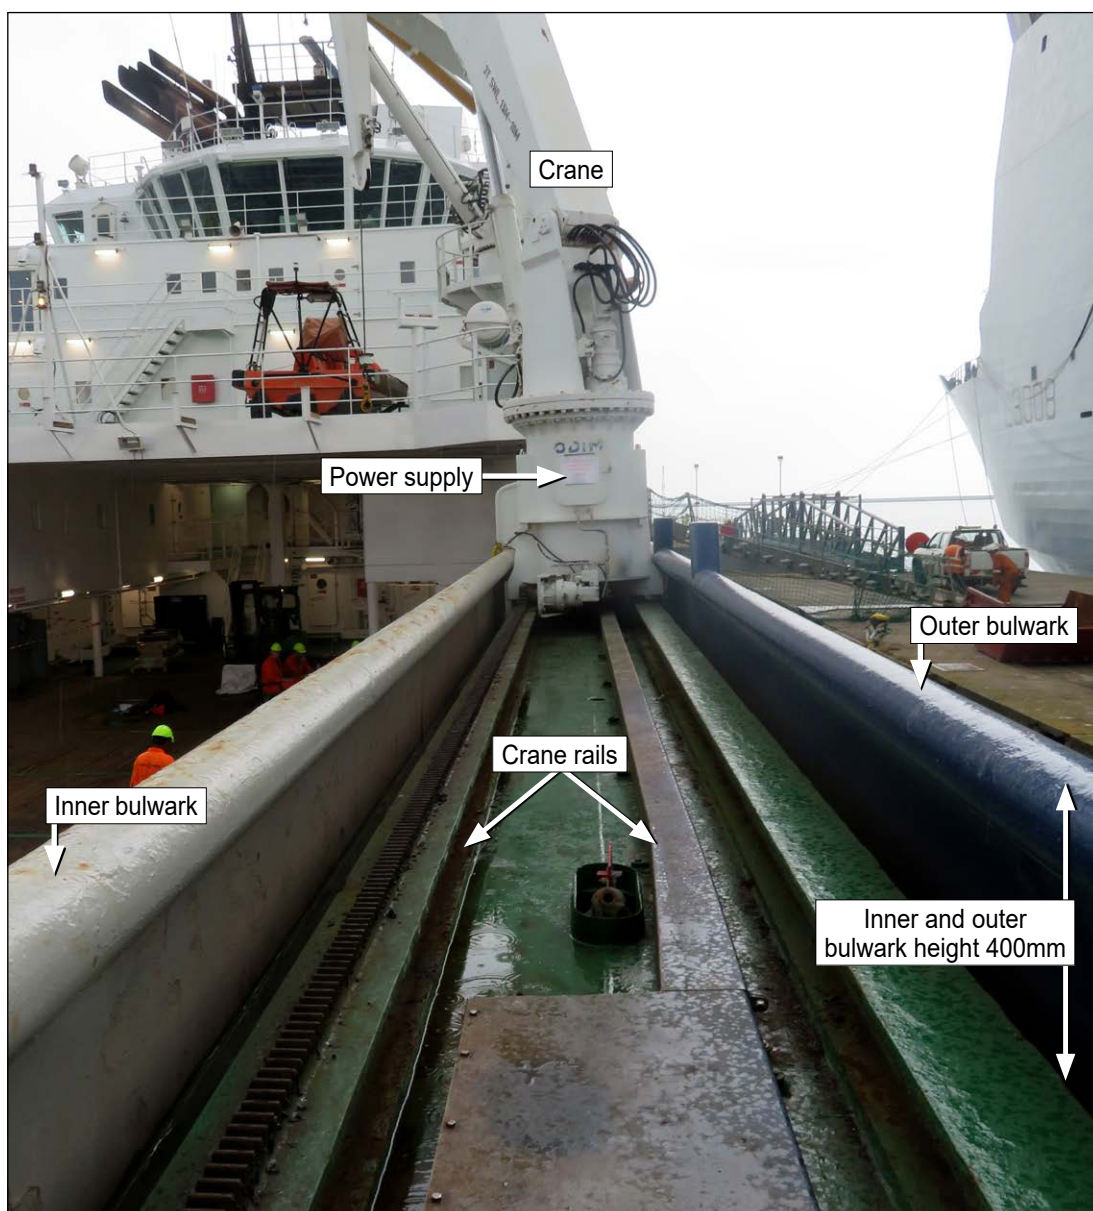
**Figure 2:** Starboard rail-mounted crane

The 2/O climbed up the ladder from the aft main deck and walked forward along the starboard crane rail to access the crane (**Figure 2**). The 2/O then used the local hydraulic valve controls in the pedestal (**Figure 3**) to manoeuvre the crane to reposition two loads on the main deck. While conducting a third lift, the 2/O stood with his left foot on the inboard bulwark and his right foot on the crane drive motor casing (**Figure 4a**); this enabled him to see both the fitter and the load positioned 4m below on the main deck.

The vessel had two rail-mounted cranes, each with a safe working load of 3 tonnes, which were fitted 4m above the main deck on platforms running the length of the deck, one on the port side and one on the starboard side. An outer and inner bulwark of 400mm in height was adjacent to each crane rail (see **Figure 2**).

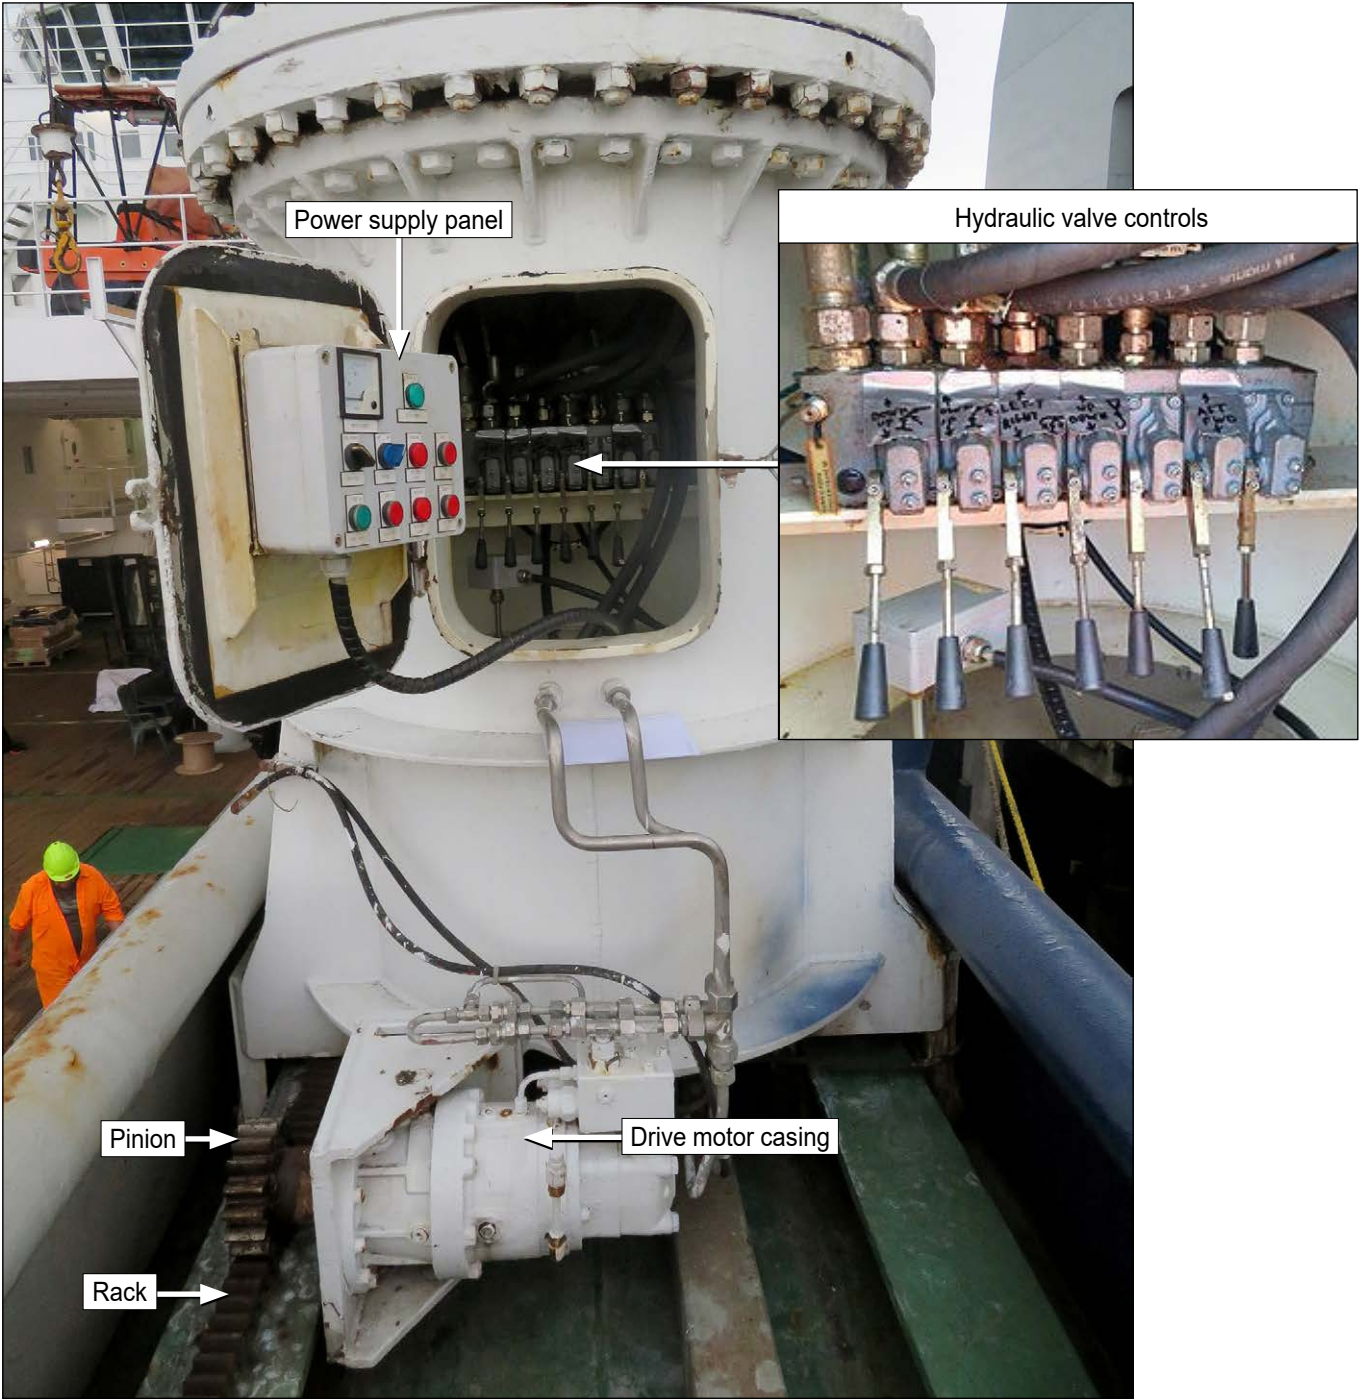
**Figure 3:** Crane local controls and (inset) the duct-taped instructions on the hydraulic valve controls

The crane pedestals housed the local hydraulic valve controls (see **Figure 3**) behind an access hatch. These local controls were proportional, which meant that the selected function sped up as the lever was increasingly pushed or pulled. At some point in time before the accident the crew had annotated the local controls using permanent marker pen on duct tape to indicate the function of each lever. The manufacturer's operations manual, which was available on board, stated that the local controls were for *emergency use only* and that normal operation was to take place using either the bridge station or the remote control unit.

The manufacturer's manual stated that the crane was to be remotely controlled from either the bridge station or the wireless remote control unit on the deck, and that the local hydraulic controls were for *emergency use only*. The starboard crane could have been operated using the wireless remote or the bridge control position. However, the inability to use the wireless remote control on the port side crane due to a fault, the visibility constraints of the bridge control, and the need to mobilise the remote controls, appeared to have had the senior officers and crew seek the simplest solution and operate both cranes using the local controls. Additionally, in the absence of permanent and legible signs, the crew had labelled the crane's local controls with duct tape and marker pen, which was neither questioned nor alerted anyone to the fact that this was not the usual method of operation.

- Mandated the use of the bridge station and wireless remote control units when operating the rail-mounted cranes.
- Provided its crews with instruction in lifting operations by an approved training organisation.
- Undertaken a full review of its SMS and amended the sections on crane operations and cargo handling.
- Fitted *Kommandor Orca* with bulwark guardrails, rack and pinion guards and a crane emergency stop to enable safe access to the local controls for maintenance, or in the event of a remote control unit failure.
- Supported the injured 2/O with the intent to continue his employment in a suitable capacity.

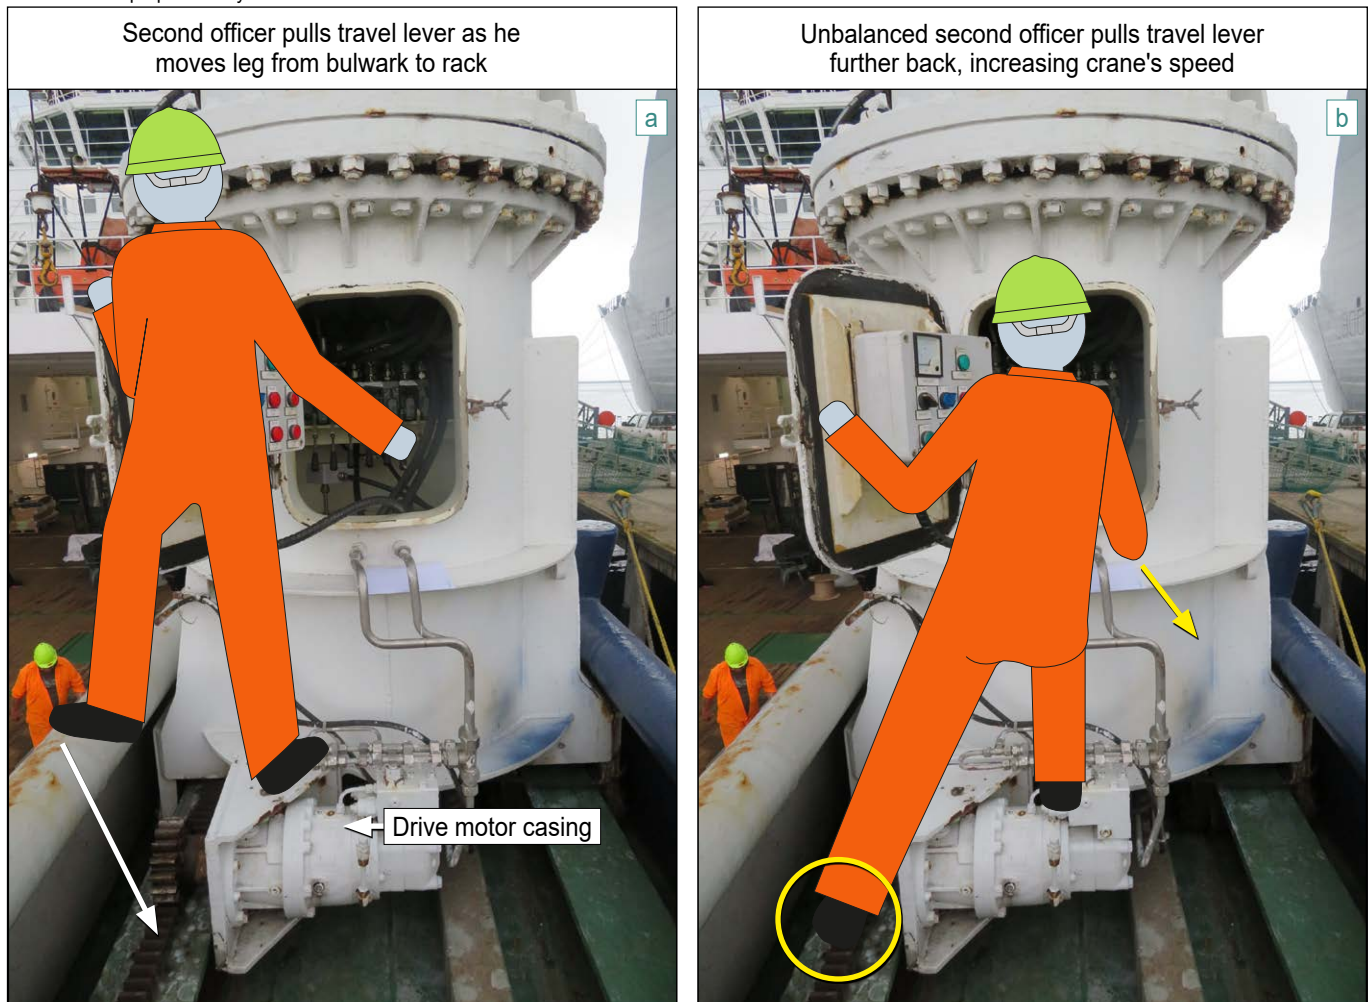
Figure 4: Positions and movements of the second officer

At 0841, *Kommandor Orca*'s 2/O pulled the travel control lever to move the crane a few metres aft. At the same time, he moved his left foot from the bulwark to the rack (**Figure 4b**). He then felt his left leg overalls being pulled, which unbalanced him and forced his right leg closer to his body. He held onto the

*Kommandor Orca's* 2/O was following his training when he operated the crane's local controls from the exposed position at height and without safeguards. His position, with his left foot on the inboard bulwark and his right foot on the crane drive motor casing, was stable until he needed to step down from the bulwark as the crane moved aft. When the crane mechanism dragged his boilersuit into the unguarded rack and pinion gear, he lost his balance backwards and continued to hold on to the travel control lever. The added pressure that this applied to the lever was an automatic reaction, which in turn increased the crane's speed and dragged the 2/O's leg further into the pinion gear.

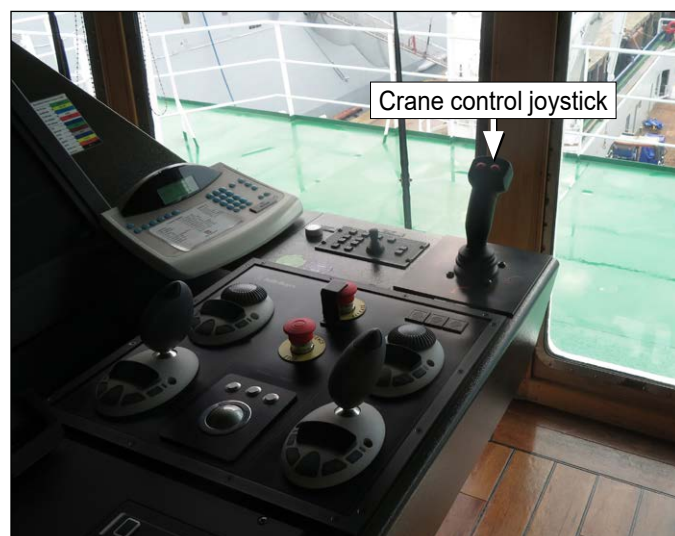
**Figure 5:** Bridge aft station, showing left-hand crane control joystick

The cranes could be controlled remotely, either from the bridge aft station overlooking the main deck (**Figure 5**) or by using a wireless remote control unit (**Figure 6**). A wireless remote control fault required that the port side crane could only be operated using the local emergency controls, or the bridge control. The starboard crane was operable with both remote and bridge controls.
