Near miss between a train and heavy goods vehicle near Craven Arms, Shropshire, 22 July 2024

Summary of the incident

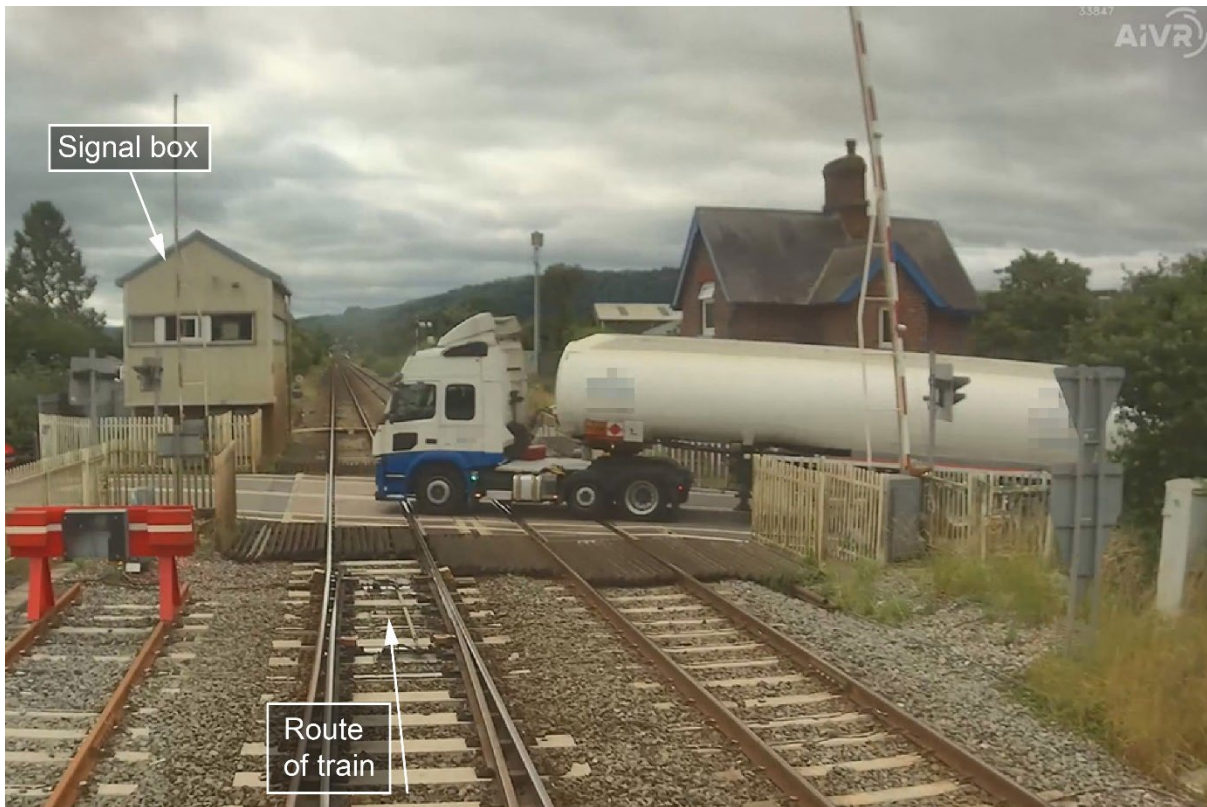
A heavy goods vehicle (HGV) entered the crossing shortly before the train reached it. On sighting the HGV, the driver of the train made an emergency brake application, while travelling at around 15 mph (24 km/h). The train avoided striking the HGV by around 2 seconds. The driver of the HGV was unaware of the near miss.

HGV on the crossing as the train approached (courtesy of One Big Circle).

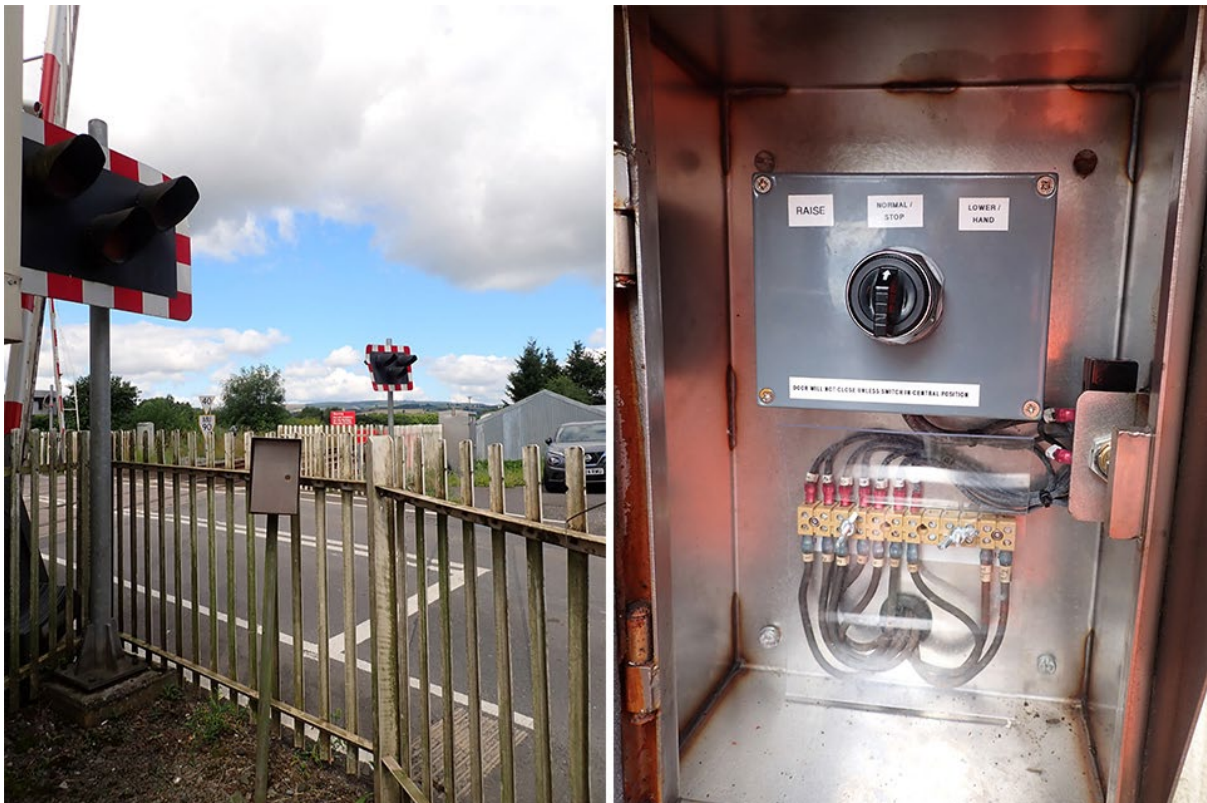
Outside the signal box, next to the level crossing, there is a local control unit (LCU) for the crossing. The LCU has a switch with 3 possible positions which override the commands from the control panel and allow the crossing to be operated in the event of a failure, or to facilitate maintenance activities. The options available at the LCU are 'raise', 'lower' or 'normal'. Returning the switch to the normal position returns control to the control panel within the signal box. Use of the LCU will operate the crossing outside of the engineered safeguards provided by the interlocking. For this reason, the LCU should be used only when authorised by the relevant rules and access to it should be controlled.

LCU located outside of the signal box (left). LCU's internal switch (right).

LCU data logger evidence shows that the external LCU door had been opened 359 times since 22 November 2021. Although a small number of such events could be expected due to maintenance and out-of-course operations, this number of recorded events supports witness evidence that the LCU was routinely used by signallers at this location to control the crossing for some time before this incident occurred.

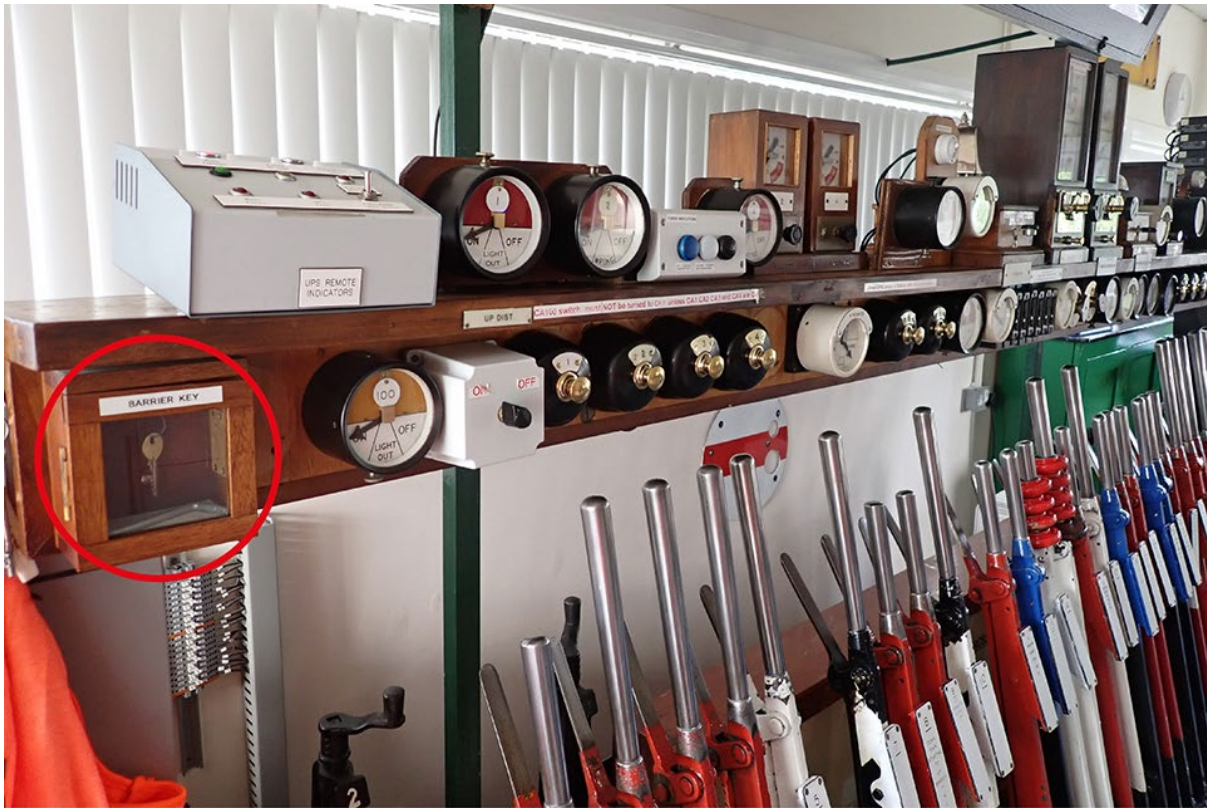
Craven Arms signal box block shelf, showing the key used to access the LCU.

Following this incident, RAIB visited Craven Arms signal box on 23 July 2024. During this visit, RAIB observed that the key to the LCU was still stored in a glass-fronted box that was not locked or sealed, allowing anyone within the signal box uncontrolled access to it. This meant that there was no effective control on the use of the LCU and, without the need to break the glass on the box, a source of evidence of LCU usage which could have been used by managers for assurance purposes was lost.

The relevant signal maintenance standard, NR/L3/SIG/10663, 'Signal Maintenance Specifications', issue 23 dated June 2022, states that one of the tasks required during the relevant check is to 'check all block shelf components and fittings are secure and seals are correctly fitted'. In the case of Craven Arms, this would mean verifying that the LCU key box is locked or sealed. The standard requires this check to be undertaken at a nominal interval of 91 days, and a maximum interval of 364 days. The S&T maintenance team responsible for Craven Arms reported that this check had been completed in line with the requirements of the standard. The status of the LCU key box during and after the incident suggests that these examinations were not effective at detecting if it was correctly secured.
