# Track worker struck by a road-rail vehicle at Braybrooke, 6 February 2024

## Summary of the accident

## Cause of the accident

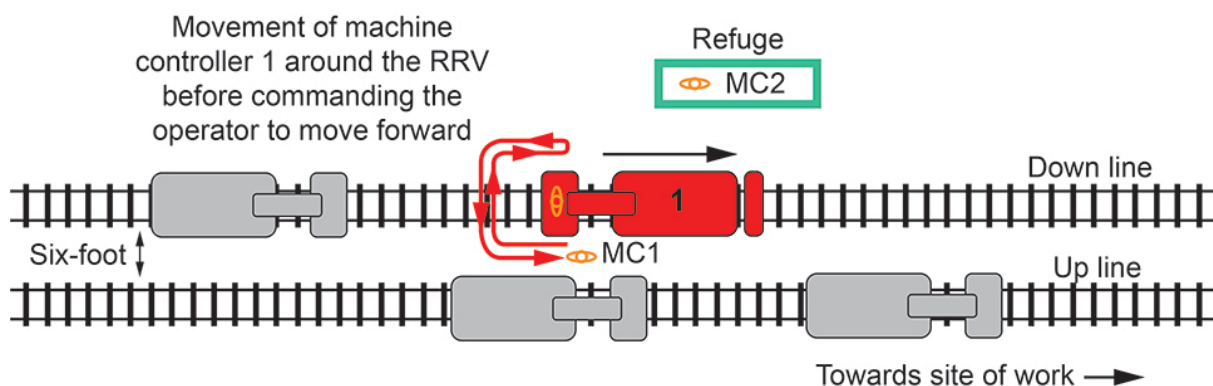
Witness evidence indicates that machine controller 1 walked from a position between the two tracks (the 'six-foot') around the rear of RRV1 to the Down cess side to check that the way ahead was clear. During this check, machine controller 1 saw that machine controller 2 was in a refuge in the Down cess. Machine controller 1 then returned to the six-foot via the rear of their machine, retracing their steps. Satisfied that the way ahead for RRV1 was clear, machine controller 1 gave the machine operator of RRV1 the instruction to move. The machine operator (machine operator 1) raised RRV1's basket and sounded the horn, as was their standard practice when about to move their machine. They also checked the area ahead of their machine as best they could, given the restricted view from the basket. Machine operator 1 then commanded RRV1 to move forward.

**The route (red arrow) of machine controller 1 around RRV1 when checking around the RRV.**

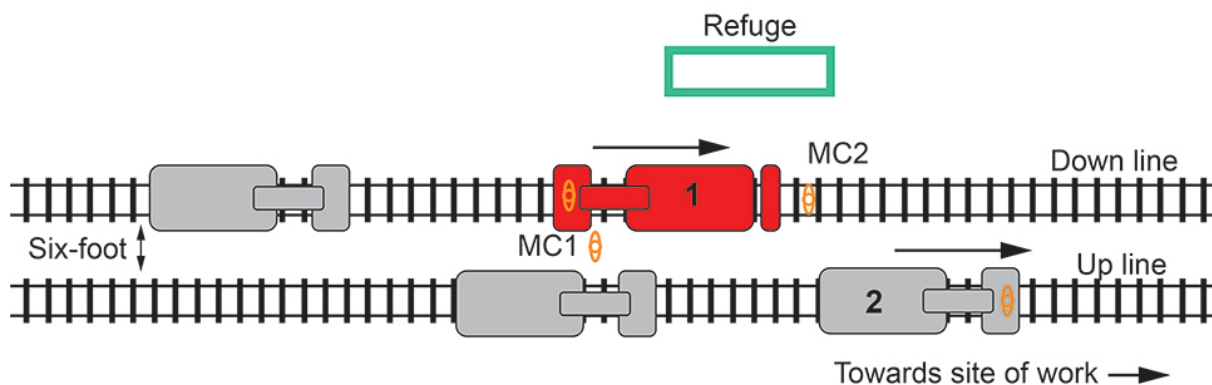
Sometime after machine controller 1 had checked the cess side of their machine, machine controller 2 left the refuge and walked towards RRV2, which was on the Up Main line. Machine controller 2 took a position in between the rails of the Down Main line (the 'four-foot') and started to walk ahead of RRV1, with their back to it.

Immediately before the accident, the operator of one of the RRVs on the Up Main line saw machine controller 2 walking in the four-foot of the Down Main line. They realised that RRV1 was about to strike machine controller 2, so they shouted a warning. This was heard by machine operator 1, who responded by stopping RRV1. Machine controller 2 tried to move out of the way of RRV1, towards the six-foot. However, they reported being struck on the back of one of their legs by the carry deck of RRV1 as they did so, and they fell to the ground in the six-foot. Only after RRV1 had stopped did machine operator 1 see machine controller 2 lying on the ballast and realise why a warning had been shouted.

**Approximate positions of the four RRVs and the position of machine controller 1 and machine controller 2 immediately before the accident.**

This accident occurred because machine controller 2 was walking in the area directly ahead of RRV1 and because the movement of the machine brought them within its exclusion zone and then into contact with the carry deck. The area directly ahead of RRV1 was outside the vision of machine operator 1, who had a restricted view of the line ahead, and also of machine controller 1, who was to the rear of the machine. Although machine controller 1 had checked the line ahead before authorising RRV1 to move, machine controller 2 had in the intervening period left the refuge and walked ahead of the machine.
