# Collision between a train and an object left on the track at Kings Langley, Hertfordshire, 25 April 2024

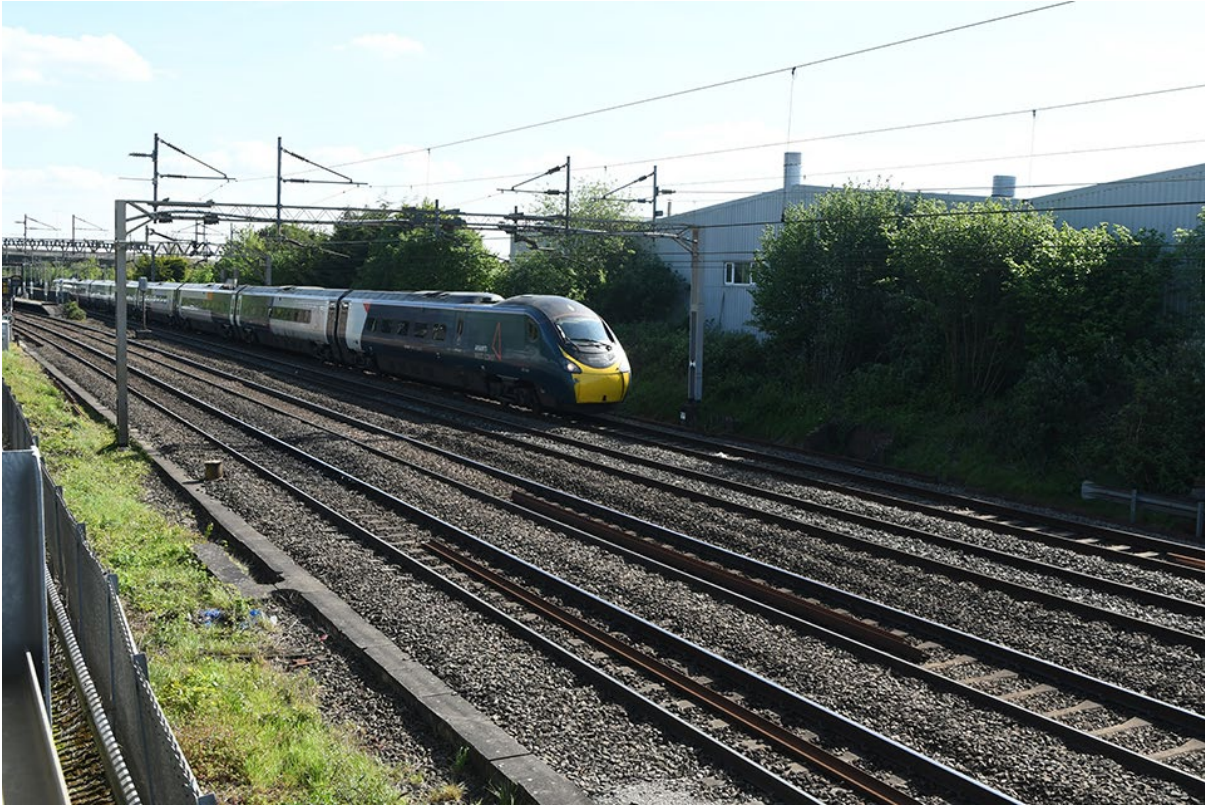
**Location of the collision near Kings Langley access point, looking south towards the station.**

No one was injured as a result of the collision and neither train derailed. The damage caused to both trains meant they were unable to continue in service.

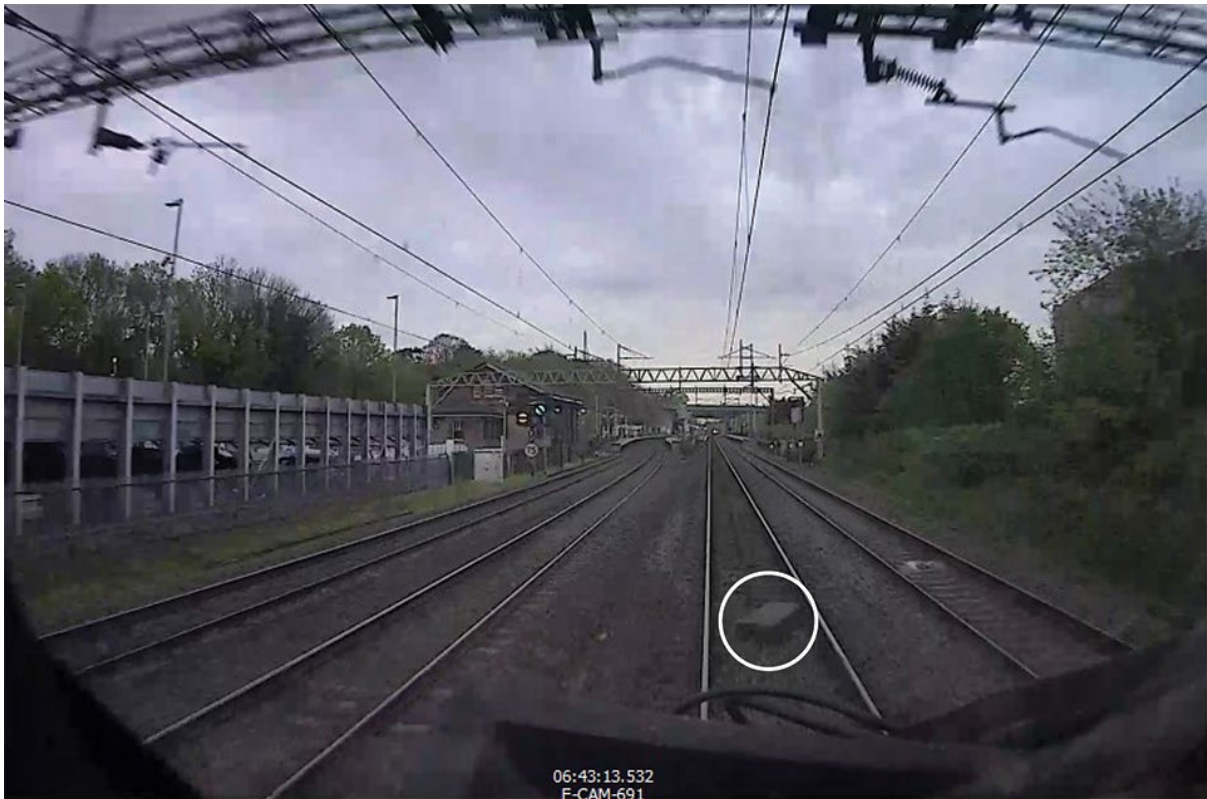
The remaining workers removed the pieces of the temporary RRAP that could be seen in the darkness using head torches. These were loaded onto a flatbed lorry and taken away from the site. The PIC completed a check of the access point for equipment but did not notice the displaced part of the temporary RRAP around 40 metres away, which remained on the Up Fast line. No component counts or other checks were undertaken to ensure that all 20 pieces of the RRAP were accounted for and had been removed from the railway.

Train 1R00, the 04:57 hrs service from Wolverhampton to London Euston, operated by Avanti West Coast, was the first movement of the day over the Up Fast line after the possession was given up. This train struck the temporary RRAP piece which remained on the Up Fast line. The train's on-train data recorder recorded that the train was travelling at a speed of 124 mph (200 km/h) at the point of the collision. The permissible speed for this train on the Up Fast line at the location is 125 mph (201 km/h).

**Forward-facing CCTV from the cab of train 1R00. The displaced piece of the temporary RRAP can be seen in between the running rails of the Up Fast line (courtesy of Avanti West Coast).**

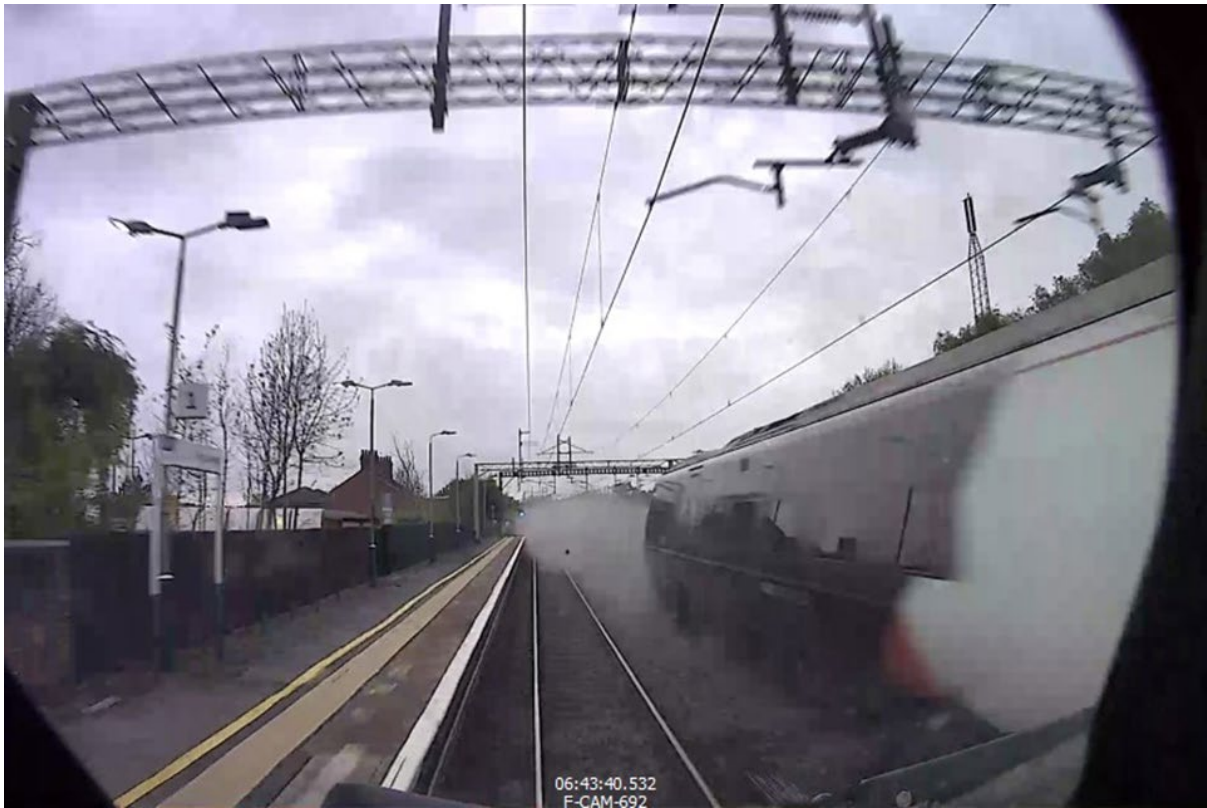
Train 9S44, the 06:16 hrs service from London Euston to Edinburgh Waverley, also operated by Avanti West Coast, was travelling at approximately 107 mph (172 km/h) when it passed train 1R00 on an adjacent line at Kings Langley station. Debris from train 1R00 impacted train 9S44, damaging its windscreen, and the latter was subsequently brought to a halt by its driver. The driver of train 9S44 made the signaller aware of what had happened. The signaller then stopped 1R00 and all other trains in the area.

**Forward-facing CCTV from 9S44 as it passes 1R00 through Kings Langley station. A dust cloud and debris is evident from the rear of 1R00 (courtesy of Avanti West Coast).**

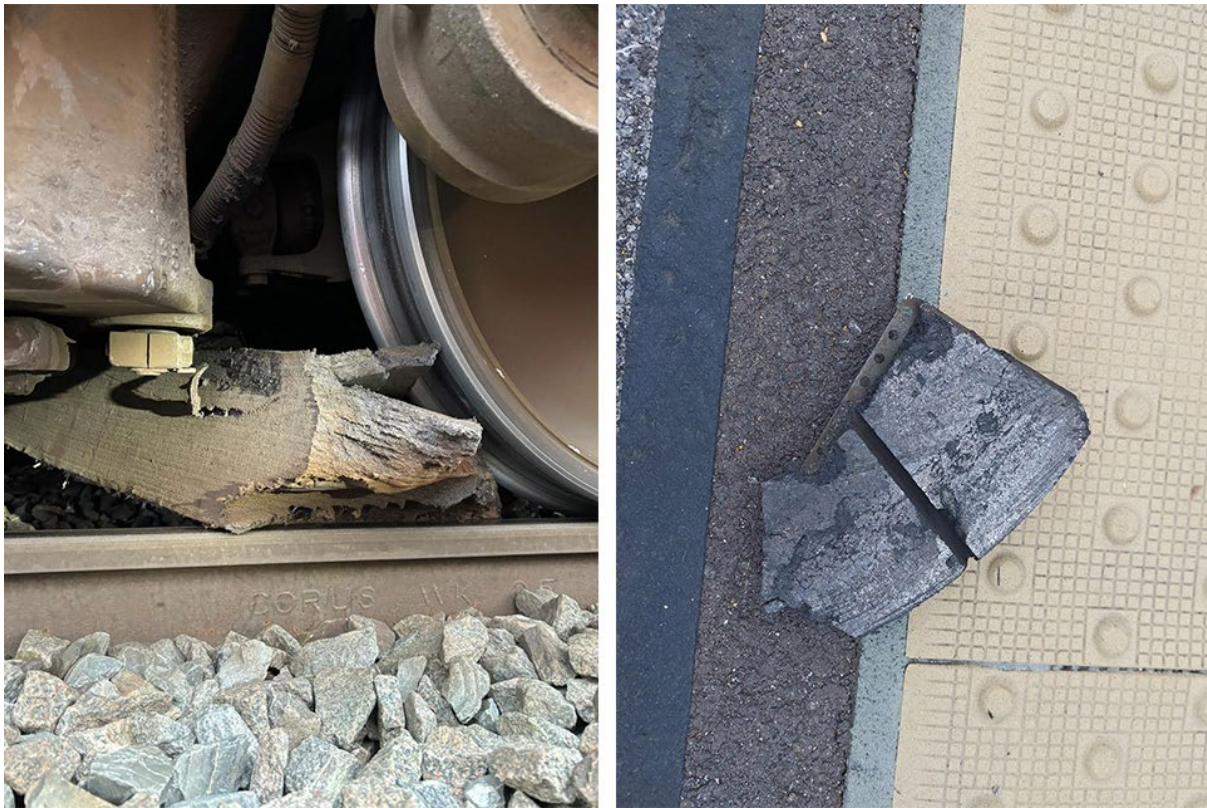
The RRAP piece became trapped under the rear of train 1R00, disturbing ballast and dislodging a brake pad. The drivers first became aware of an issue when the train's systems indicated a loss of electrical power. Staff further along the train also reported a loud noise which was followed by the deflation of a secondary suspension airbag on the rearmost coach.

Ballast and the brake pad from train 1R00 were later found on the platform of Kings Langley station. Train 9S44 was allowed to move forward to Milton Keynes Central station where its passengers were disembarked and it was removed from service. The section of the temporary RRAP was removed from under train 1R00. This train was moved forward to Watford Junction station where its passengers were disembarked and it was also removed from service.

**Remains of the temporary RRAP found under train 1R00 (left) and the brake pad found on Kings Langley station platform (right) (courtesy of Network Rail).**
