Near miss with a track worker, Littlehempston, Devon, 13 March 2024

Summary of the incident

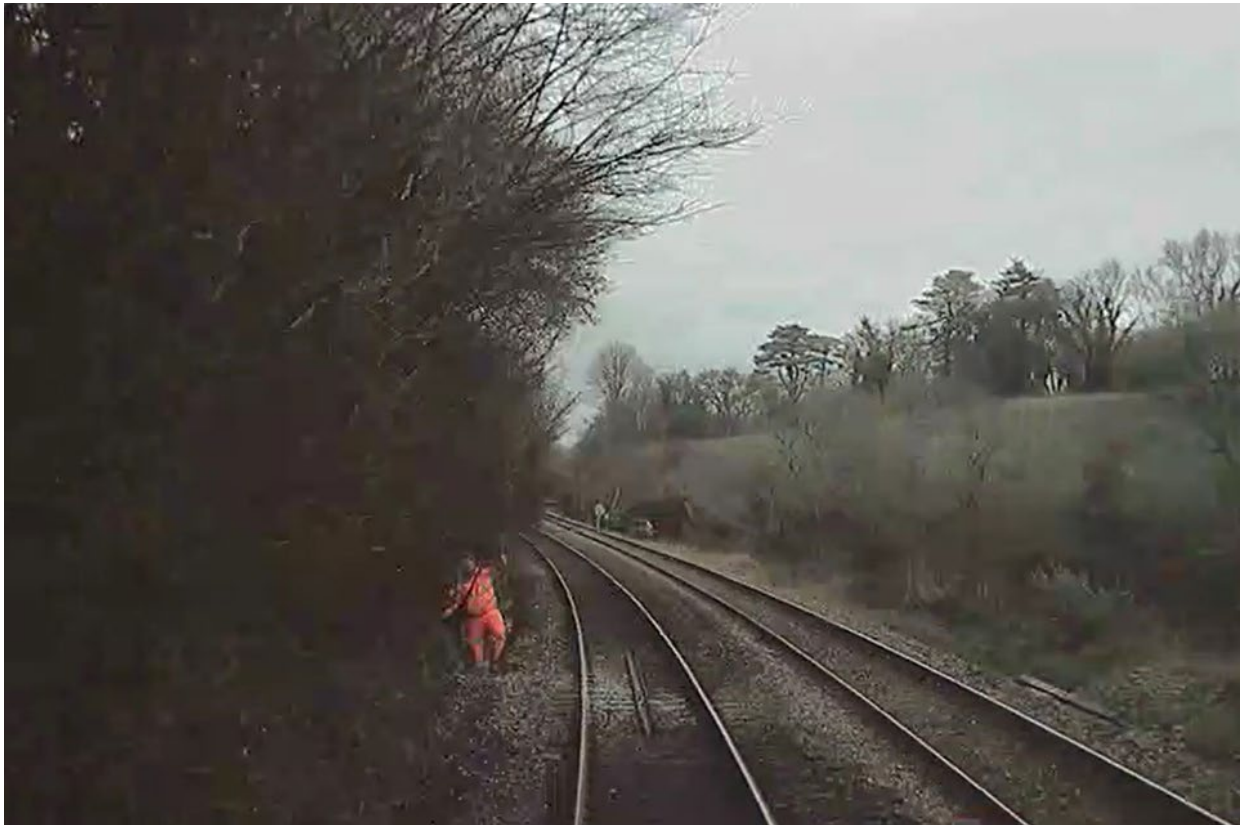
As the train approached, the COSS moved to the cess (the space alongside the line outside the ballast shoulder) and out of the path of the approaching train. The COSS moved clear around 2 seconds before the train passed.

Forward-facing CCTV showing the COSS in the up line cess as the train approaches (courtesy of Great Western Railway).

On-train data recorder evidence and forward-facing CCTV images show that the train approached the COSS at 10:44 hrs. The COSS was obscured from the driver's view until around 5 seconds before the train reached them. This was due to overhanging vegetation and because the train was approaching around a tight curve. Around 1 second later, with the train travelling at 54 mph (87 km/h), the driver sounded the warning horn to warn of the train's approach. CCTV images show that, in response, the COSS moved into the vegetation by the side of the cess and that they were clear of the train's path around 2 seconds before it passed. The train driver immediately reported the near miss to the signaller.

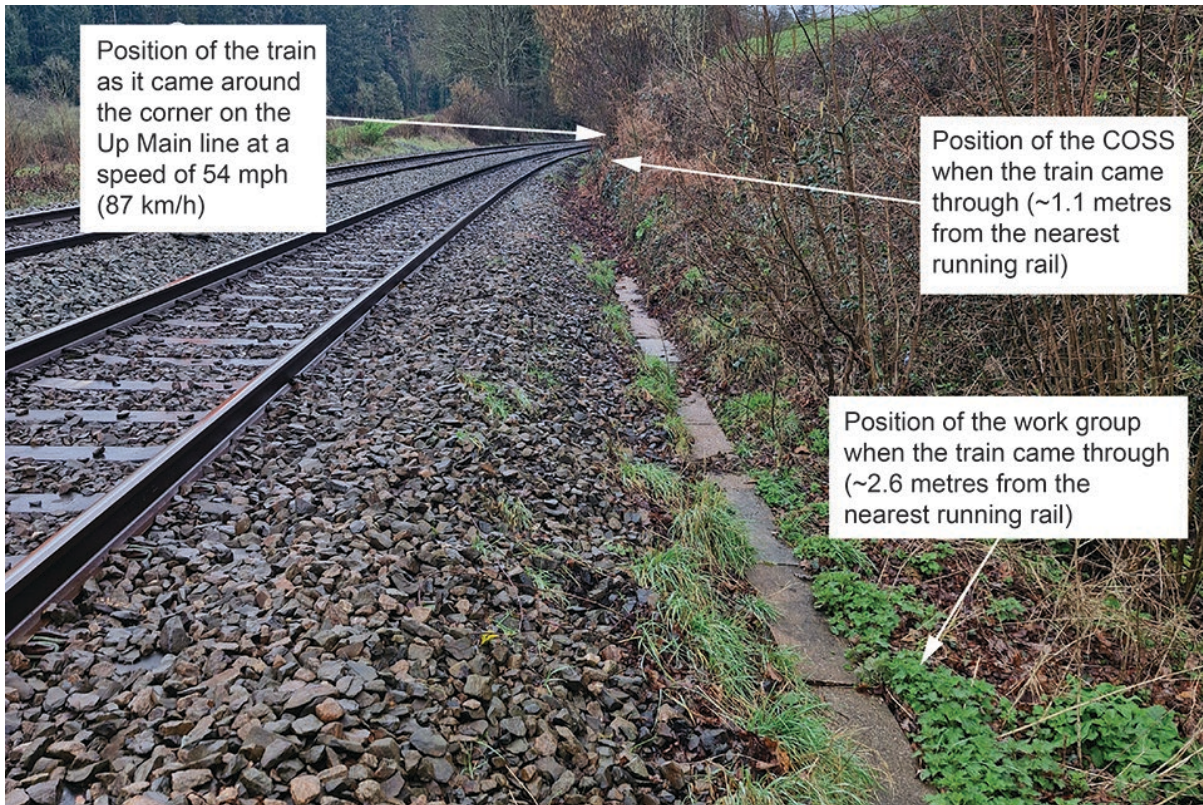
Despite the separation distance narrowing, the COSS continued along the cess as they moved south. This moved them close to the cess rail of the Up Main line to the point that they eventually became at risk of being hit by a passing train. As the COSS was now remote from the group, there was no one present to challenge or warn the COSS that they were now too close to the open line. Measurements undertaken after the incident by Network Rail and Colas showed that the distance between the troughing and nearest rail at the incident location is less than 2 metres.

Measurements taken at incident location (courtesy of Colas/Network Rail with RAIB annotations).

While Network Rail standards require there to be a minimum distance of 3 metres between troughing and the nearest running rail, this requirement can be varied as topographic or other obstructions dictate. This means that, as in this case, the use of

the troughing as the demarcation line may not always meet the requirements of the relevant rules for a separated system of work.
