Rail Accident Investigation Branch

# Rail Accident Report

**Train overspeeding at Spital Junction,  
Peterborough  
17 April 2022**

Report 06/2023  
v2 August 2024

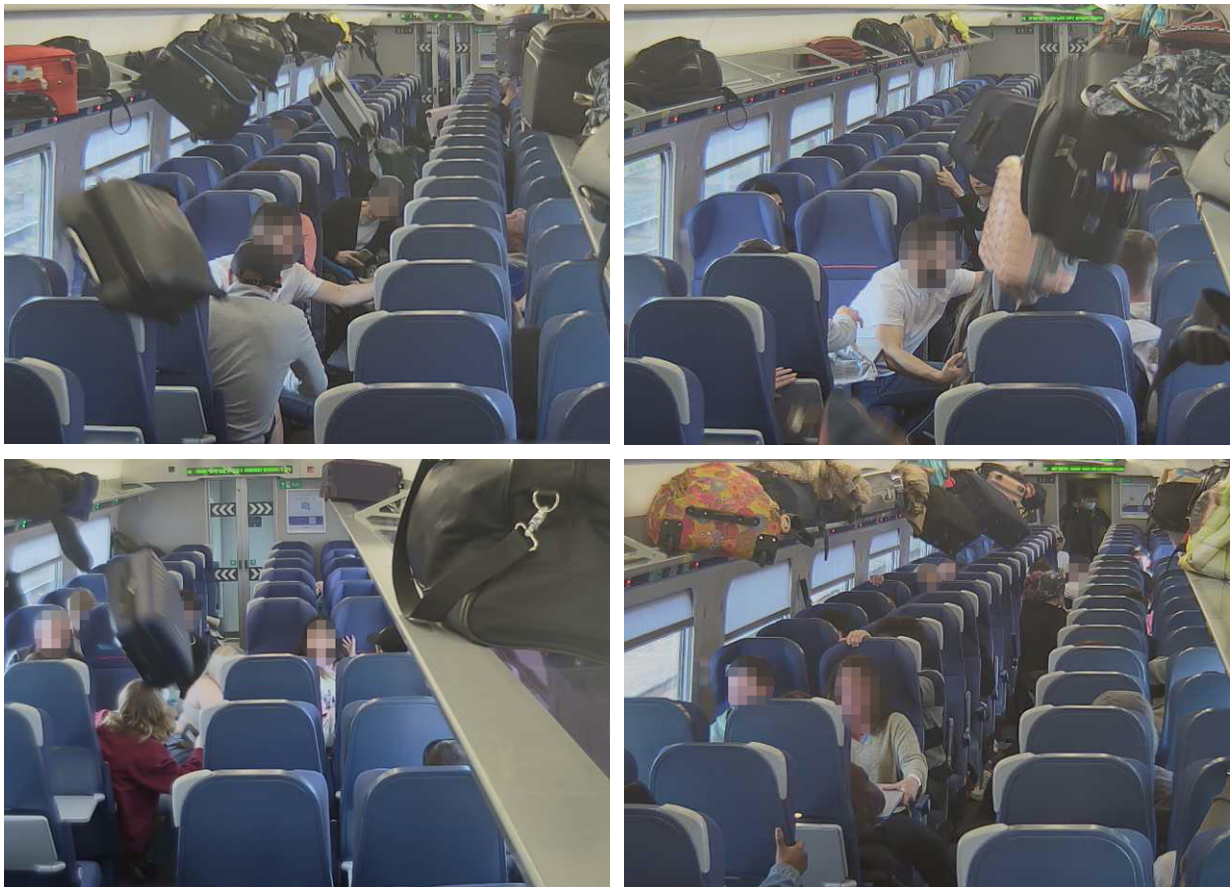
Figure 20: Luggage falling from the overhead racks during the incident.

178 RAIB's review of the train's internal CCTV and the descriptions of the injuries sustained by passengers concluded that half of the injuries were caused by luggage falling from the overhead luggage racks as the train went over the junction (figure 20).

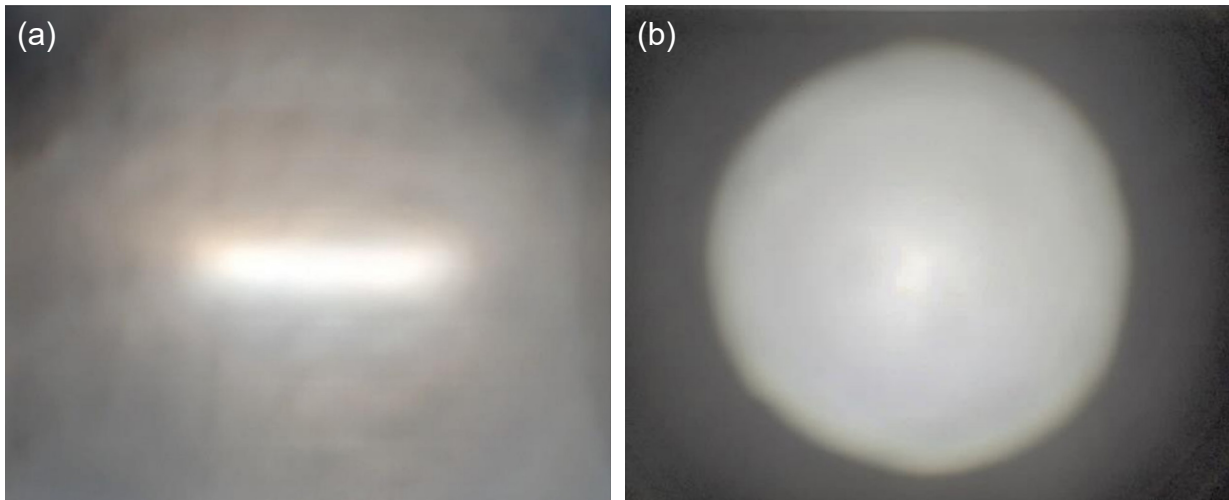
Figure E4: JI projected beam characteristic from filament indicator (a) and LED module (b).

E13. The LED JI light modules were found to be at different alignments within the JI housing, ranging between  $-0.4$  and  $-2.7$  degrees error relative to the designed position within the housing. The pivot light was also found to be installed upside down. These issues are likely to be a consequence of the sample JI having been supplied from one of Network Rail's training centres and is unlikely to be representative of the LED JIs in use. To account for the misalignment, the luminous intensity of all modules was tested 'on-axis' and relative to the light module itself, and not to its position within its housing.

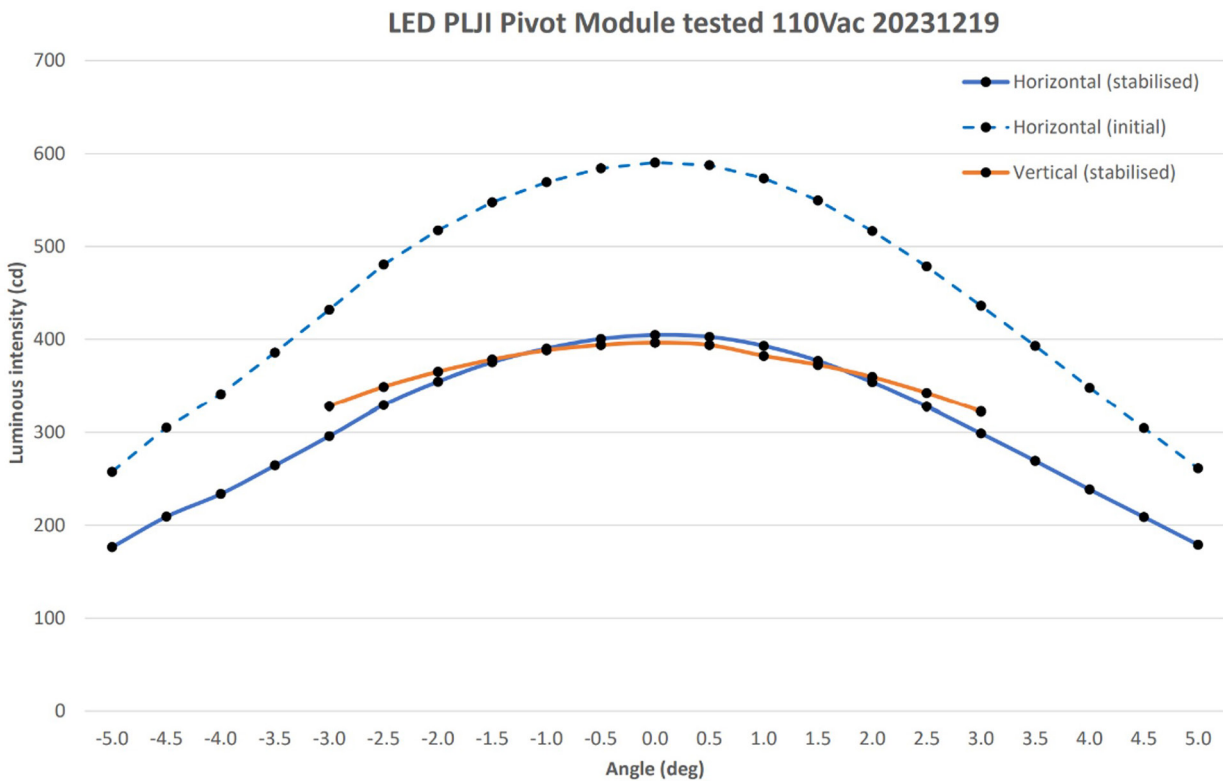
Figure E6: Measured luminous intensity from an LED junction indicator module.

E14. During testing, the LED JI modules were found to emit a greater luminous intensity when initially illuminated. The luminous intensity reduced as the modules became warmer. Although it is unlikely that the LED JI modules fitted to P468 signal would create sufficient heat to affect the light output in the time they were illuminated for an approaching train, it was necessary to allow the modules to stabilise to enable the testing to take place. When tested, the LED JI pivot light module produced the highest output of 591 cd initially, which reduced to 403 cd once it had stabilised after 40 minutes (figure E6). The other LED JI light modules produced a light output of between 255 cd and 314 cd when stabilised.

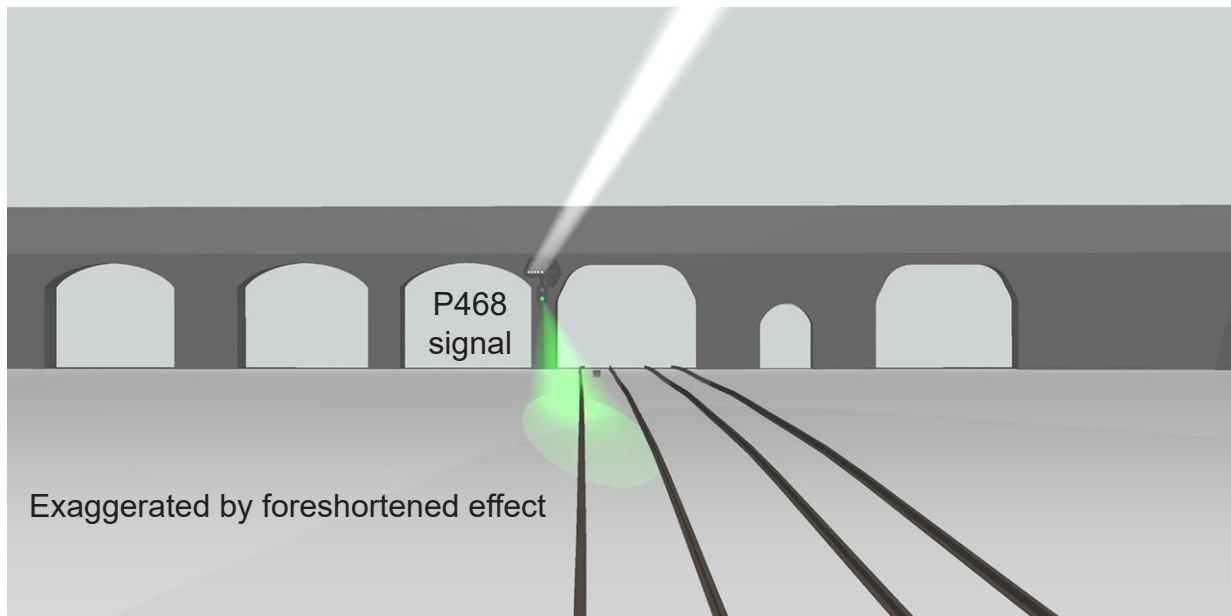
Figure E7: Alignment of green aspect and JI when viewed at 800 metres from P468 signal.

- E19. When a beam drawn from the green aspect and JI of P468 signal is overlaid on the topographical survey of the Up Fast line, the centre line of the green main aspect was found to be pointing down towards the track, and the JI pointing upwards (figure E7). This downwards alignment of the main aspect is in line with the signal sighting guidance to aim the main signal towards driver's eye level at the AWS magnet associated with the signal. Figure E8 places an approaching train at 100 metres (110 yards) from P468 signal. At this distance, the centre of the green aspect beam is to the left and at a height approximating that of a driver's eye line. In contrast, the top of the windscreen of an approaching train is approximately 5 degrees below the centre of the beam projected by the JI.

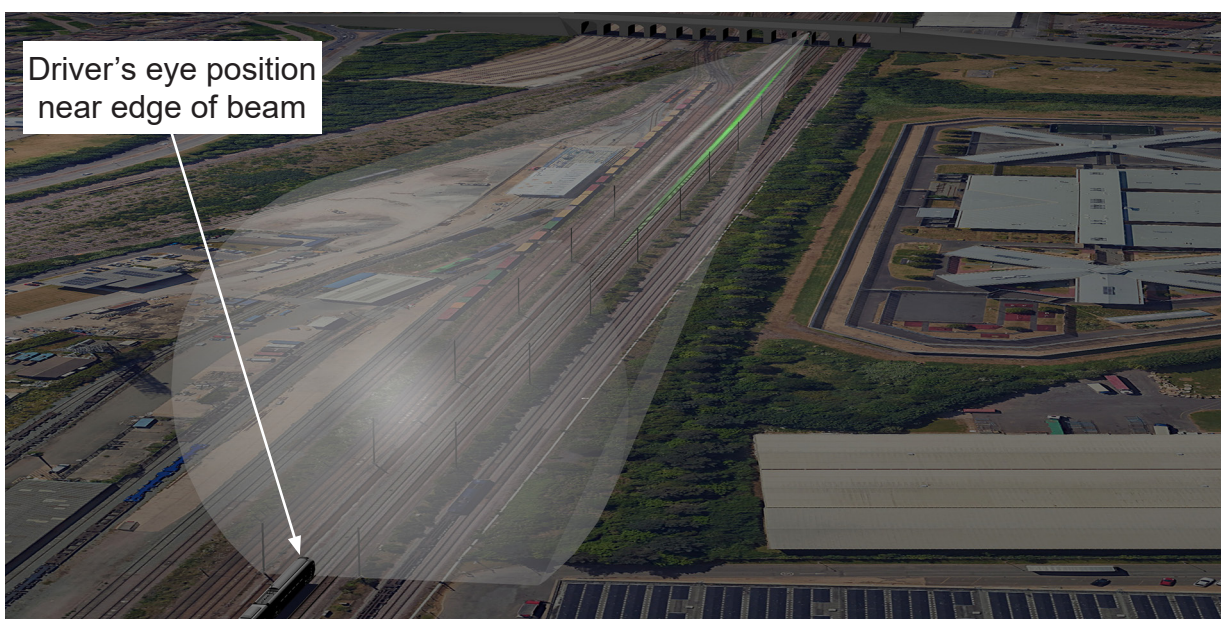
Figure E9: Illustration of the JI beam projected by a 5 degree cone out to a distance of 800 metres.

- E20. When these beams are projected to 800 metres (875 yards) from P468 signal, the centre of the green aspect beam remains closer to the driver's eye line, although below the windscreen level of an approaching train. However, the centre of the JI is much further from the driver's eye line (figure E9).

E21. It is likely therefore that the conspicuity of the route indication was reduced compared to that of the green main aspect because:
