Rail Accident Investigation Branch

Rail Accident Report

Overspeed at Spital Junction, Peterborough 4 May 2023

Report 10/2024
September 2024

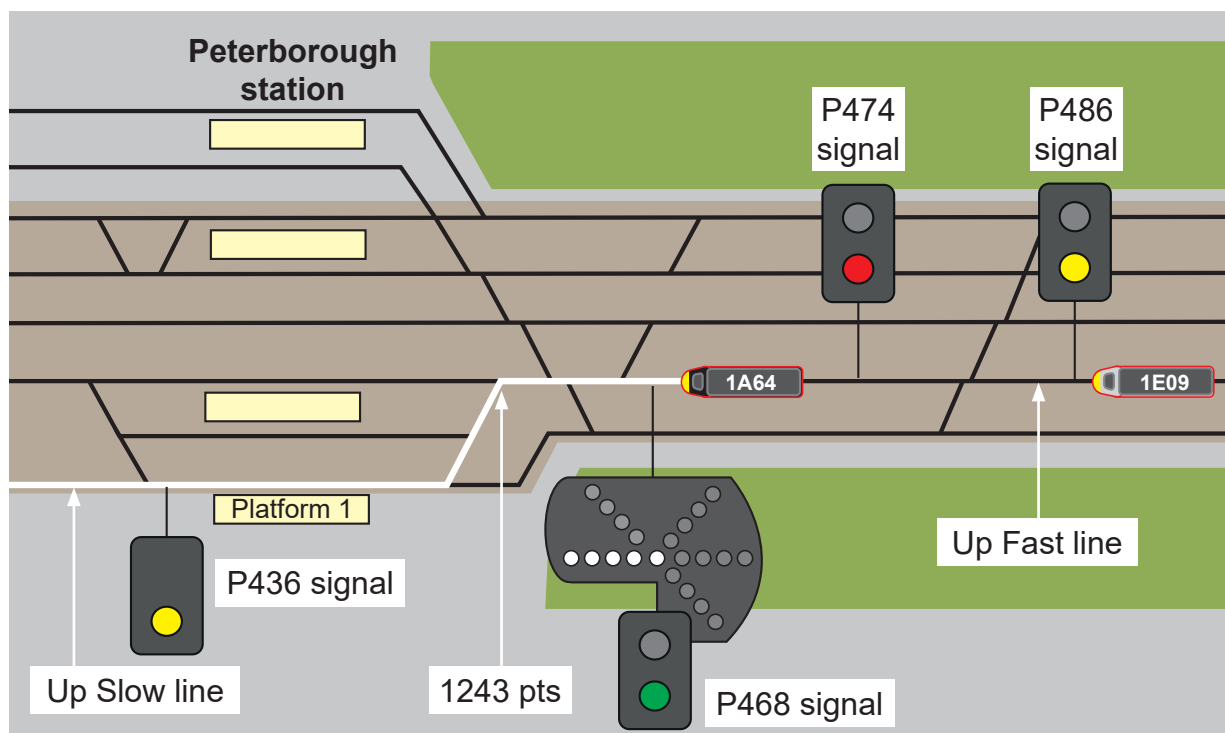
Figure 18: The driver applies power to train 1A64 when approximately 750 metres from P468 signal at 12:59:19 hrs, with full power being applied 8 seconds later when approximately 680 metres from the signal.

- 63 At 12:59:19 hrs, when the train was approximately 750 metres from the signal and coasting at 16 mph (26 km/h), the driver responded to the green main aspect by moving the power brake controller to apply power to the train (figure 18).
