Overspeeding incidents at Wood Green, and Melton Lane level crossing, 11 and 12 June 2023

Summary of the incidents

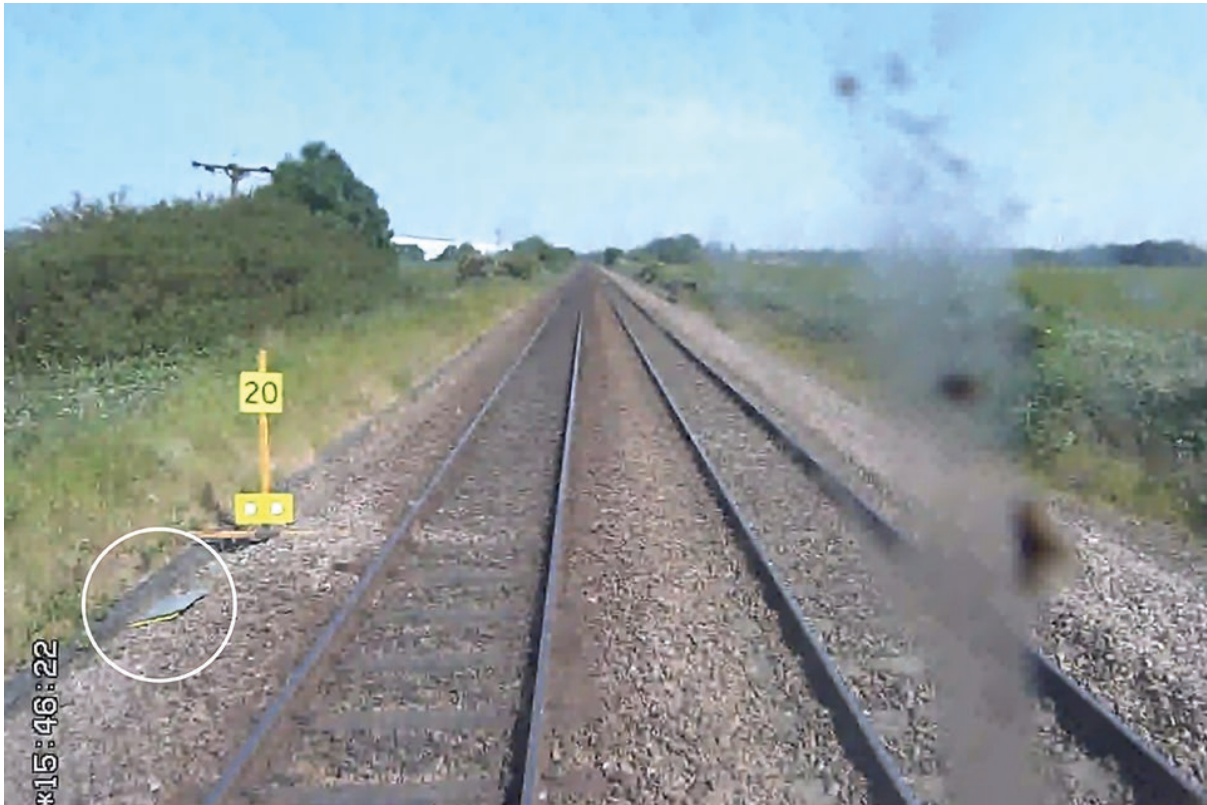
RAIB has seen no evidence that a new design was produced when it became necessary to impose a CRT(20) ESR due to the hot weather on 12 June. Instead, track maintenance staff swapped the 30/75 mph (48 and 121 km/h) warning and commencement boards for 20 mph (32 km/h) boards. Network Rail advised that this was because it had insufficient staff to move the ESR equipment when the critical rail temperature was reached. If the CRT(20) ESR had been implemented in accordance with the requirements of Railway Group Standard GKRT0075 for a reduction in speed from 75 to 20 mph (121 to 32 km/h), it would have been necessary to have moved the warning board and associated equipment 70 metres further from the start of the ESR, as the minimum deceleration distance would have needed to increase to 1,257 metres.

Image from forward-facing CCTV showing the CRT(20) warning board on 12 June 2023 (previous 30/75 warning boards lying on ground, shown in white circle).

The configuration of the ESR warning equipment on the Down Hull line approaching the CRT(20) ESR at Melton Lane level crossing on 12 June 2023 had the potential to mislead drivers. This was because it was installed at the same location as the earlier 30/75 ESR that had not been applicable to passenger trains throughout this period. Repositioning the ESR equipment would have provided drivers with a cue that the ESR speed limit had changed.
