Passenger dragged at Beeston Centre tram stop, Nottingham, 22 February 2023

Summary of the accident

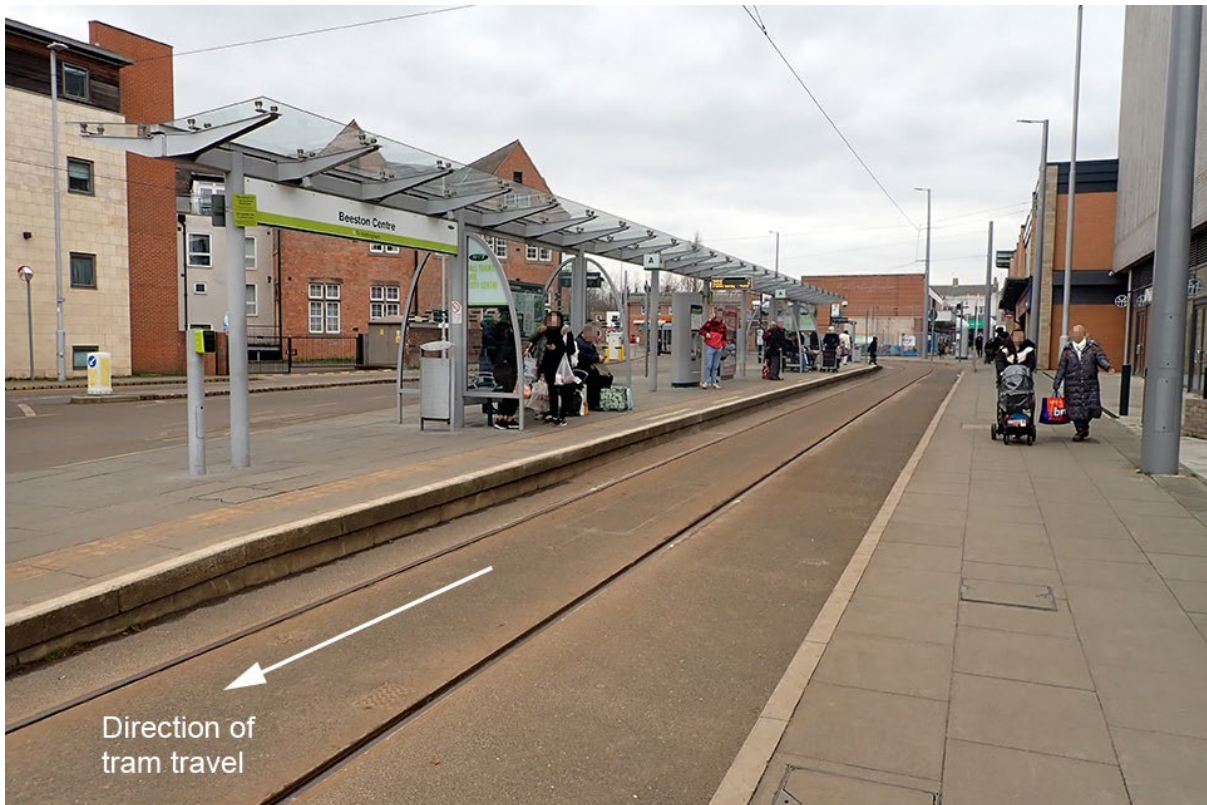
Beeston Centre tram stop.

At around 18:04 hrs on Wednesday 22 February 2023, a passenger was dragged alongside a departing tram at Beeston Centre tram stop, on the Nottingham tram network.

Shortly before the tram departed, the passenger had placed a hand and a walking stick into the closing doors of the tram, in an unsuccessful attempt to prevent them from closing. Once the doors closed, the walking stick became trapped. The driver was unaware that the stick was trapped and started the tram. The passenger held onto their walking stick as the tram departed and was pulled alongside the tram for around three seconds, before falling against the tram and landing on the edge of the tram stop. This resulted in serious injuries to the passenger.

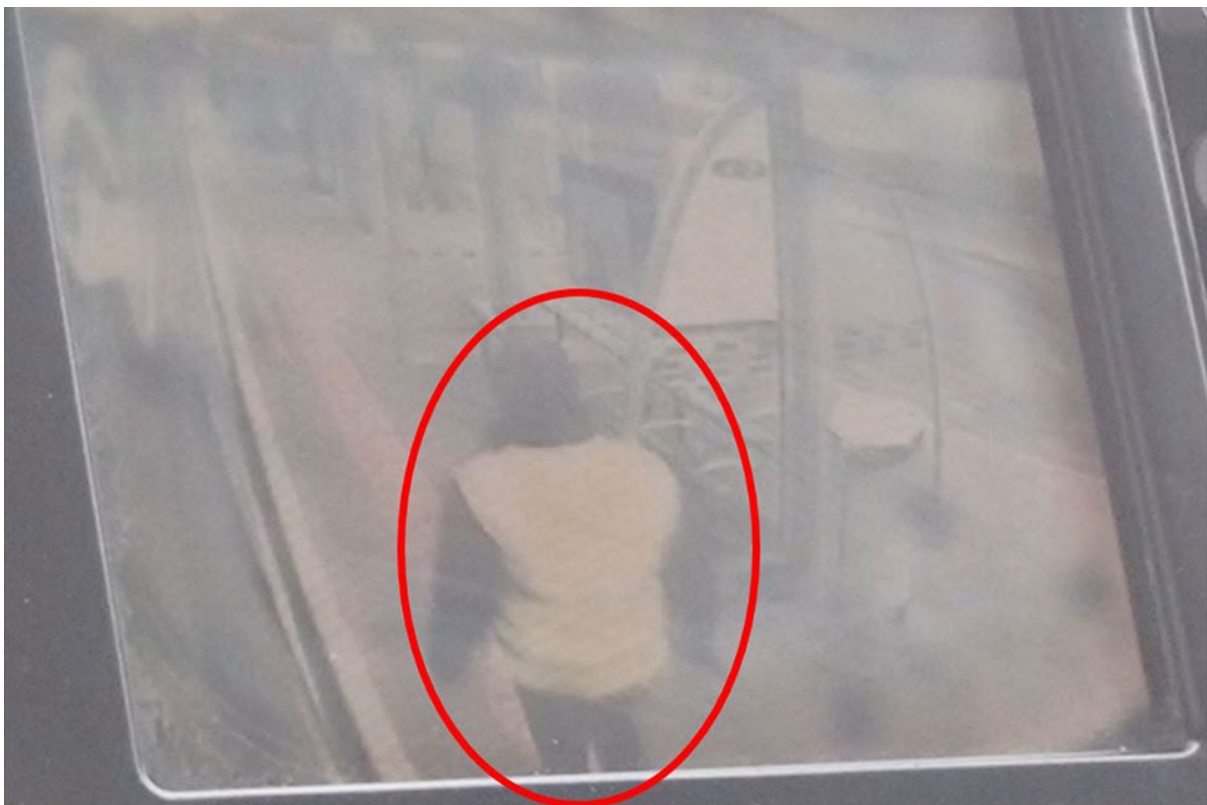
RAIB attended Beeston Centre tram stop in daylight and positioned a person, wearing a high-visibility vest, at the rearmost doors (at which the passenger attempted to board). The conspicuity of the person on the platform, in the most favourable conditions, was poor when the bodyside camera footage was displayed in 'wing mirror' view. When the cameras were commanded to display 'rear view' mode, the person on the platform became more visible.

Rear view image from RAIB reconstruction.
