Accident

| Aircraft Type and Registration: | Piper PA-28-181, G-BVNS |

Synopsis

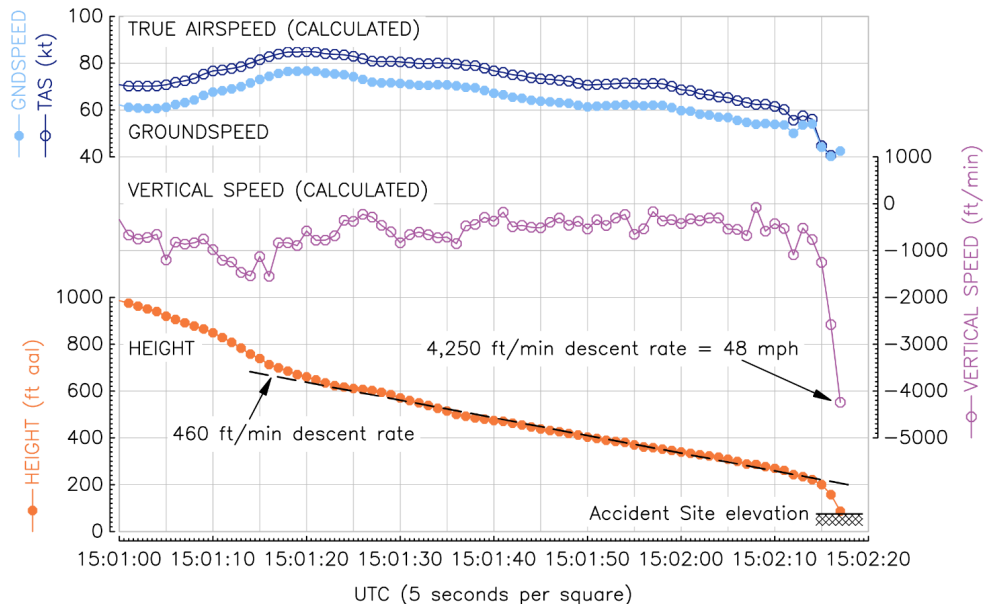
Figure 5
GPS derived data for the descent

Figure 5 plots data for the descent starting with the aircraft descending through 1,000 ft amsl (980 ft aal and about 600 ft agl) on base, at about 800 ft/min, just under 2 nm from the threshold of Runways 21 and 30. The descent rate reduced to about 460 ft/min for the remaining 60 seconds of the descent, during which the airspeed reduced from 85 to below 60 kt. The aircraft then struck the tree, after which it descended towards the ground at about 4,250 ft/min (equivalent to 48 mph).
