MARINE ACCIDENT INVESTIGATION BRANCH

SAFETY FLYER TO THE FISHING INDUSTRY

Collision between the pair trawlers *Guiding Light* (H 90) and *Guiding Star* (H 360) resulting in the flooding and sinking of *Guiding Star* 33 nautical miles south-east of Fair Isle, Scotland on 6 October 2022

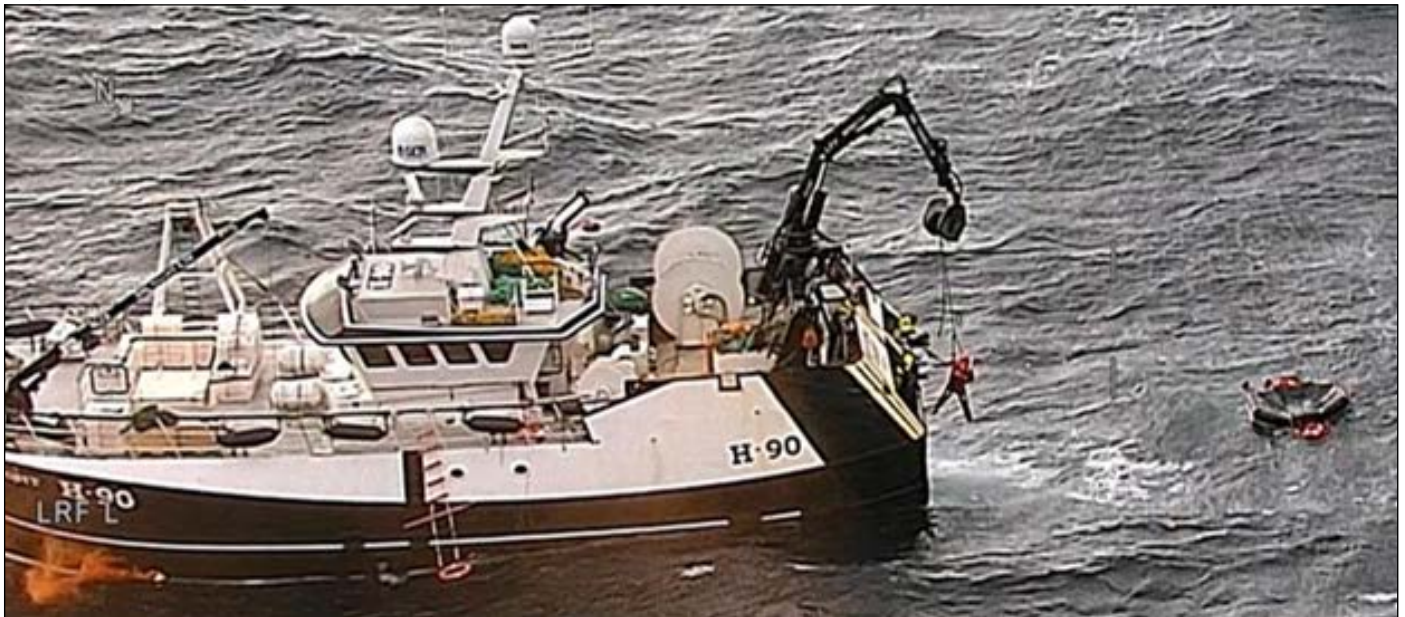
HM Coastguard helicopter footage following the collision, showing the overturned liferaft and a member of *Guiding Star*'s crew being recovered from the water using *Guiding Light*'s power block

Guiding Light's crew used the vessel's power block to lift two of *Guiding Star*'s crew on board before a large wave struck and capsized the liferaft. The six occupants were thrown into the water but were able to swim back to and grab hold of the overturned liferaft. Three of the six crew members were recovered from the water using *Guiding Light*'s power block and the last three crew members were winched to safety by a coastguard rescue helicopter. There were no serious injuries, and *Guiding Star* sank about an hour after the collision.
