## **Collision between the pair trawlers *Guiding Light* (H 90) and *Guiding Star* (H 360) resulting in the flooding and sinking of *Guiding Star* 33 nautical miles south-east of Fair Isle, Scotland on 6 October 2022**

### **SUMMARY**

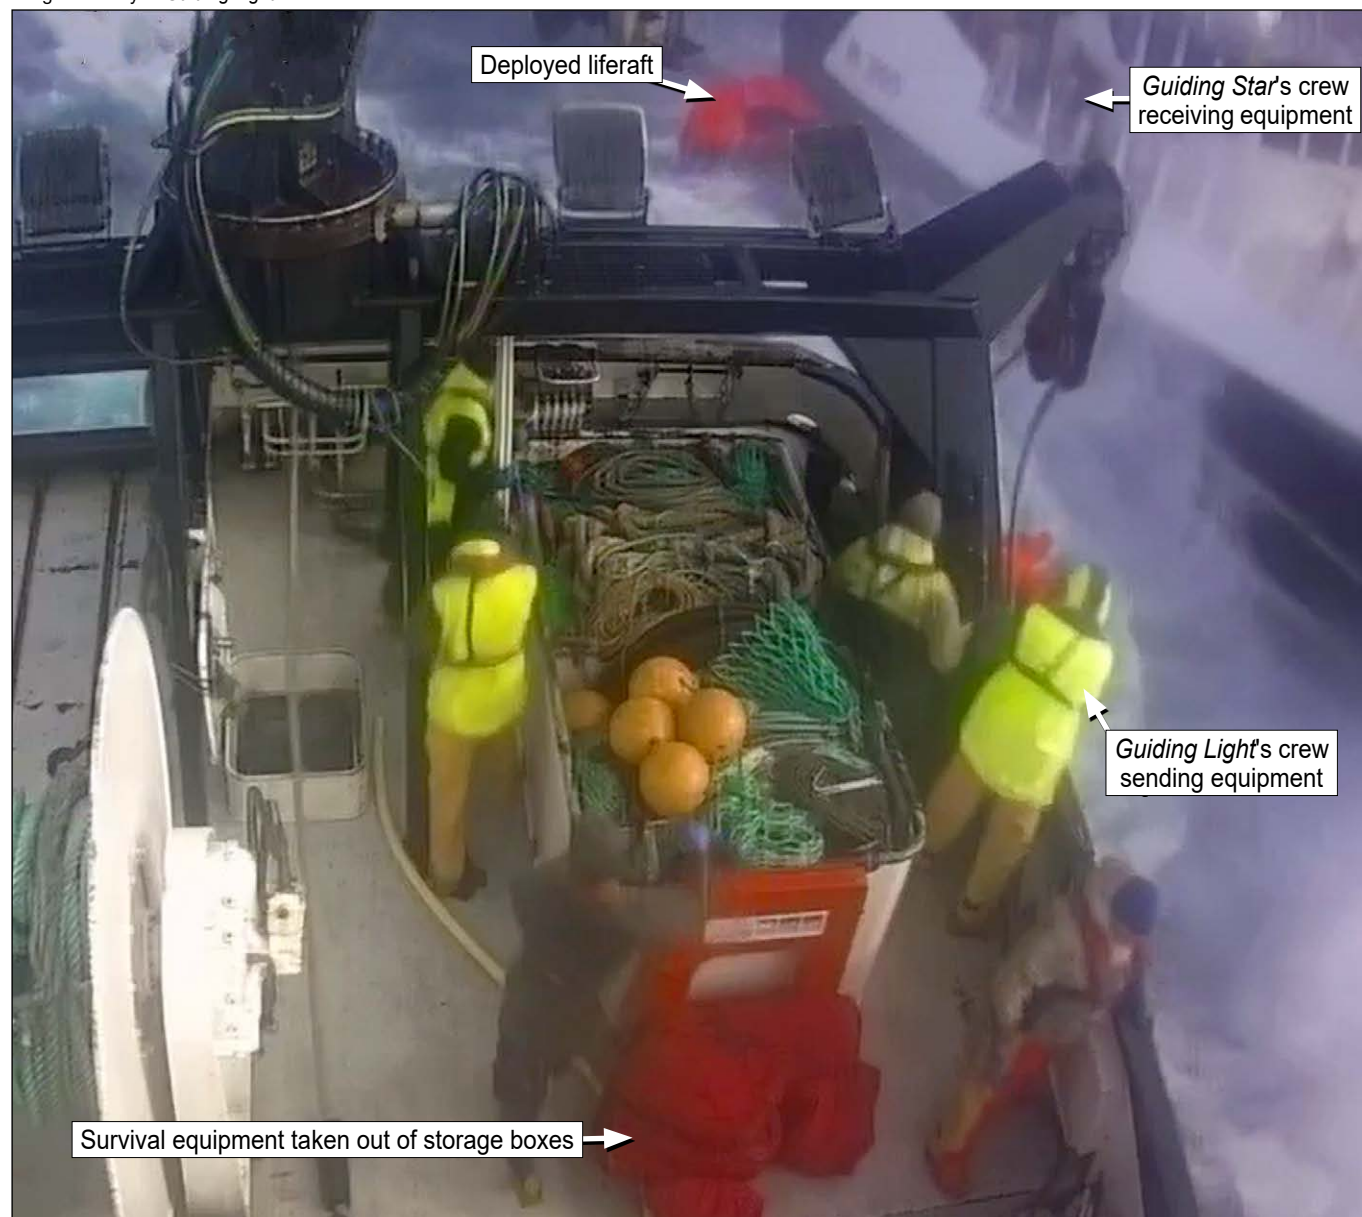
**Figure 1:** CCTV still, showing the transfer of survival equipment from *Guiding Light* to *Guiding Star*

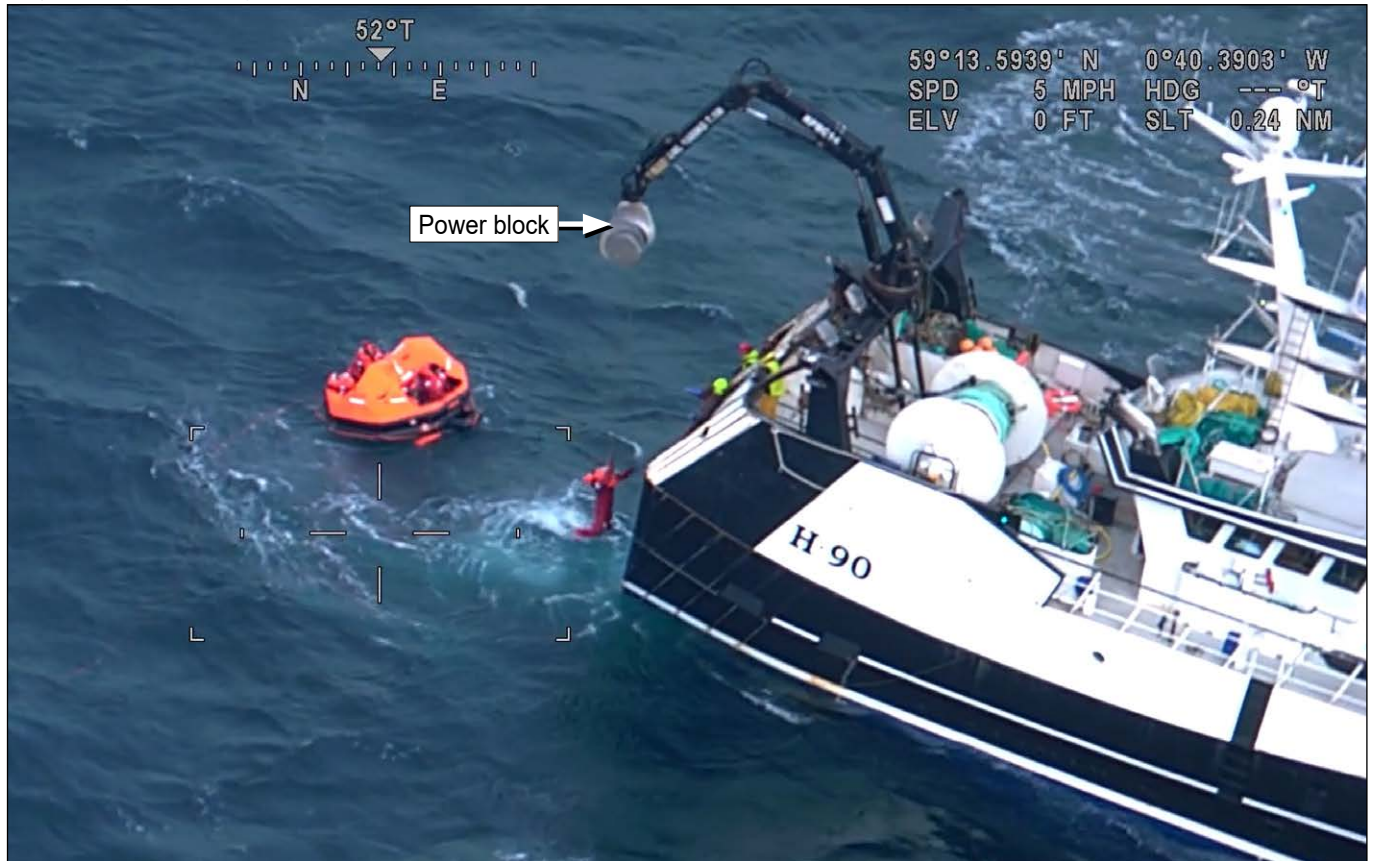
**Figure 2:** Power block recovery of the second crew member

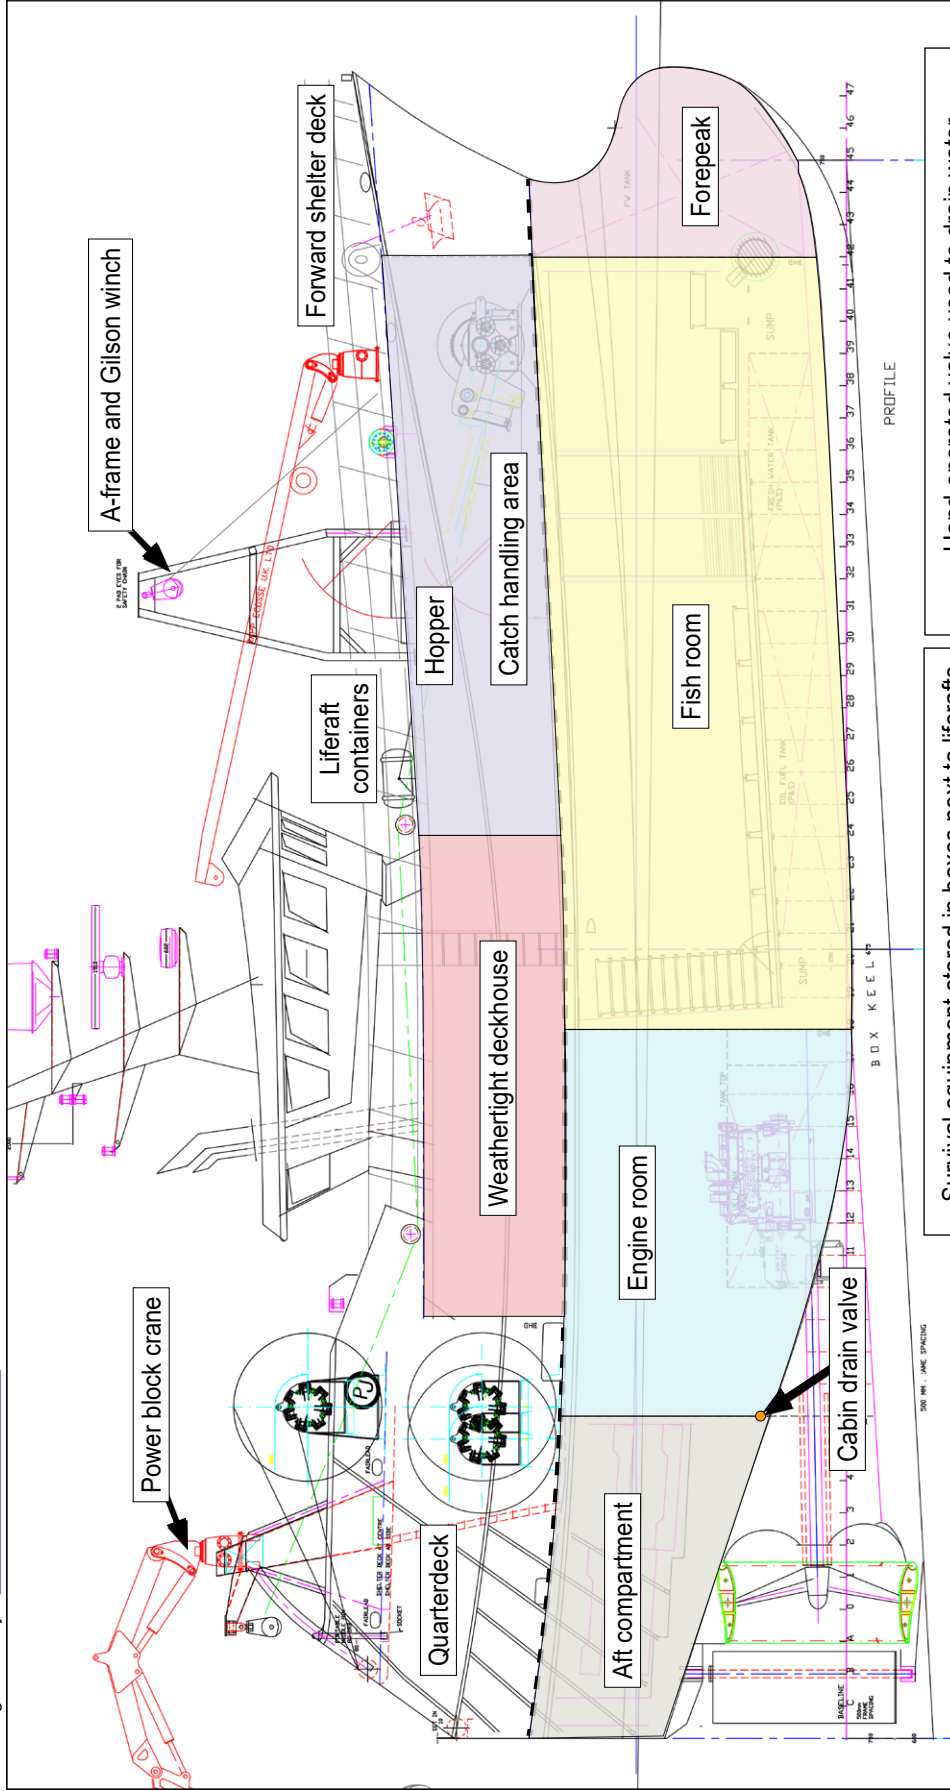
The engine room had three bilge pumps that provided suction for the engine and fish rooms. In line with Sea Fish Industry Authority (Seafish) Construction Standards<sup>4</sup> at the time of the vessels' builds there was no bilge suction inside the aft compartment. Instead, any accumulated water within the compartment could be drained into the engine room bilge through a 40mm diameter pipe fitted with a hand-operated valve<sup>5</sup> (**Figure 3**).

**Figure 3:** Vessel layout, showing watertight divisions and weathertight deckhouse and (insets) survival equipment and cabin drain valve

The lifejackets and immersion suits on board *Guiding Light* were stored in boxes next to the liferafts on the forward shelter deck (see **Figure 3**). The boxes had been custom-built following an MCA intermediate survey in October 2020, which recommended that the lifejackets be moved above the waterline. An MCA surveyor made a similar note during the intermediate survey of *Guiding Star* in December 2021, recommending *that life jackets are stowed above waterline at a designated space. It was found that the jackets were behind the clothes in crew cupboards in cabin and were not readily accessible* [sic]. This recommendation was not actioned, and the survival equipment remained in the same place at the time of the accident.

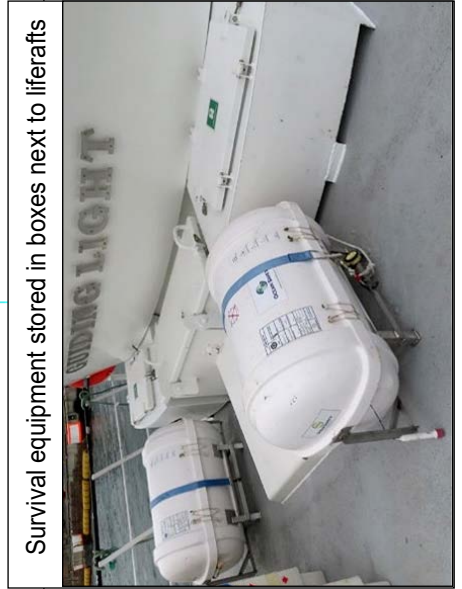
Survival equipment stored in boxes next to liferafts

remained inside crew cabins. It is unfortunate that the vessels' manager did not intervene to ensure survival equipment locations were aligned across its vessels. It is fortunate that *Guiding Star's* crew were able to abandon ship with survival equipment due to the quick transfer of replacement gear from *Guiding Light*. Proper consideration must be given to the location of the survival equipment for timely use in an emergency.

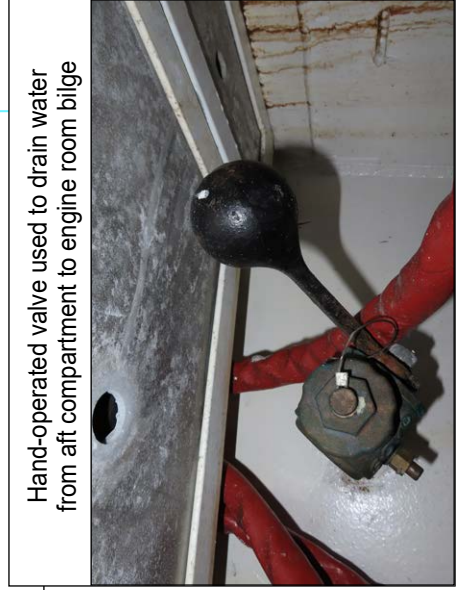
Hand-operated valve used to drain water from aft compartment to engine room bilge

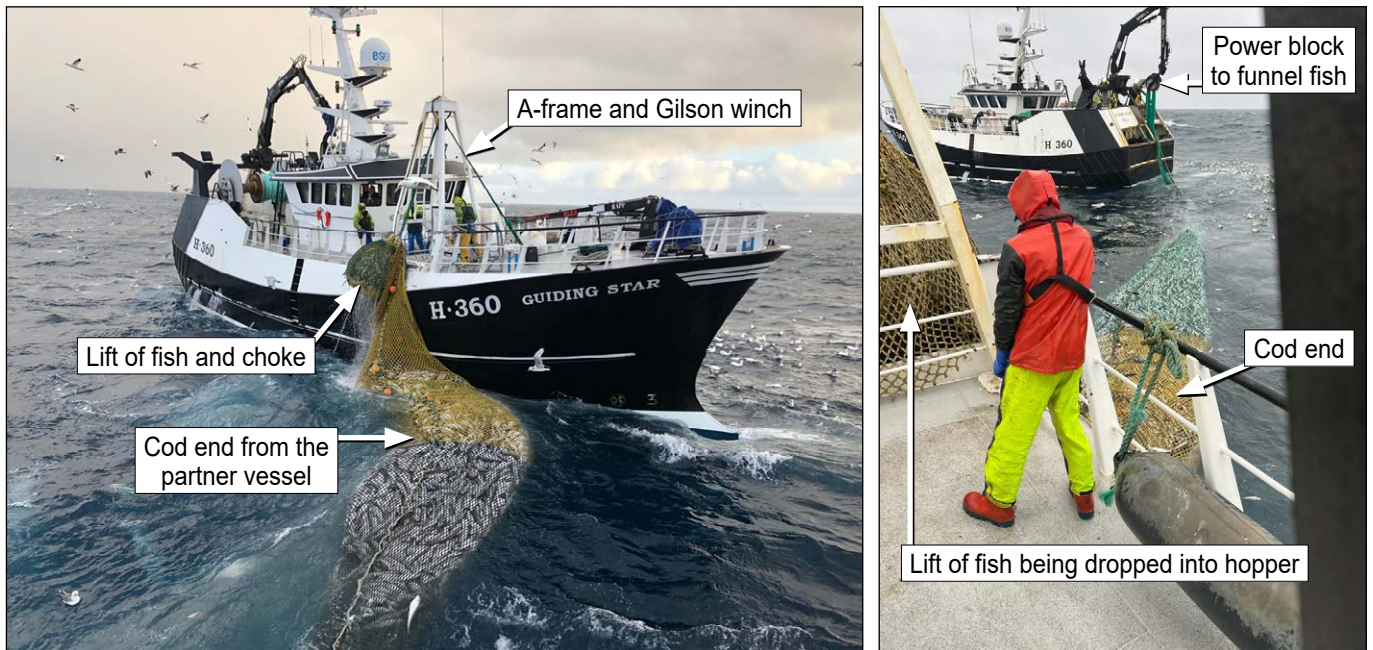
The two engineers worked together to control the position of the cod end using the power block and Gilson winch on their respective vessels. The fish were funnelled into the end of the net using the power block. The cod end was hoisted to the receiving vessel's hopper via the Gilson winch (**Figure 4**). The power block was simultaneously used to maintain some slack in the net to avoid pulling the two vessels together, although it needed to be taut enough to stop the fish from spreading throughout the cod end. The remaining catch was loaded into the hopper, which usually required two or three lifts. The net was pulled and slackened between the two vessels during each lift, trapping the fish at the end of the net where it was 'choked' and lifted out of the water (**Figure 4**).

**Figure 4:** The relative position of each vessel during a fish transfer
