Accident

Aircraft Type and Registration:	Spitfire IXT, G-LFIX	
No & Type of Engines:	1 Rolls-Royce Merlin 25 piston engine	
Year of Manufacture:	1944 (Serial no: ML407)	
Date & Time (UTC):	6 May 2024 at 1400 hrs	
Location:	Pitsford Airfield, Near Sywell, Northants	
Type of Flight:	Private	
Persons on Board:	Crew - 1	Passengers - 1
Injuries:	Crew - None	Passengers - None
Nature of Damage:	Propeller damaged, left wing rear spar buckled	
Commander's Licence:	Airline Transport Pilot's Licence	
Commander's Age:	62 years	
Commander's Flying Experience:	23,000 hours (of which 90 were on type) Last 90 days - 25 hours Last 28 days - 17 hours	
Information Source:	Aircraft Accident Report Form submitted by the pilot and further enquiries by the AAIB

Synopsis

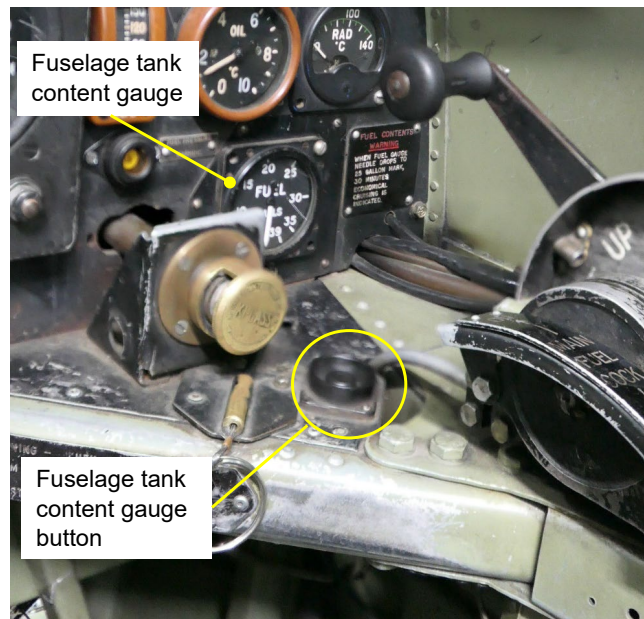
Figure 1

The wing tanks do not have a quantity gauge, however the fuselage tank does. The quantity of fuel is displayed on a gauge on the lower right of the instrument panel when a button is depressed by the pilot (Figure 1). Prolonged depression or removal of the button to make the gauge read permanently would cause the measuring element to fail.

Spitfire G-LFIX fuselage fuel tank content indication gauge

The second opportunity was when the pre-flight checks were being completed prior to the third flight. If the pilot had not been distracted during the checks, he would have identified that the contents of the fuselage tank were below that expected and taken action to rectify the issue.

Had the pilot checked the contents of the fuselage tank prior to changing it during either flight he may have identified that the contents were below that expected and taken mitigating action to maintain fuel flow to the engine.

As a result of this event, the operator has introduced a requirement in their operating procedures for pilots to confirm the contents of the fuselage tank before changing to it.
