Passenger trapped in doors and dragged at Enfield Town station, 17 July 2024

Summary of the accident

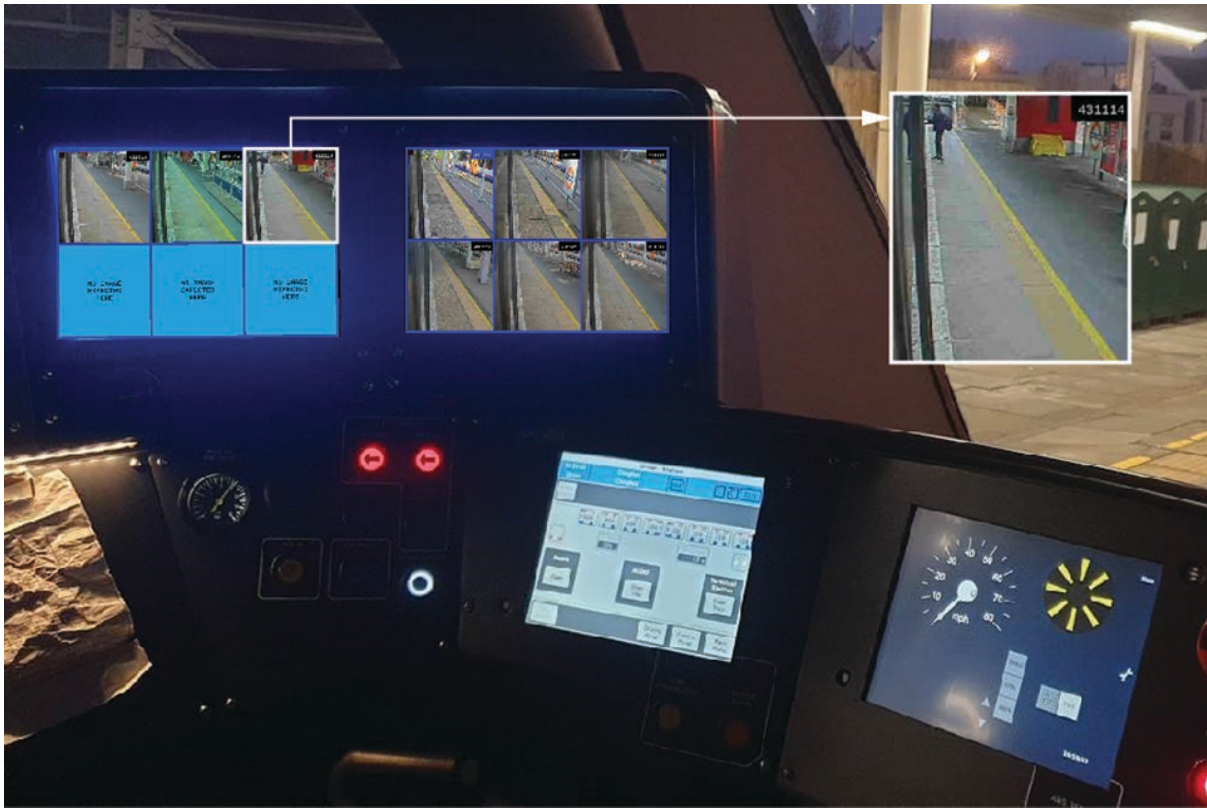
The in-cab CCTV images from train 2U67 were recorded and show what the driver could see before the passenger arrived on the platform. These recordings show that, before the train started, the passenger was located by the rearmost door and was visible in the top right image of the left monitor.

A class 710 driving cab with images from the monitors on the day of the accident superimposed by RAIB showing the passenger on the platform (courtesy of Arriva Rail London).

The driver of train 2U67 stated that they had checked the monitors before beginning to close the doors. A comparison of the in-cab CCTV images from the station and OTDR data shows that the check happened before the passenger was visible on the platform. OTDR data shows that the driver of train 2U67 received an indication that interlock had been gained and began to take power approximately 4 seconds later.

The train safety check that should be undertaken by the driver after the doors were closed did not detect that the passenger was standing close to the train or was trapped in the doors. The driver stated that they believed they had looked at the monitors after the doors had closed. As the passenger was at the rearmost door of the vehicle they were attempting to board, they would have been less conspicuous in the relevant monitor image since their relative size would have been small compared to a passenger standing closer to the camera. In addition, the driver may have developed a belief that it was safe to depart based on the images shown on the monitors at the point where they closed the doors. At that time, the in-cab CCTV recording shows that nobody was near to the train and the passenger involved in the accident had not yet reached the platform.

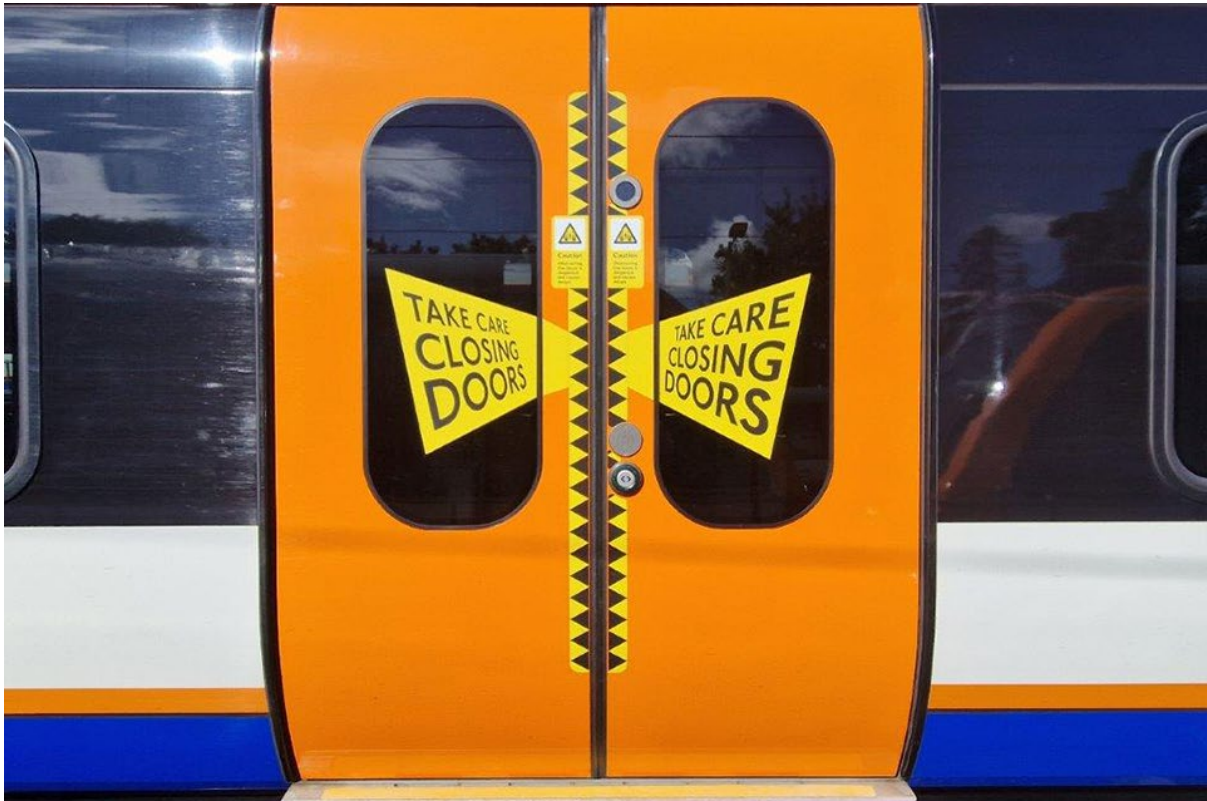
Class 710 trains, including train 2U67, have ‘sharks teeth’ markings on the door edges and warning labels intended to warn passengers of the potential danger of placing an object between closing doors. Some doors on class 710 trains, including those used by the passenger in this accident, have also been fitted with larger warning labels. ARL and other train operators have run passenger education campaigns to warn of the dangers of obstructing train doors and the Rail Safety and Standards Board facilitates a cross-industry group that aims to reduce passenger risk, including that associated with boarding and alighting trains.

Doors on the side of a class 710 showing the ‘sharks teeth’ markings and warning labels (courtesy of Arriva Rail London).

Evidence from this accident, and other incidents involving class 710 trains, also suggests that the door seals on this class of train (which meet at the edge of each door as they close and seal the doorway) may make it difficult for passengers to pull themselves free once their hand becomes trapped.
