# ***AAIB Bulletin***

# ***10/2024***

<b>Aircraft Type and Registration:</b>	Vans RV-6A, G-RVSH	
<b>No &amp; Type of Engines:</b>	1 Lycoming IO-360-A1AD (Modified) piston engine	
<b>Year of Manufacture:</b>	2004 (Serial no: PFA 181A-13026)	
<b>Date &amp; Time (UTC):</b>	3 September 2023 at 1406 hrs	
<b>Location:</b>	Truro Airfield, Cornwall	
<b>Type of Flight:</b>	Private	
<b>Persons on Board:</b>	Crew - 1	Passengers - None
<b>Injuries:</b>	Crew - 1 (Fatal)	Passengers - N/A
<b>Nature of Damage:</b>	Aircraft destroyed	
<b>Commander's Licence:</b>	Private Pilot's Licence	
<b>Commander's Age:</b>	60 years	
<b>Commander's Flying Experience:</b>	261 hours (of which 115 hours were on type) Last 90 days - 6 hours Last 28 days - 3 hours	
<b>Information Source:</b>	AAIB Field Investigation

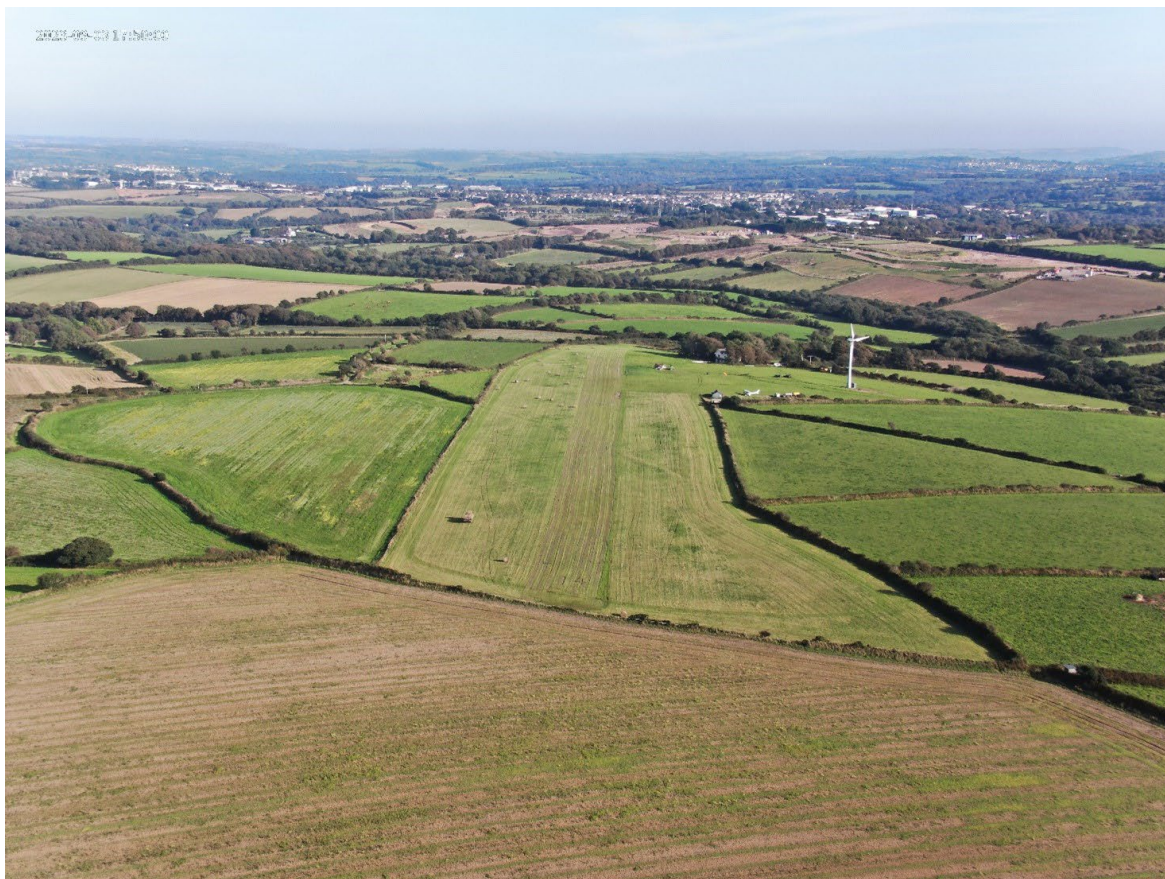
**Figure 1**

View of Truro in the direction of Runway 14, taken later on the same day as the accident

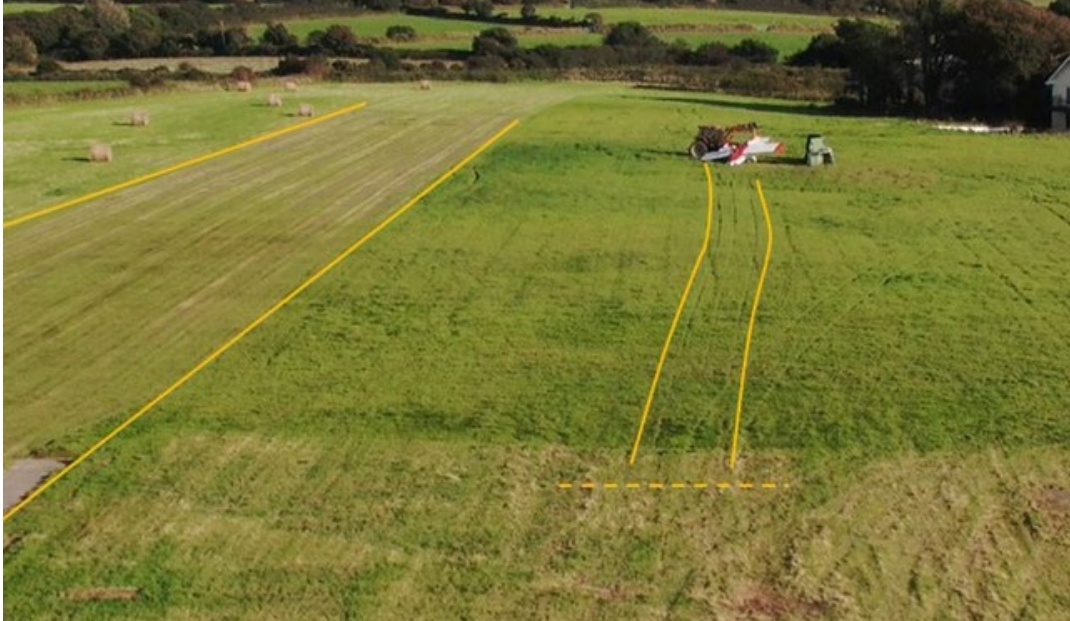
**Figure 2**

The aircraft came to rest approximately 20 m to the right side of Runway 14 after a ground roll of approximately 100 m. The first ground marks consisted of three tyre tracks in the grass, which started to the side of and about halfway down the runway length (Figure 2).

Accident site, viewed from the Runway 14 direction

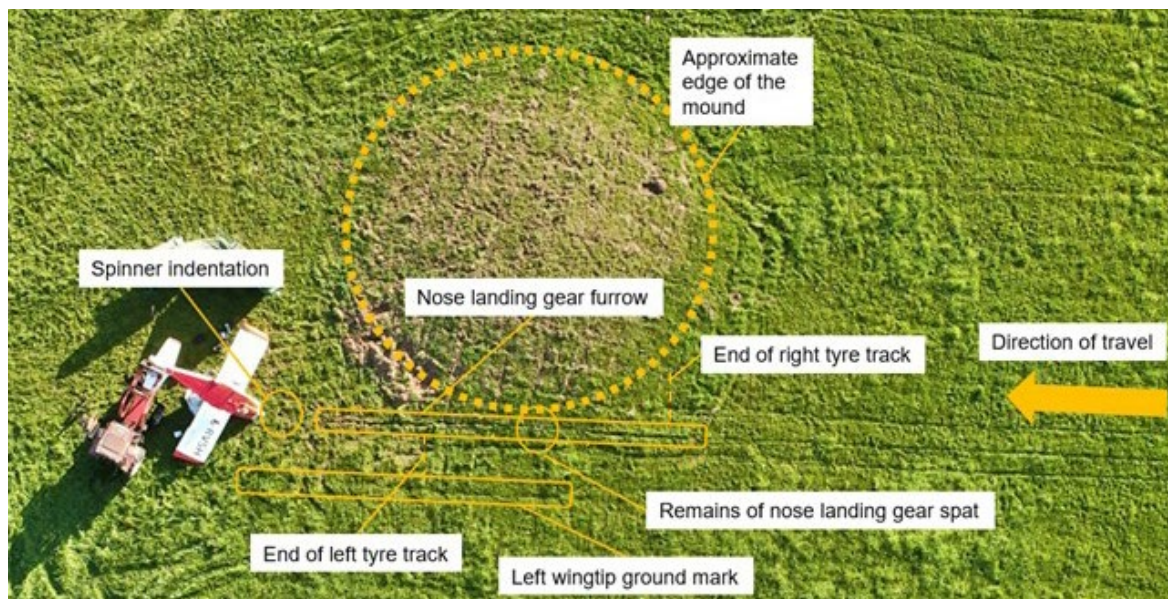
**Figure 3**

The three tracks were consistent with the three wheels touching down at the same time and were parallel to the runway until adjacent to the north side of the mound (Figure 3). The right landing gear wheel track ended near the periphery of the mound. Approximately 6 m after the right track ended, the partial remains of the nose wheel spat were found. Leading up to the spat was a deep furrow created by the nose landing gear, which started before the point where the right tyre track ended. At the same approximate position there was evidence that the left wing tip was in contact with the grass, and this was further confirmed by light scratches on the left wingtip structure. The nose landing gear furrow extended a further 10 m beyond the remains of the spat with the left tyre track ending approximately halfway along. After a gap of approximately 2 m beyond the nose landing gear furrow, an indentation had been made by the propeller spinner. The aircraft came to rest inverted just beyond this indentation.

Accident site ground marks

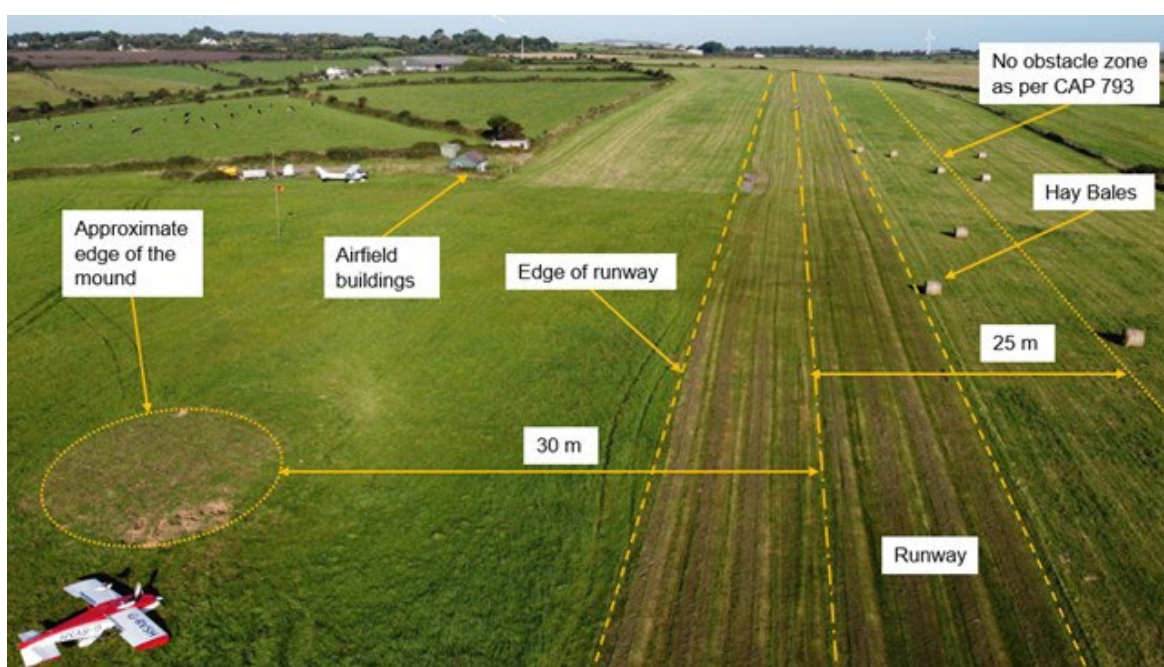
**Figure 7**

*'No vertical obstacles within 25 m either side of centreline.'*

Truro airfield viewed in direction of Runway 32 showing hay bales and the mound

- The airfield owner has instructed the farmers to remove the hay from the airfield as soon as it is baled and not to store it on the airfield.
- The airfield owner has provided additional guidance in the Pooley's Plate on which runway to use depending upon the wind conditions.
- The airfield owner has removed the training mound.

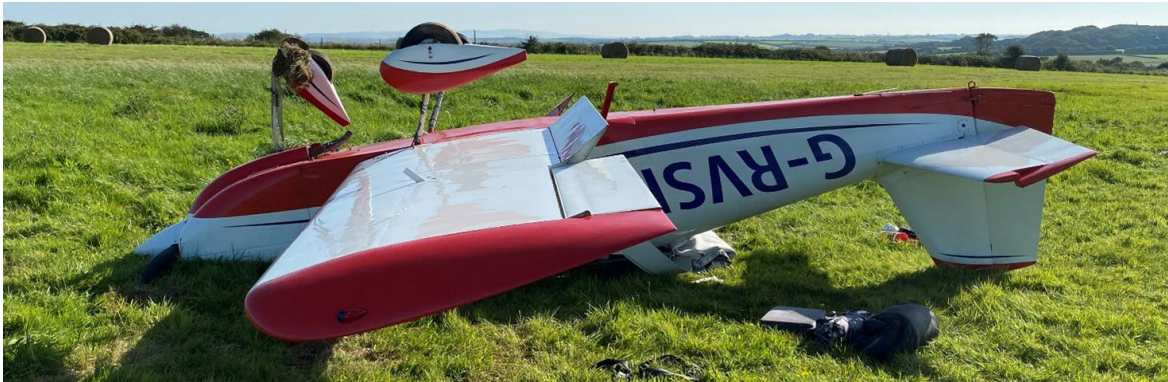
**Figure 8**

The aircraft structure was intact with crush damage to the top of the vertical fin and deformation of the canopy frame and the Perspex shattered. The main landing gear was intact and there was evidence on the tyres of skidding on earth and grass. The nose landing gear strut was bent rearwards, and the front of the spat was damaged with a section missing. The aircraft was recovered to the AAIB facilities for further inspection.

G-RVSH at the accident site

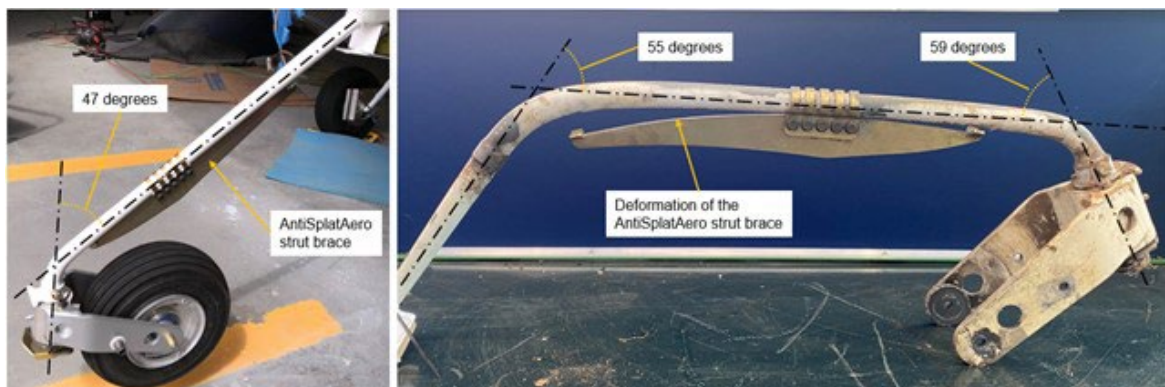
**Figure 9**

The nose landing gear was disassembled to enable inspection of the individual components and measurements to be taken. The landing gear usually has a 47° bend at the lower end and following the accident this had increased to 59°. An additional bend had occurred just before the mounting position of 55° (Figure 9). The blade of the strut brace had also been deformed rearwards.

Nose landing gear damage detail

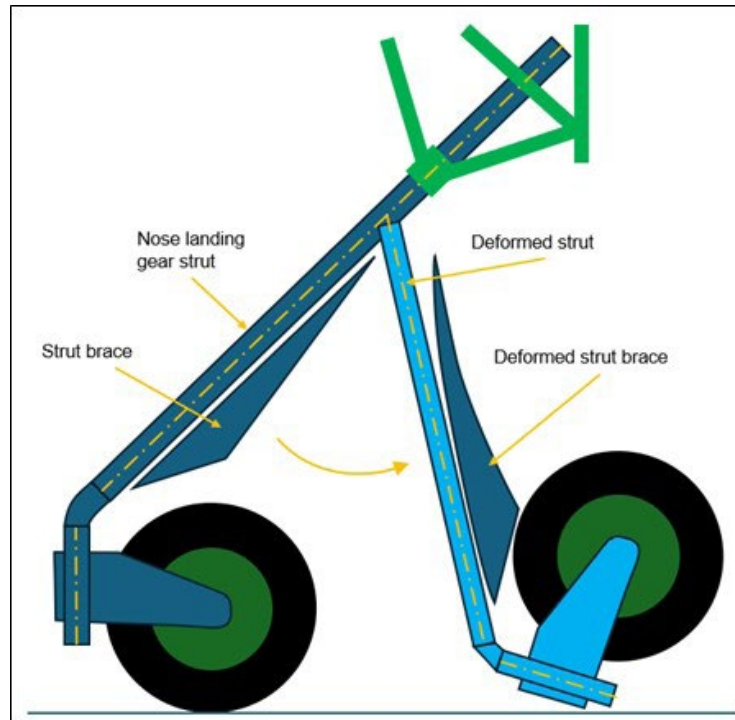
**Figure 10**

The change in the geometry of the nose landing gear strut resulted in the nose wheel no longer contacting the ground (Figure 10). This is consistent with the furrow that was created just prior to the aircraft becoming inverted. It was noted that despite the deformation of the strut brace, the centre portion of the landing gear strut had remained straight, but that the strut had bent beyond the ends of the brace.

Deformation of the nose landing gear

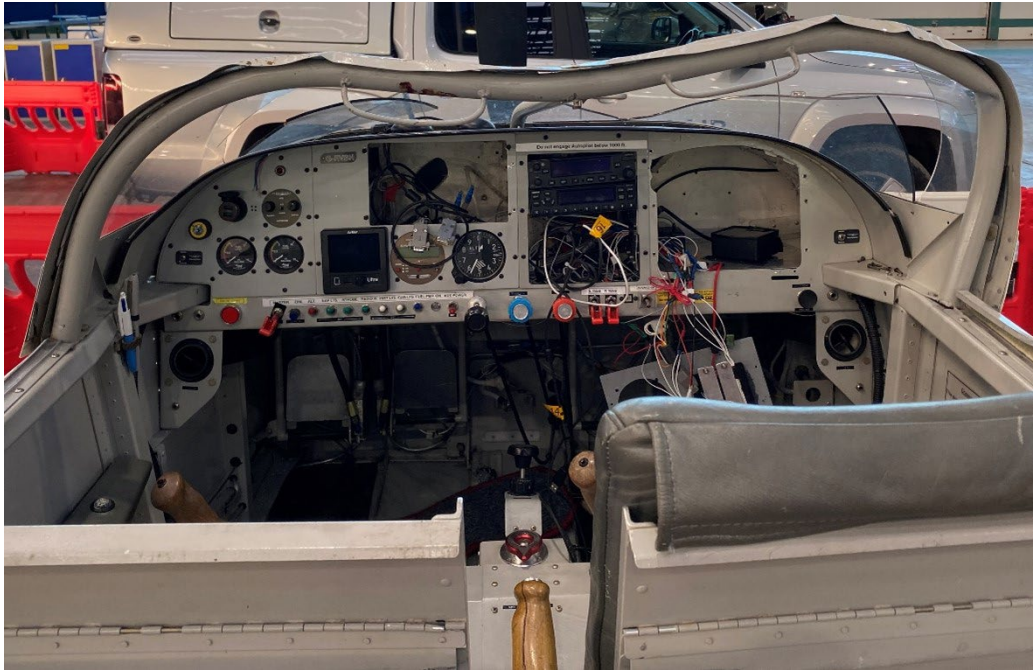
**Figure 11**

The RV-6A is available with a choice of two canopy types: a forward hinged and a sliding split canopy. G-RVSH was fitted with the sliding canopy with the forward part of the screen fixed and supported by a tubular steel hoop. During the structural inspection of the airframe, the deformation of the airframe and canopy was assessed to understand the change in the survivable volume for the pilot as the aircraft was inverted. When the aircraft was inverted it was resting on the front of the engine cowling and the vertical stabiliser. Analysis of the aircraft geometry showed that the top of the canopy would protrude approximately 35 cm above a line drawn between the engine cowling and the tip of the vertical stabiliser. The tip of the vertical stabiliser was damaged with a loss in height of approximately 5 cm.

Canopy frame deformation – note the pilot had been flying from the left seat

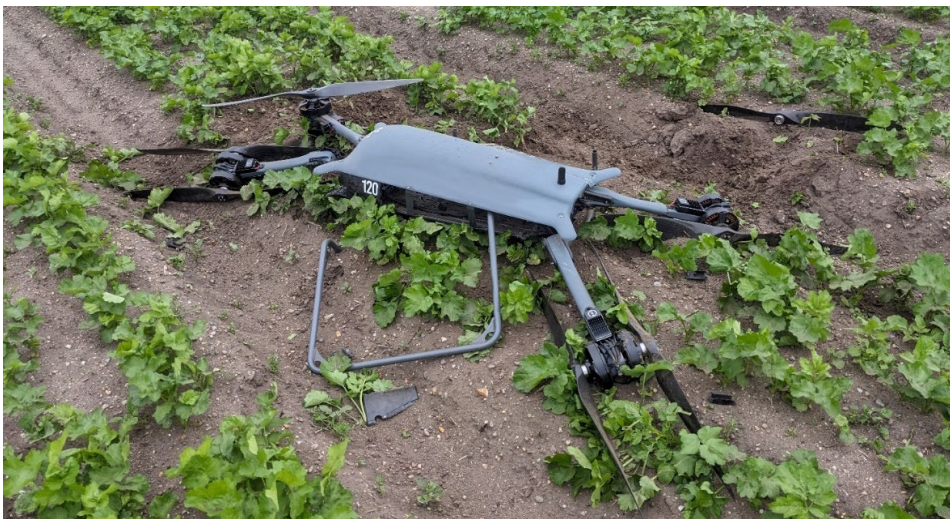
**Figure 1**

Malloy T150 unmanned aircraft at the accident site

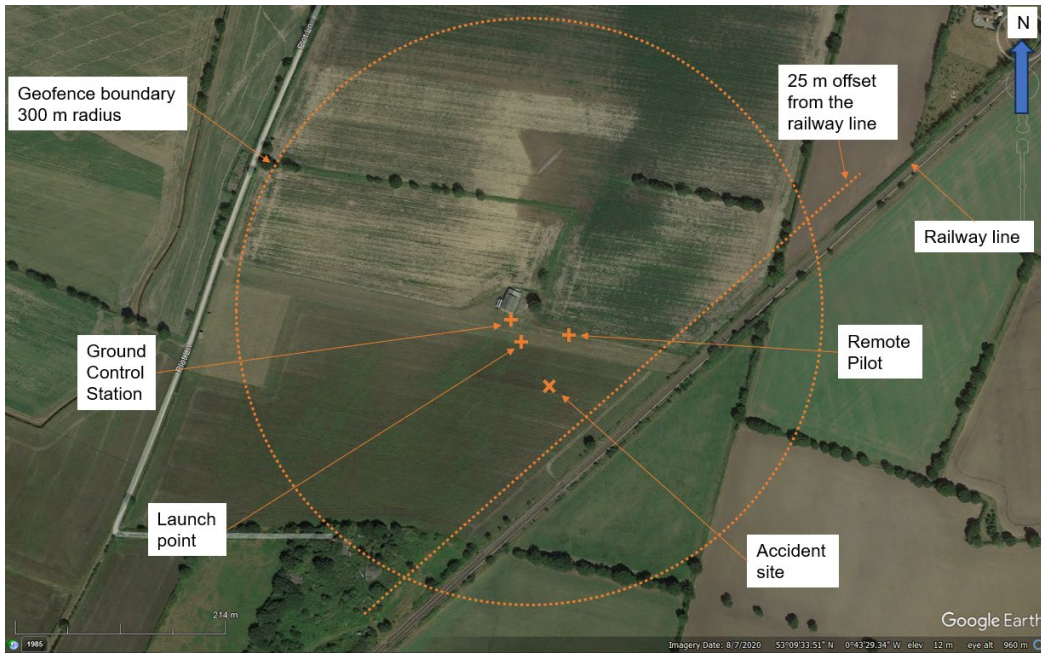
**Figure 2**

The aircraft diverged from level flight and was seen to follow an erratic flight path unfamiliar to the RP, during which it achieved a maximum pitch of  $-41^\circ$  and  $-60.9^\circ$  of roll. To regain control the RP increased the throttle to 100% which caused the aircraft to overcorrect, and it then pitched to  $85.3^\circ$  with  $60^\circ$  of roll before descending rapidly from a height of 37 m. The RP realised he could not regain control and switched to an automated mode (LOITER mode) but by this time the aircraft was heading towards the RP's ground position and he decided to close the throttle, bringing it to the ground (Figure 1). Twelve seconds had passed from the geofence breach before the aircraft struck the ground approximately 50 m from the RP's position and within the horizontal boundary of the geofence (Figure 2).

Accident site and geofence

It is recommended that the UK Civil Aviation Authority, when granting Operational Authorisations for Unmanned Aircraft Systems in the specific category, ensure that any safety feature that is used to mitigate risks, is adequately defined in the Operational Safety Case and includes the necessary operational procedures.

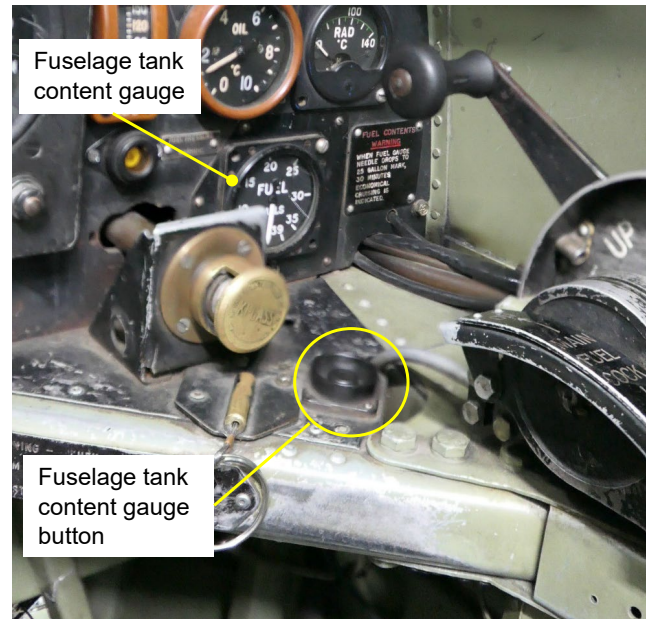
**Figure 1**

The wing tanks do not have a quantity gauge, however the fuselage tank does. The quantity of fuel is displayed on a gauge on the lower right of the instrument panel when a button is depressed by the pilot (Figure 1). Prolonged depression or removal of the button to make the gauge read permanently would cause the measuring element to fail.

Spitfire G-LFIX fuselage fuel tank content indication gauge
