Report on the investigation of
the capsizing of the recreational craft

Wheelyboat 123

with the loss of two lives
on Roadford Lake, Devon, England
on 8 June 2022

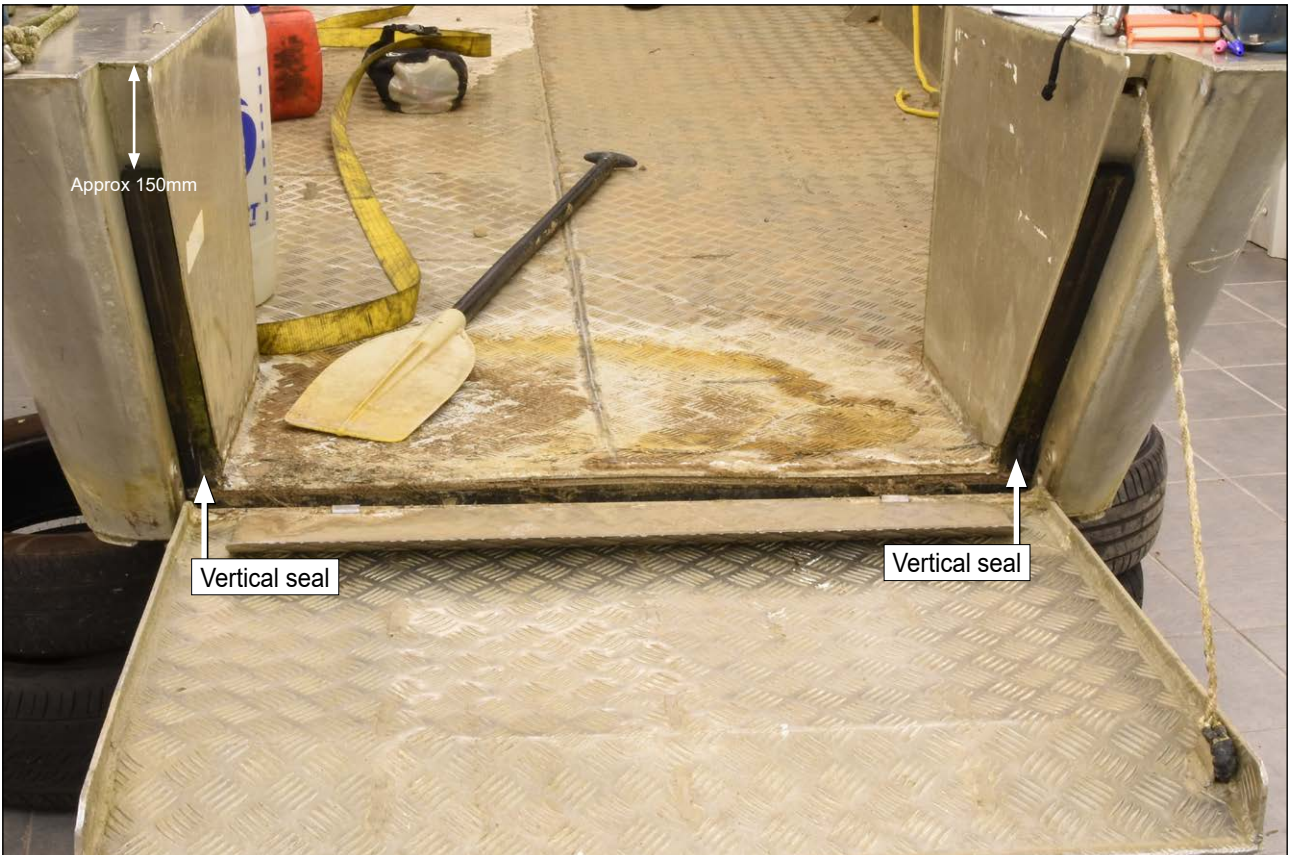
Figure 13: Bow ramp vertical seals 150mm lower than the top of the ramp

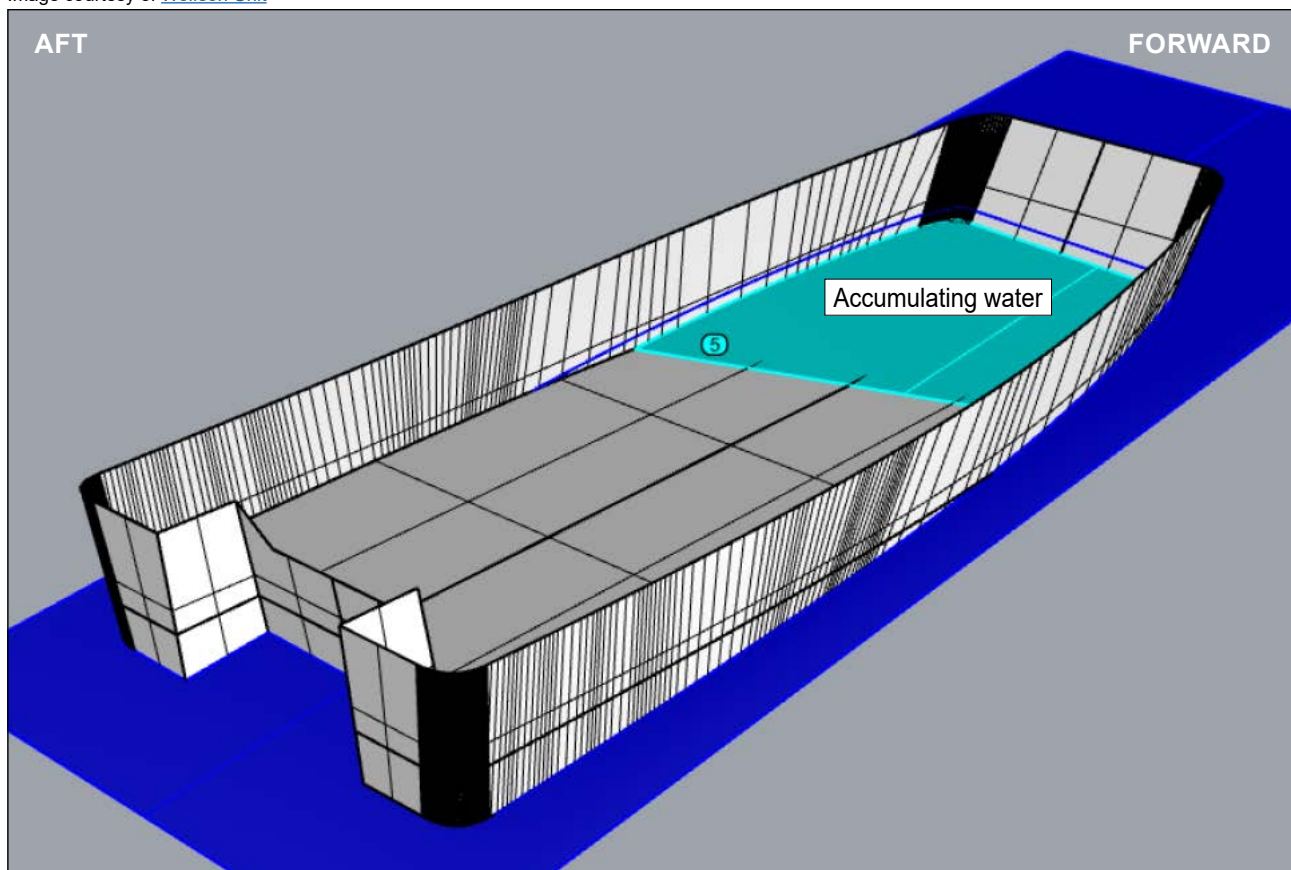
At the point before the capsize the Wolfson Unit stability model calculations resulted in a bow down trim of 0.398m (4.6°), a heel of 1.75° to port and a draft of 0.102m. The modelled waterline was approximately 20cm below the top edge of the bow ramp.

Figure 16: *Wheelyboat 123* in the as-modelled pre-capsize loading condition (Equilibrium waterline in blue)

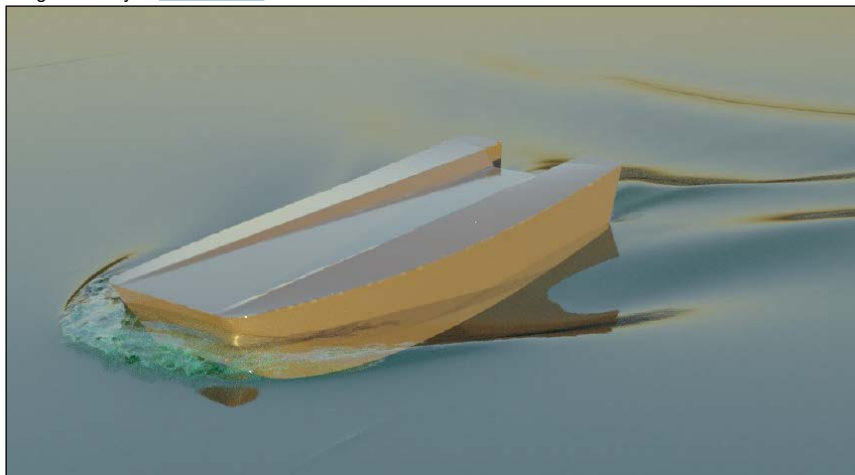
Figure 17: Computational fluid dynamics simulation of bow wave before capsize
