Accident

Aircraft Type and Registration:	Piper PA-28-181, G-BVNS
No & Type of Engines:	1 Lycoming O-360-A4M piston engine
Year of Manufacture:	1976 (Serial no: 28-7690358)
Date & Time (UTC):	23 April 2024 at 1503 hrs
Location:	1.5 miles from Prestwick Airport
Type of Flight:	Currency Check flight
Persons on Board:	Crew - 1 Passengers - 1
Injuries:	Crew - 1 (Serious) Passengers - 1 (Serious)
Nature of Damage:	Aircraft damaged beyond economic repair
Commander's Licence:	Light Aircraft Pilot's Licence
Commander's Age:	75 years
Commander's Flying Experience:	307 hours (of which 101 were on type) Last 90 days - 0 hours Last 28 days - 0 hours
Information Source:	AAIB Field Investigation

Synopsis

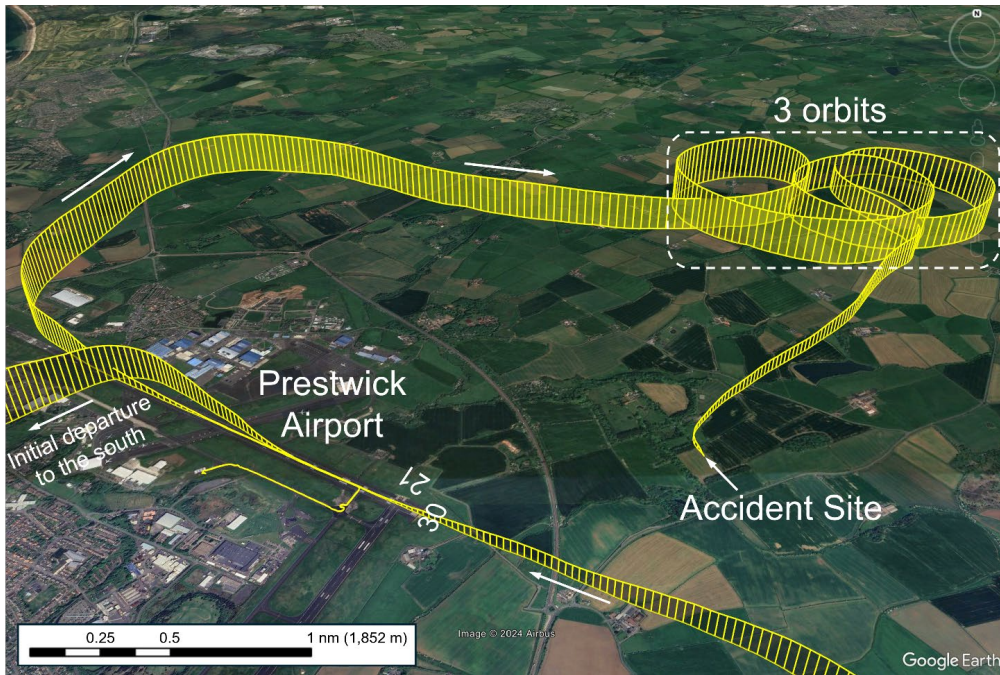
Figure 3

The CFI was using a flight-planning and navigation app on his mobile phone which recorded the aircraft’s GPS flight path (Figure 3). The figure highlights the three orbits flown at the end of the downwind leg of the circuit and the proximity of the crash site from the airport.

Flight path of right hand circuit with downwind orbits highlighted

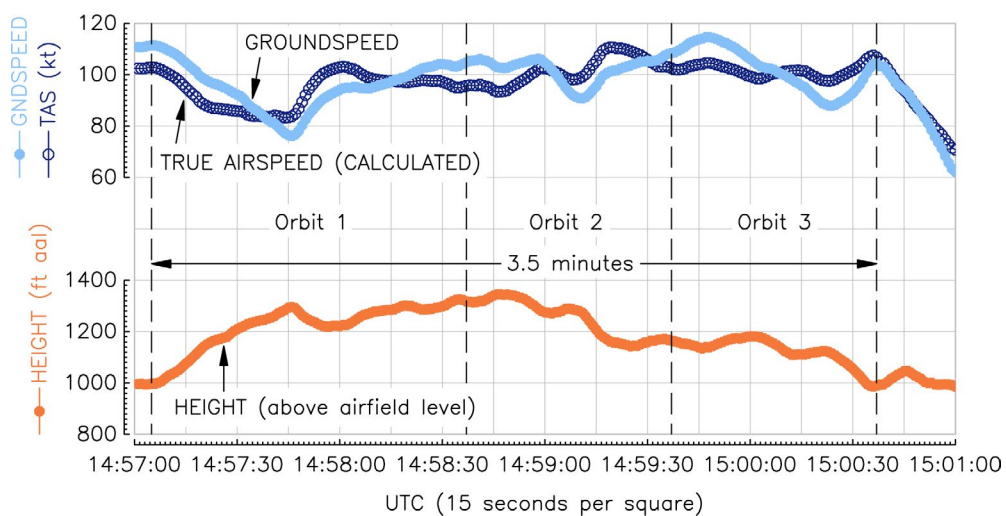
Figure 4

The orbits were flown over a period of 3.5 minutes during which the aircraft climbed and descended about 300 ft. The airspeed varied between about 83 and 110 kt (Figure 4).

GPS derived data for the three orbits

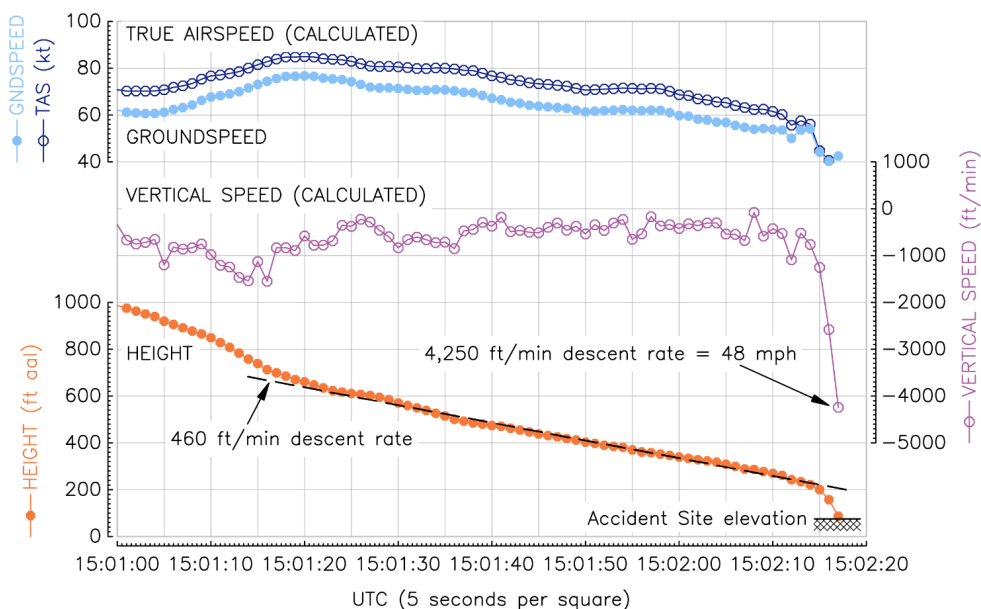
Figure 5 plots data for the descent starting with the aircraft descending through 1,000 ft amsl (980 ft aal and about 600 ft agl) on base, at about 800 ft/min, just under 2 nm from the threshold of Runways 21 and 30. The descent rate reduced to about 460 ft/min for the remaining 60 seconds of the descent, during which the airspeed reduced from 85 to below 60 kt. The aircraft then struck the tree, after which it descended towards the ground at about 4,250 ft/min (equivalent to 48 mph).

Figure 5
GPS derived data for the descent

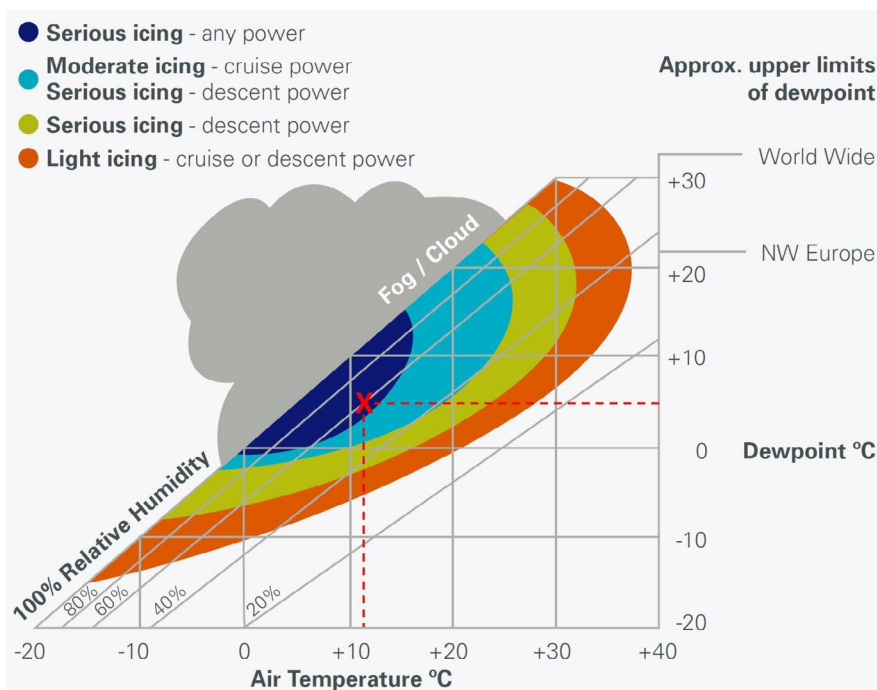
Figure 6

The temperature and dewpoint combination plotted on a CAA carburettor icing risk chart (Figure 6) from the CAA's Safety Sense Leaflet (SSL) 14 – *Piston Engine Icing*¹ indicates the conditions of the day would have created a serious risk of carburettor icing at any power.

CAA icing risk chart from SSL 14
