Rail Accident Investigation Branch

Rail Accident Report

Collision between on-track machines near to Strood, Kent 16 November 2023

Report 11/2024
October 2024

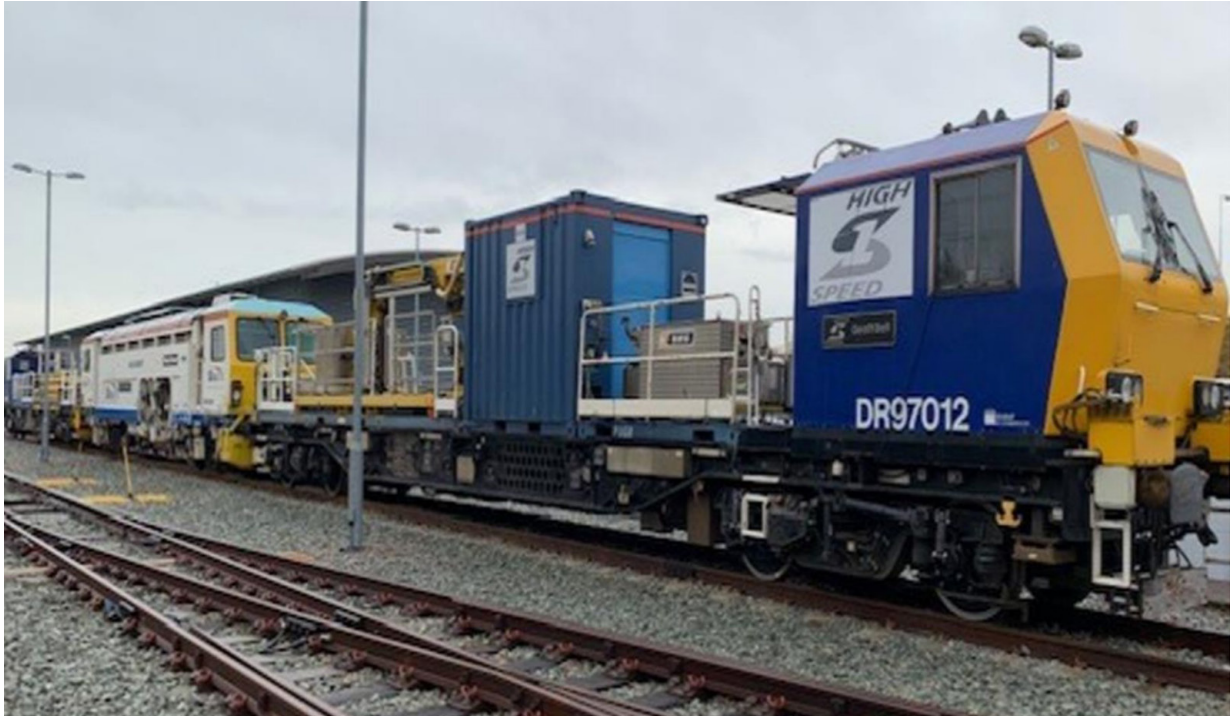
Figure 3: One of the HS1 MPVs involved in the accident (courtesy of NRHS).

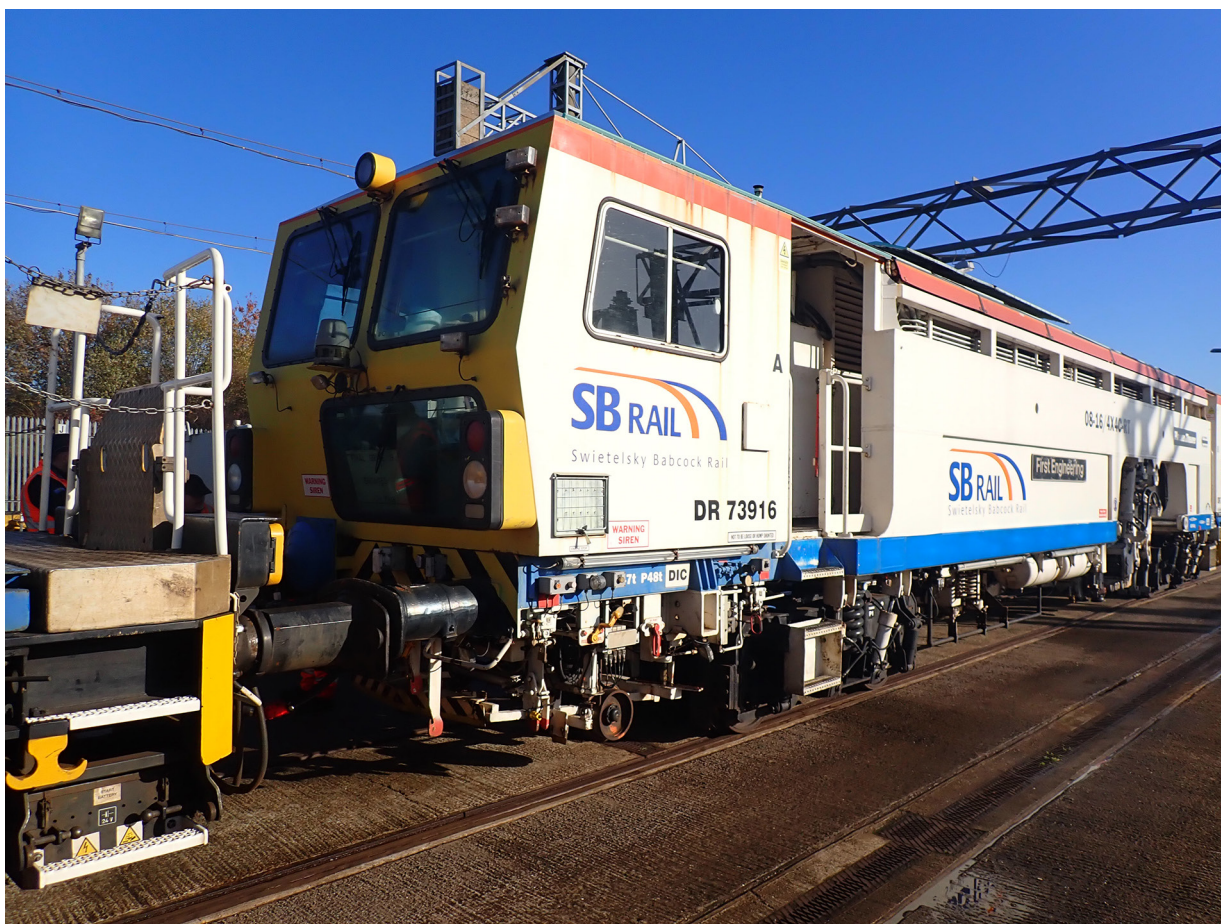
Figure 4: The tamper involved in the accident.
