**Xtralris and System Sensor OSID-R Conventional Detector**

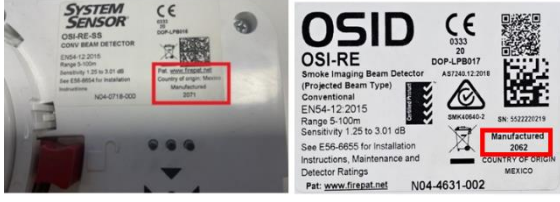
Aspect	Details
<p><b>Images</b></p>	<p><b>Right side of the OSID-R eyeball:</b></p>

<p><b>PSD Number</b></p>	<p>2409-0032</p>
<p><b>Product Type</b></p>	<p>Construction product - OSID-R Conventional Detector</p>
<p><b>Product Identifiers</b></p>	<p>Brands: Xtralris and System Sensor Models: OSI-RE and OSI-RE-SS Affected batches: Between 1041 (included) and 3043 (included) (Please note that there are 57 affected units, all of which are traceable)</p>
<p><b>Product Description</b></p>	<p>An Open area Smoke Imaging Detection Unit (OSID) for protecting large, open areas. The above images show the labelling found on the right side of the unit after removing the cover.</p>
<p><b>Country of Origin</b></p>	<p>Mexico</p>
<p><b>Counterfeit</b></p>	<p>No</p>
<p><b>Risk Level</b></p>	<p>Serious</p>
<p><b>Risk Type</b></p>	<p>Fire and Burns</p>
<p><b>Risk Description</b></p>	<p>It has been identified that a small number of affected detectors have failed and did not notify the fire panel of their failure. This may result in a fire being undetected, which may lead to users being trapped in a fire or receiving burns. The affected detectors do not meet the requirements of the Construction Products Regulations 2013.</p>

<p><b>Corrective Measures</b></p>	<p>The affected products have been recalled from end users.  All 57 affected detectors are traceable through installers/customers and can be identified by a combination of the models and the production date codes.</p>
<p><b>Online Marketplace</b></p>	<p>N/A</p>
<p><b>Notifier</b></p>	<p>Local Authority Trading Standards</p>

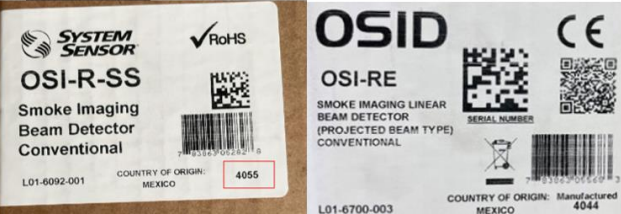
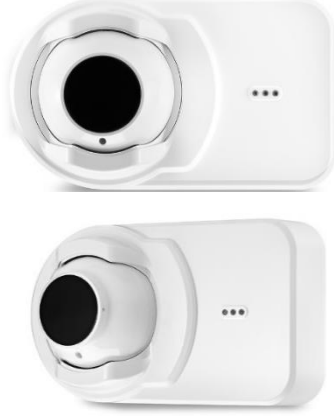
<p><b>Outer Carton:</b></p>
