Urgent Safety Advice 01/2024: Derailment on bridges with longitudinal timber systems

Published 24 October 2024

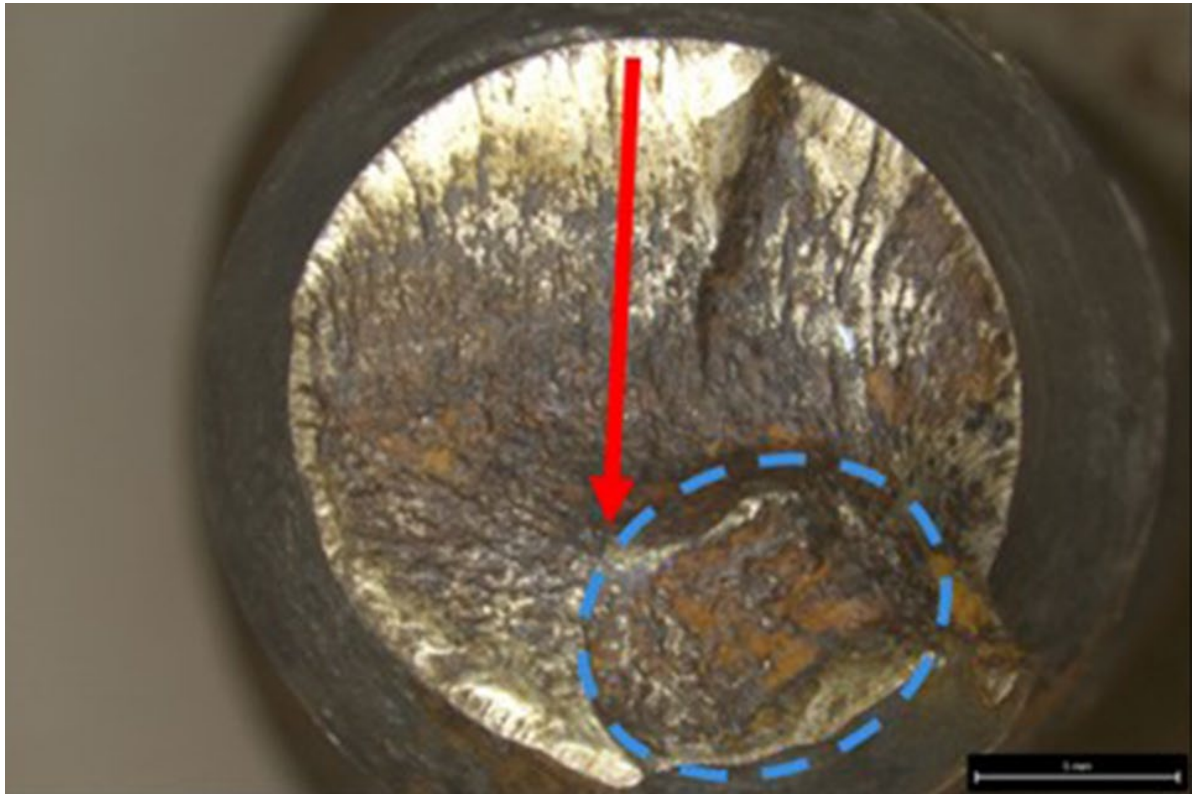
Early results from metallurgical analysis of these failed chair screws show that they all exhibited signs of low-cycle and high-cycle fatigue failure in bending (figure 1). A number of them also exhibited a small area of unfatigued material which eventually fractured by overload (figure 2). The plane of failure in most cases was just below the top level of the timber, typically one or two threads below the screws' shanks.

Figure 1: Fracture face of the upper portion of a recovered screw with indications of unidirectional high-cycle and low-cycle bending fatigue and a small area of overload (circled).

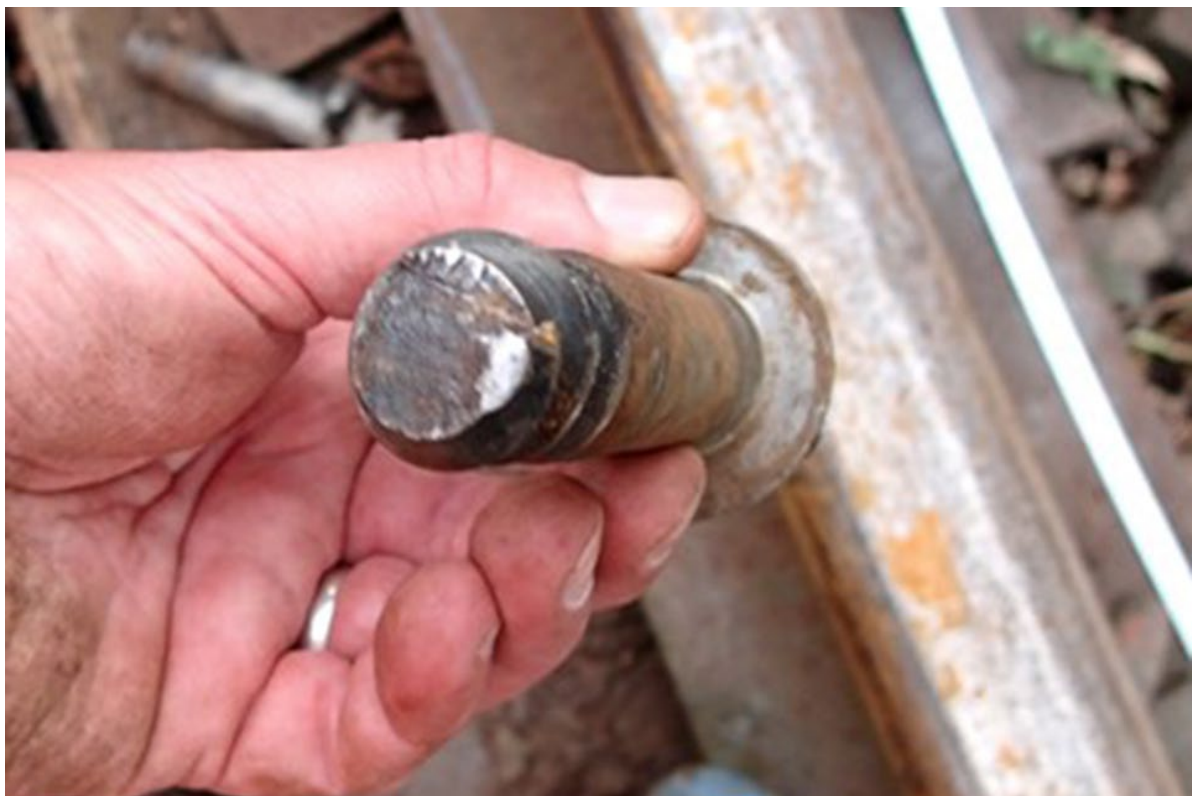
Figure 2: One of the recovered top portions of a screw with signs of historical fracture and subsequent failure by overload (bright area).
