Rail Accident Investigation Branch

Rail Accident Report

Collision between a road-rail vehicle and a trolley near Brading, Isle of Wight 22 November 2023

Report 12/2024
October 2024

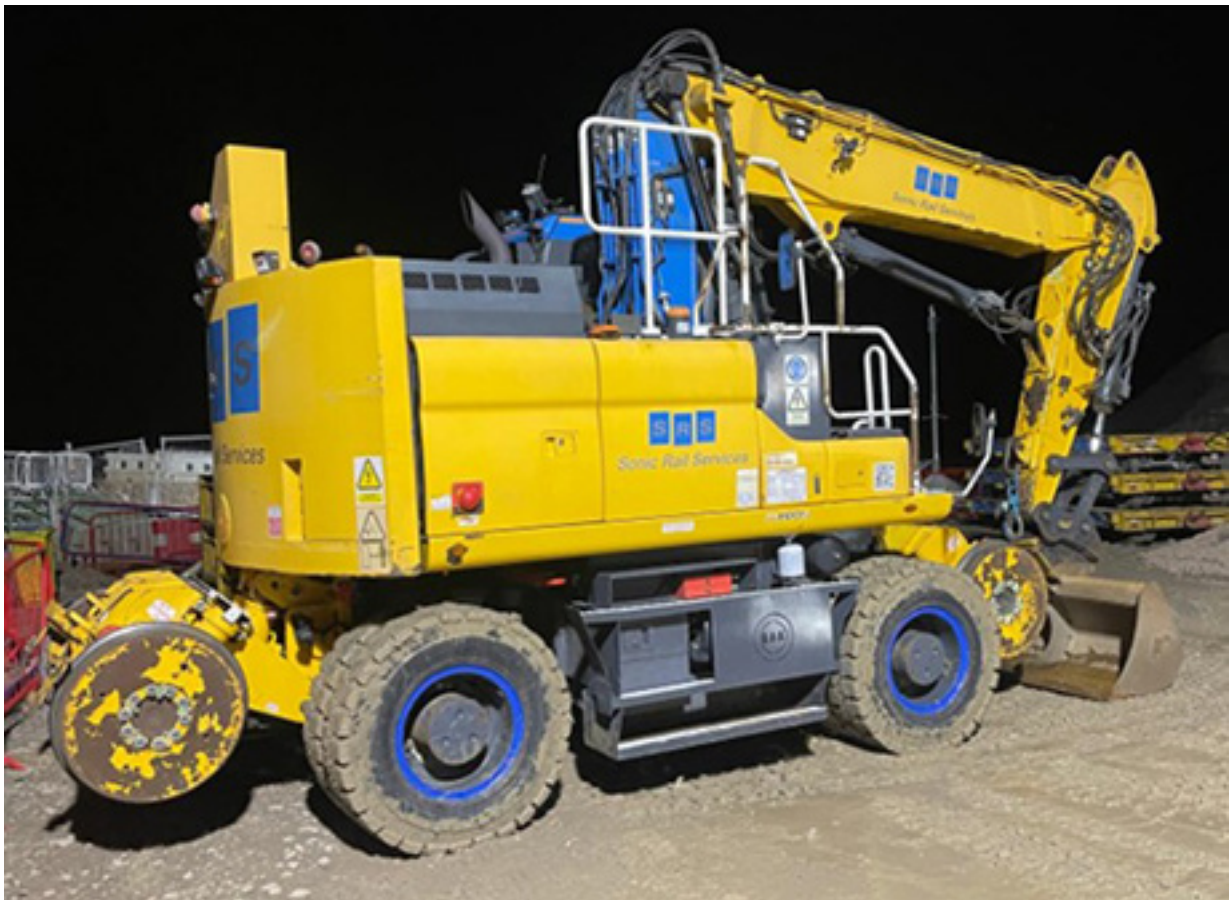
Figure 3: Road-rail vehicle used on 21 to 22 November (courtesy of Sonic Rail Services).

- 16 The RRV is equipped with rubber tyres and rail wheels and has a gross vehicle weight of 30.16 tonnes (figure 3). It is a Type 9A machine with its rail wheels powered by a hydrostatic drive, with three forward gears and a hydrostatic brake. It has a 20 mph (32 km/h) maximum permitted travelling speed on plain line track with an audible in-cab alarm if the maximum speed is exceeded. The machine is also fitted with a passive speed restrictor which removes drive power when this audible alarm sounds until the speed reduces. The machine is fitted with a data logger, although this does not record the speed of the vehicle. At the time of the accident, the machine was not fitted with a global positioning system (GPS) to record its location or a closed-circuit television (CCTV) system.

- 17 At the time of the accident, the RRV had no recorded defects. It subsequently passed a static brake test in the hours following the accident and passed a post-accident dynamic brake test on a later date (see paragraph 96). It was one of two similar machines which had been in use on the Island Line for 5 weeks preceding the accident as part of the major maintenance programme. The RRV was being operated with an on-track plant Engineering Conformance Certificate issued in 2018 and valid for 7 years. This certificate was issued in accordance with RIS-1530-PLT, 'Rail Industry Standard for Technical Requirements of On-Track Plant and Associated Equipment', issue 6 dated December 2015, which was in force when the certificate was issued.

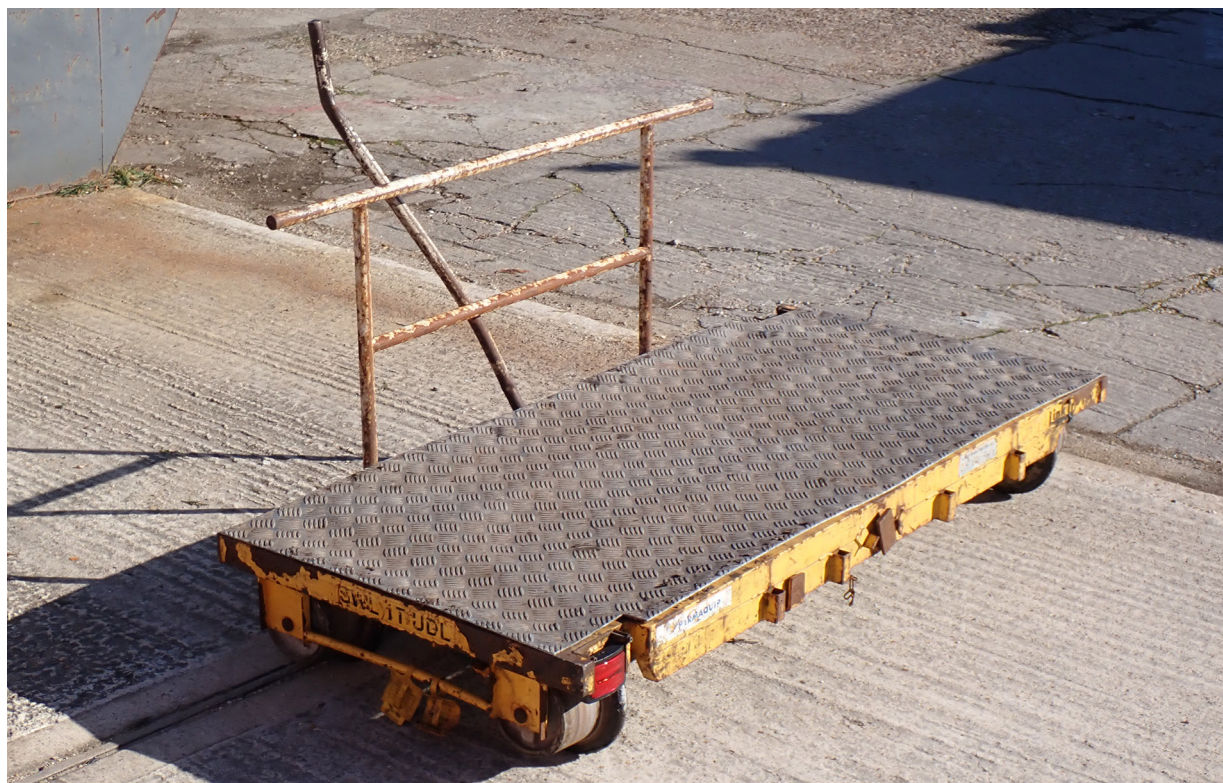
Figure 4: Hand trolley used on 21 to 22 November 2023.

- 18 The hand trolley, which was struck by the RRV, weighs 50 kg unloaded and has a carrying capacity of 1000 kg (figure 4). It had red lights affixed front and back as required by GERT8000 (the Rule Book) HB10, 'Duties of the COSS or SWL [safe work leader] and person in charge when using a hand trolley', issue 4.1, dated November 2022.
- 19 Before the accident, the hand trolley was being used to carry hand-tools, jacks, petrol-driven hand-tamping machines and fuel cans.

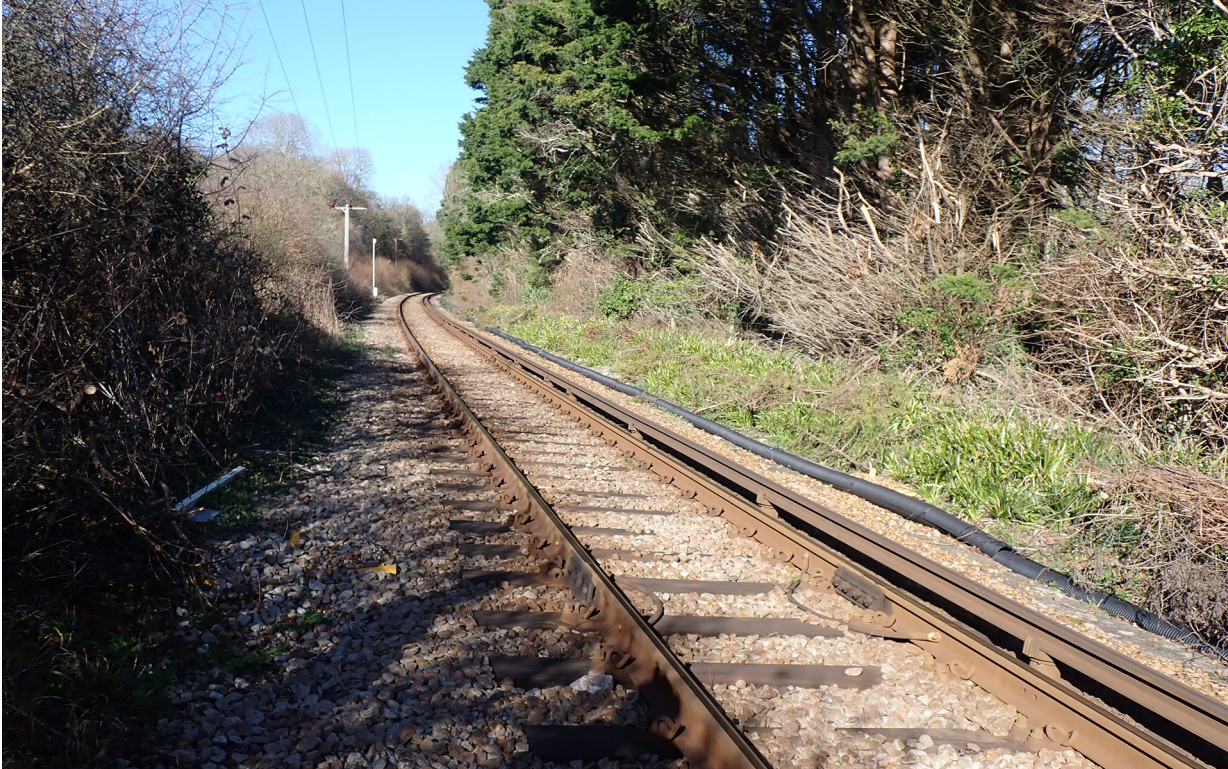
Figure 5: Location of accident looking north. The RRV approached from this direction.

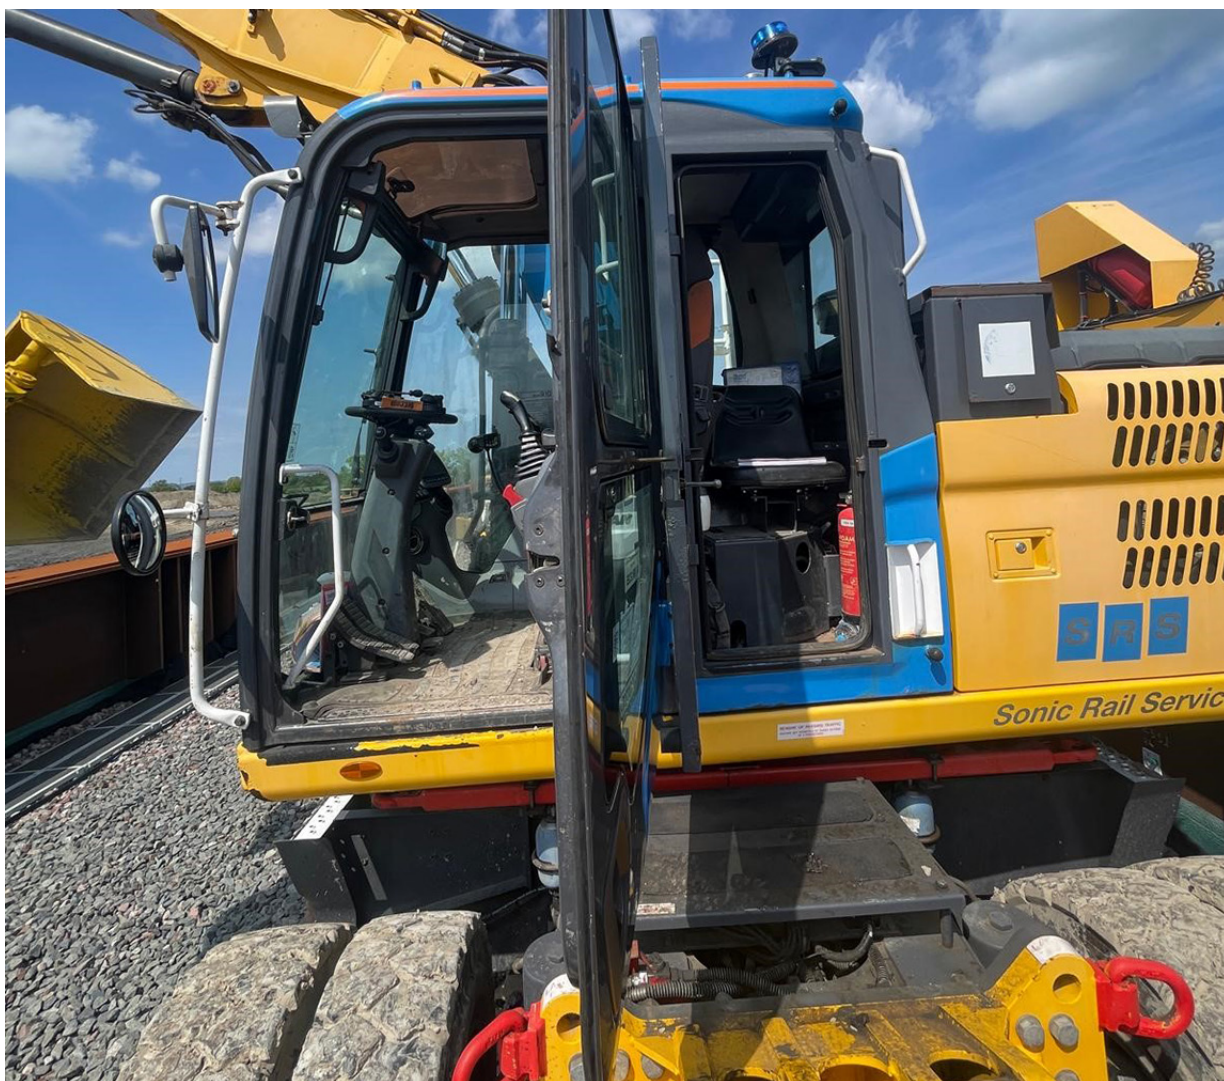
Figure 6: RRV's double cab. The MC sat in the rear part of the cab with limited forward visibility (courtesy of Sonic Rail Services).

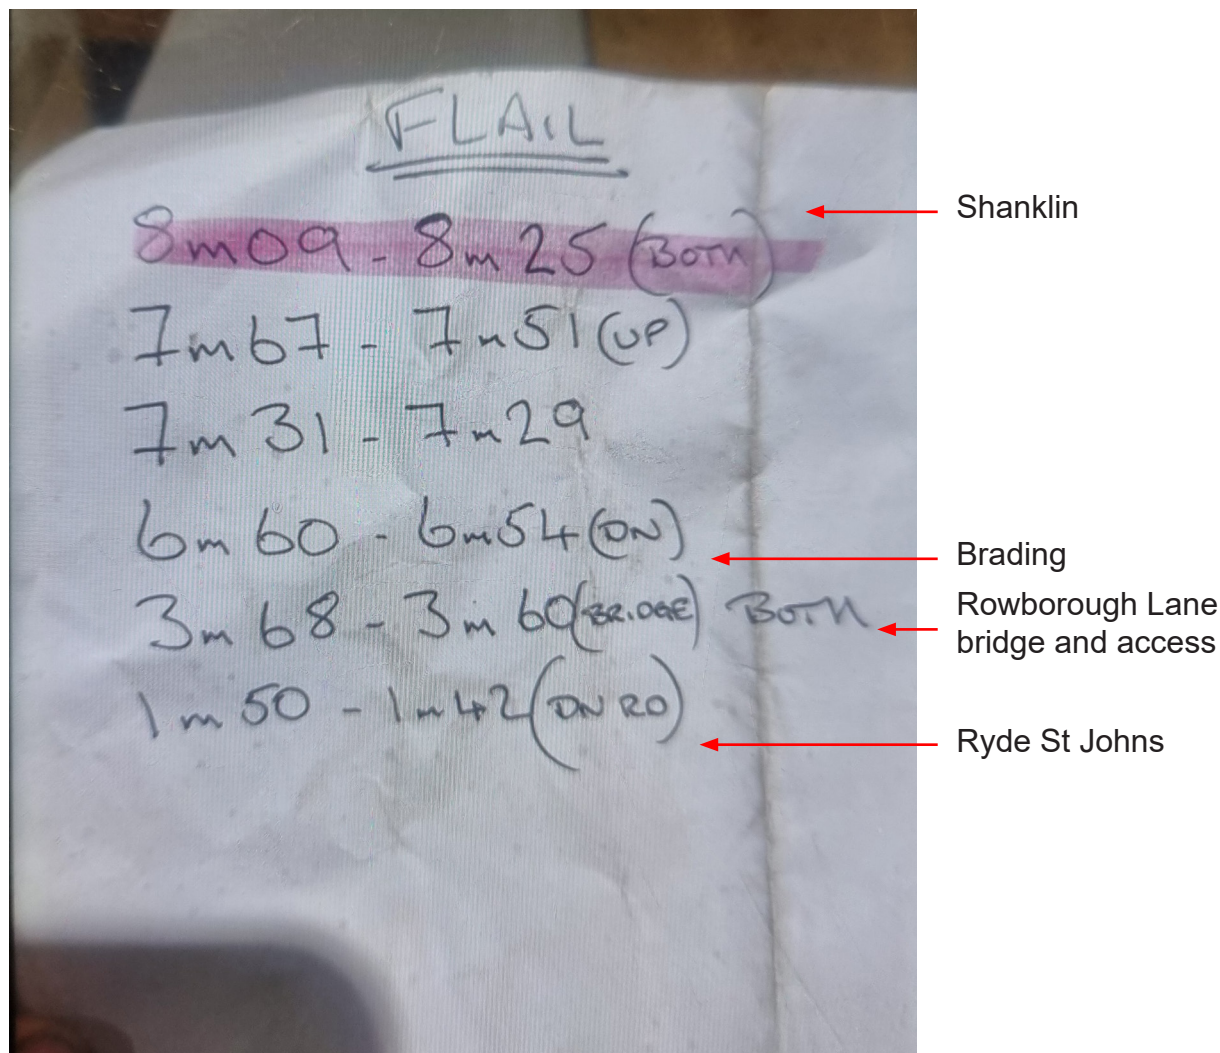
- 44 During the briefing at Sandown yard, the ES gave the MC a handwritten list of six locations where lineside vegetation was to be cut back (figure 8). As the SWP (RRV) did not include details of any tasks or sites of work for the RRV, the ES instructed the MC to start cutting vegetation at 1 mile 42 chains, towards the north end of the line near Ryde St Johns station, and then travel back to the next location at Rowborough Lane bridge (3 miles 60 chains). The MC stated that the ES had told them that the track repair work group would be at Brading station. The first two RRV sites of work were both located north of Brading (figure 9).

Figure 8: Handwritten list of sites of work which the ES gave to the MC.

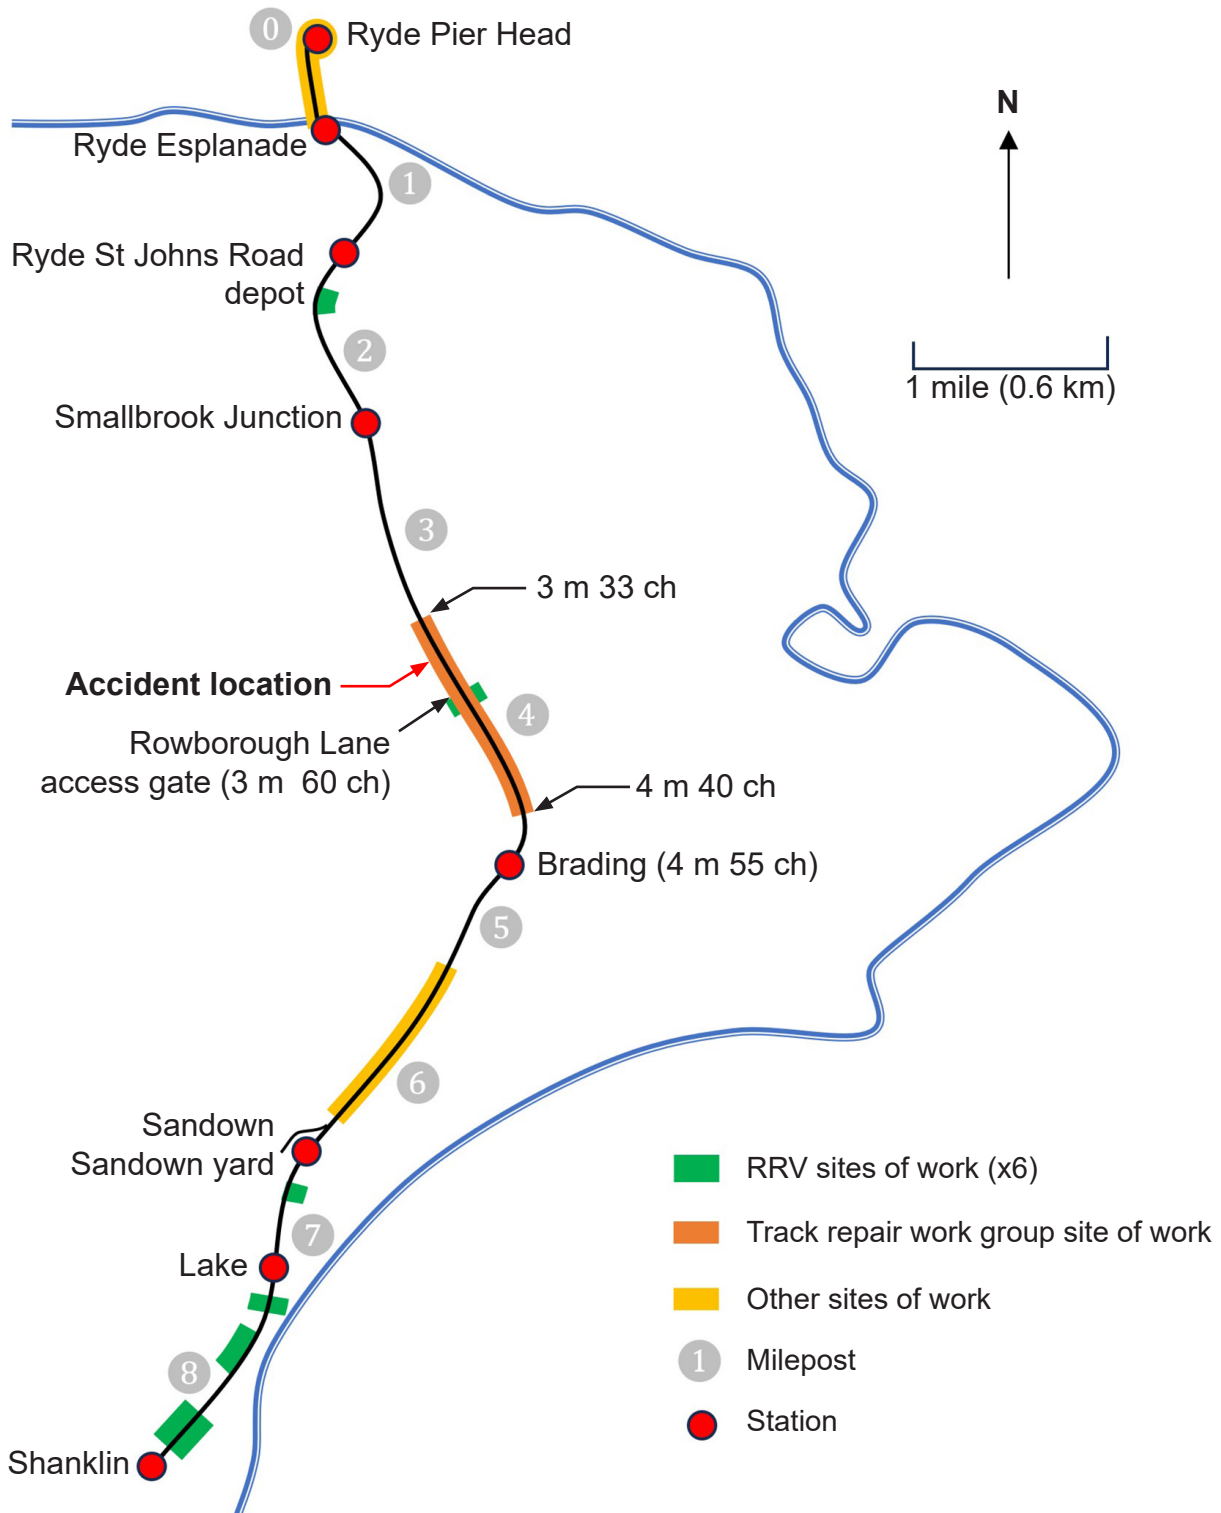
Figure 9: Sites of work on 21 to 22 November.

- 50 After completing vegetation trimming at the RRV's first site of work near Ryde St Johns, it started its return journey travelling south towards its second site of work next to Rowborough Lane bridge (figure 9). This required the RRV to pass through the track repair work group's site of work.

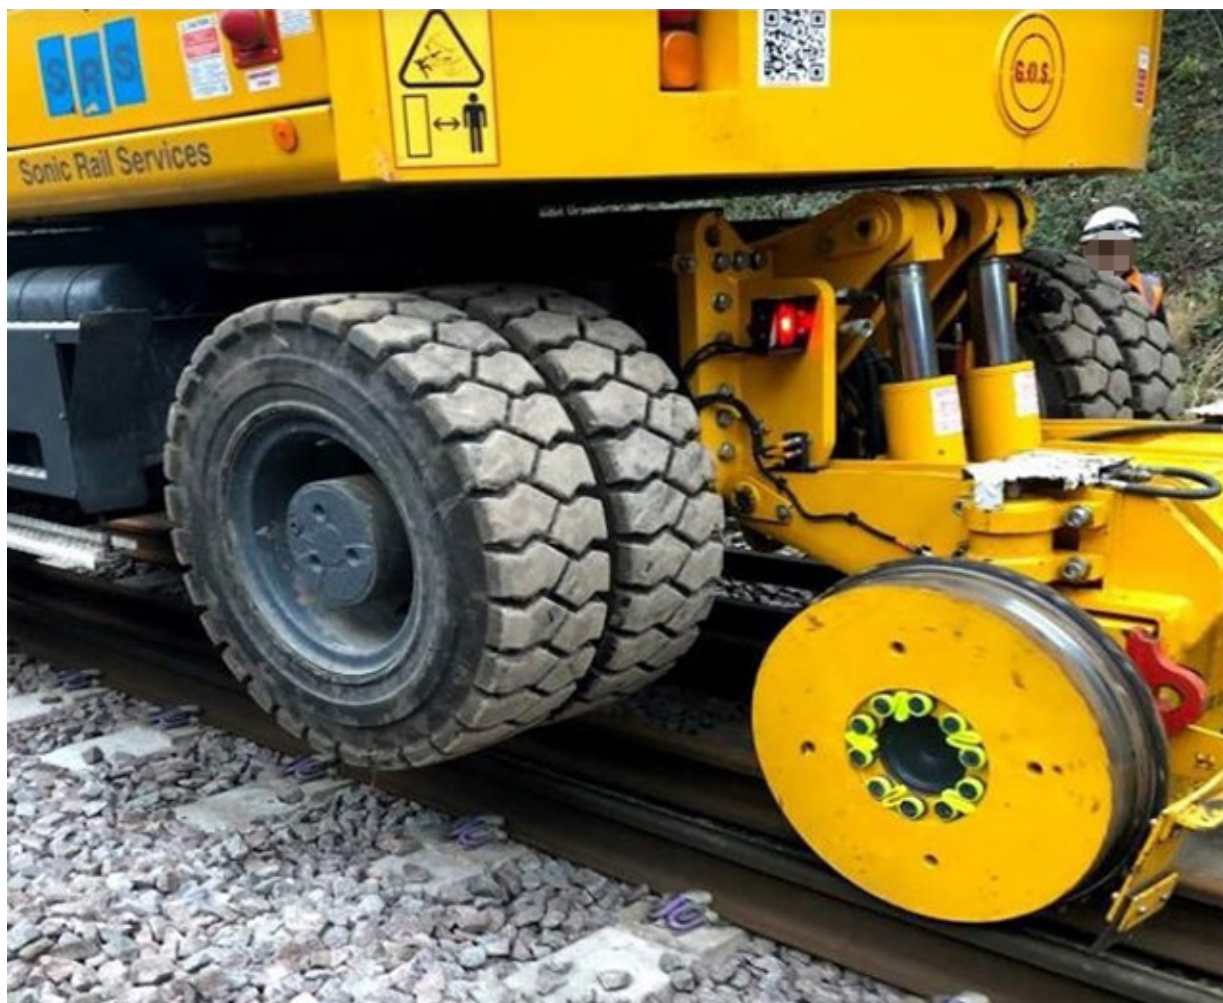
Figure 11: An RRV of the same type showing the overhang of the rubber tyre in relation to the rail (courtesy of Sonic Rail Services).

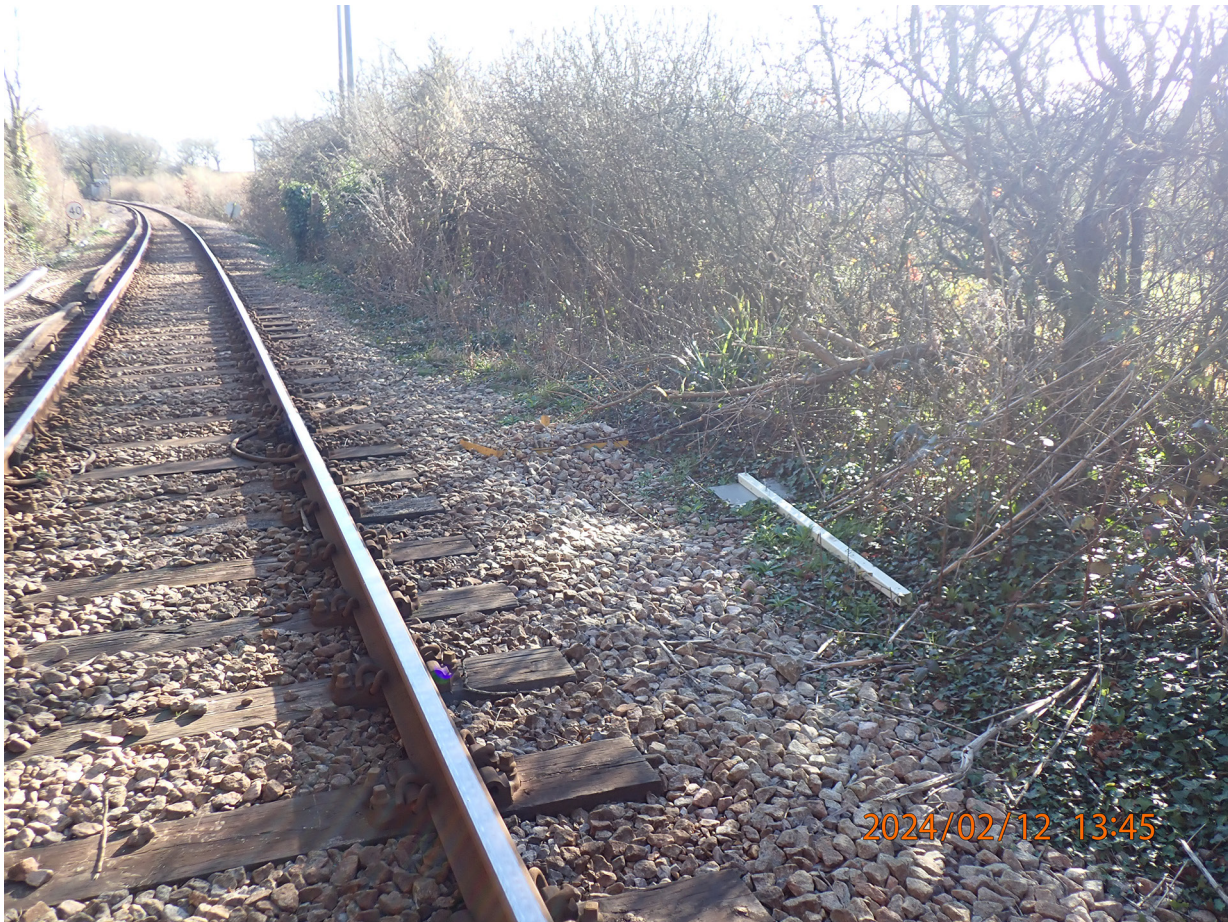
Figure 12: Location of accident looking south.

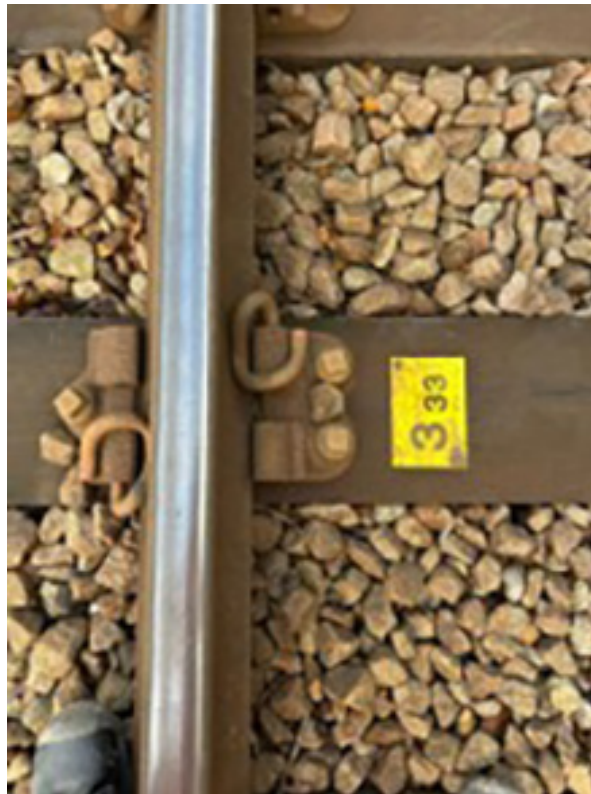
The sequence of events

Figure 13: Railhead condition near the site of the accident on 21 November. Image also shows a chainage marker plate provided at regular intervals along the Island Line (courtesy of South Western Railway).
