Rail Accident Investigation Branch

Rail Accident Report

Freight train derailment at Sheffield station 11 November 2020

Report 07/2021
October 2021

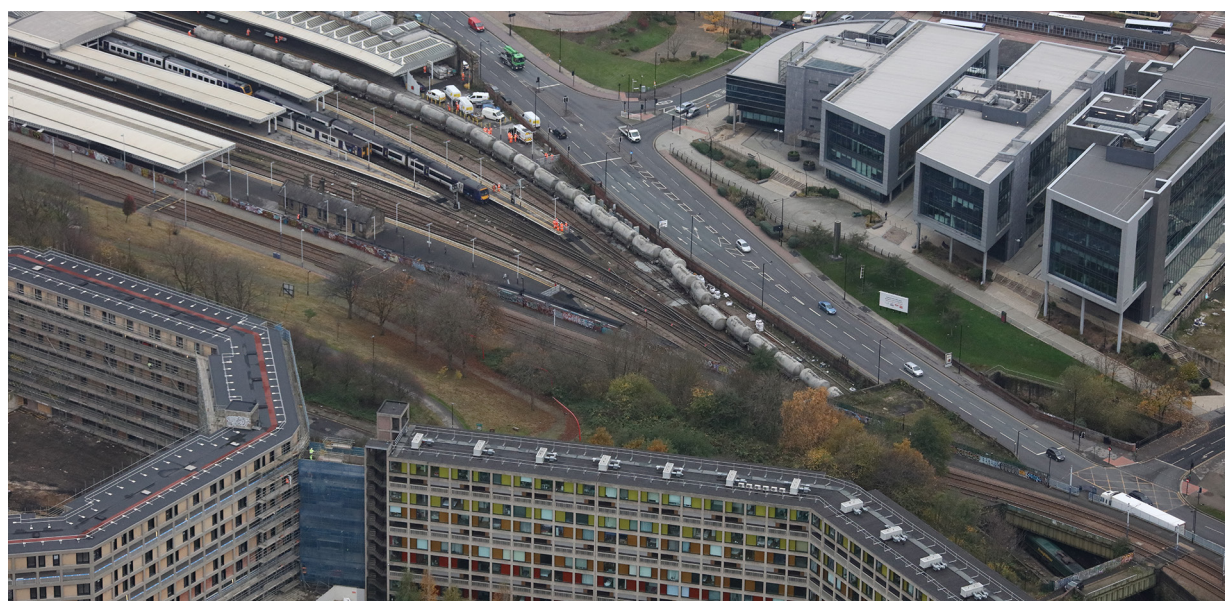
At 02:44 hrs on Wednesday 11 November 2020, 16 wagons of a freight train that was conveying cement powder from Hope, Derbyshire, to Dewsbury, West Yorkshire, derailed at the north end of Sheffield station. A number of wagons were damaged and there was significant damage to the track, resulting in a partial closure of the station. No one was injured.

Figure 2: Aerial overview of the derailed train (image courtesy of Network Rail Air Operations team)

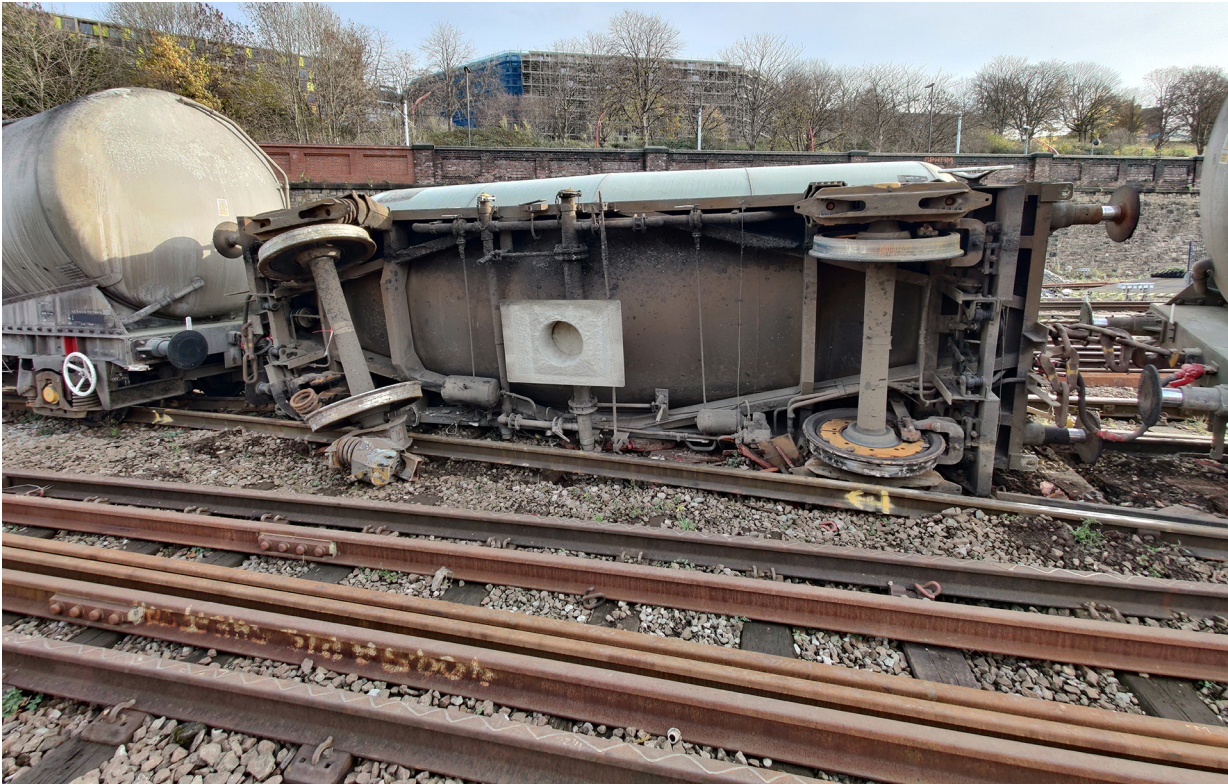
Figure 3: Wagon BCC10756 toppled on its side

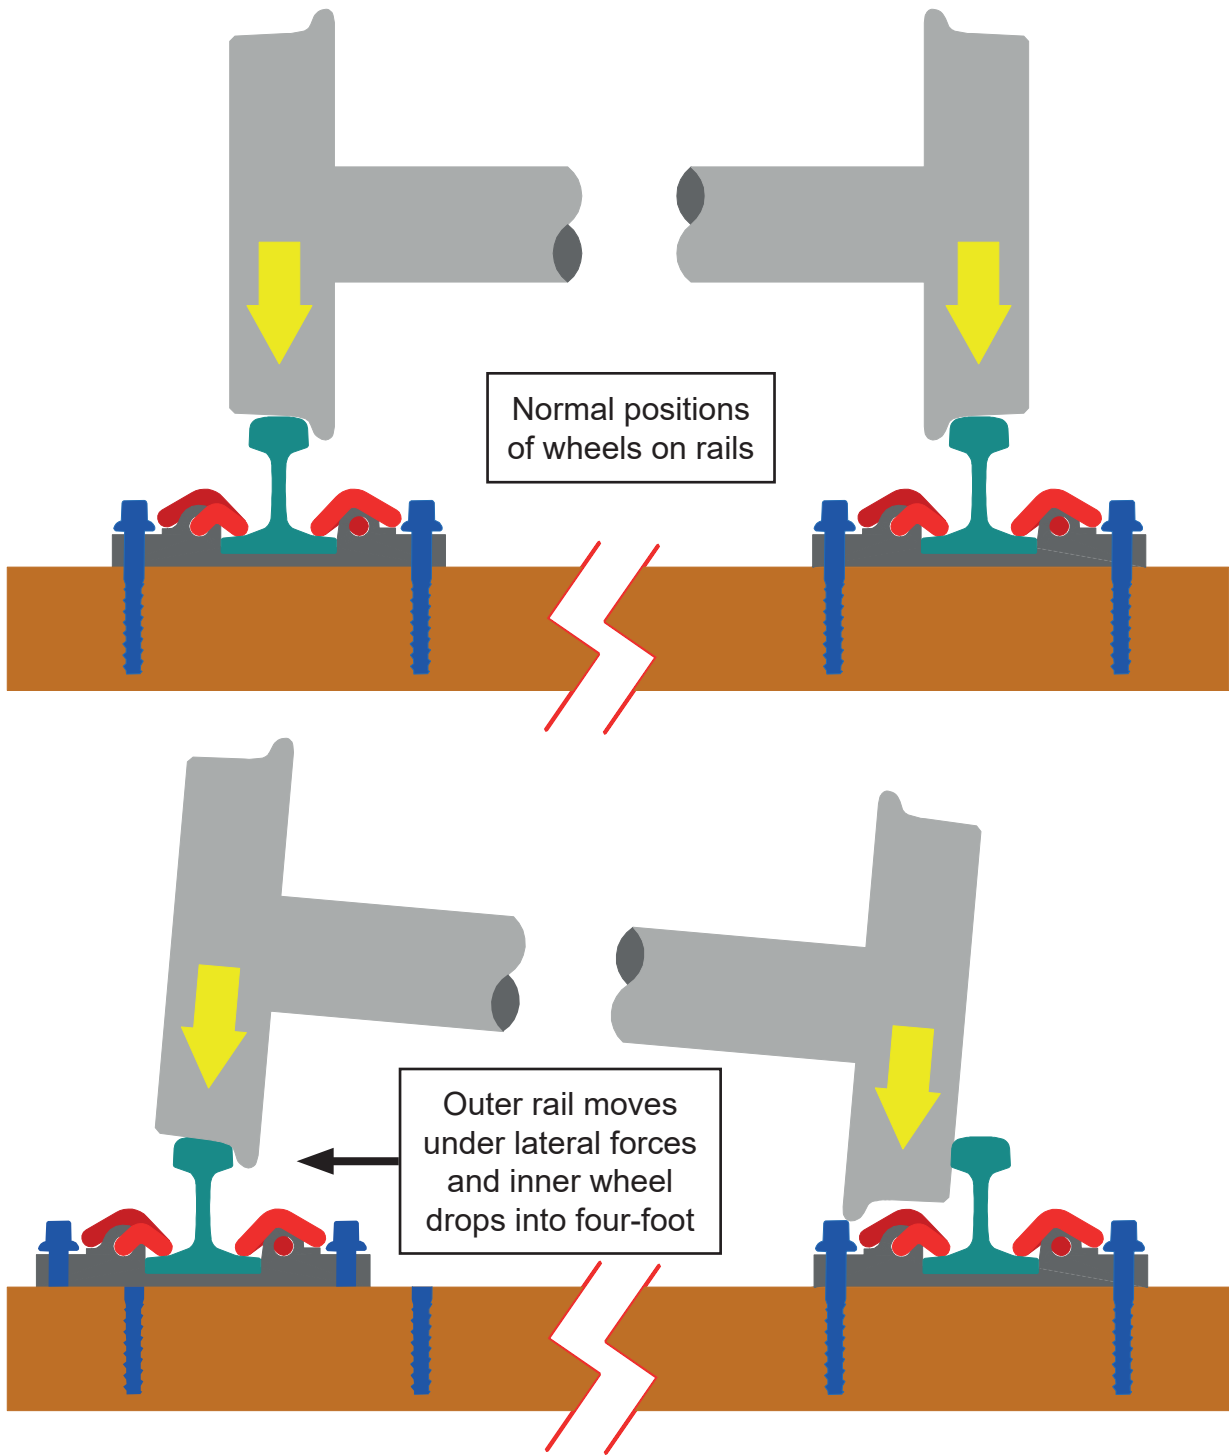
Figure 6: Sketch of the derailment in 4062 points

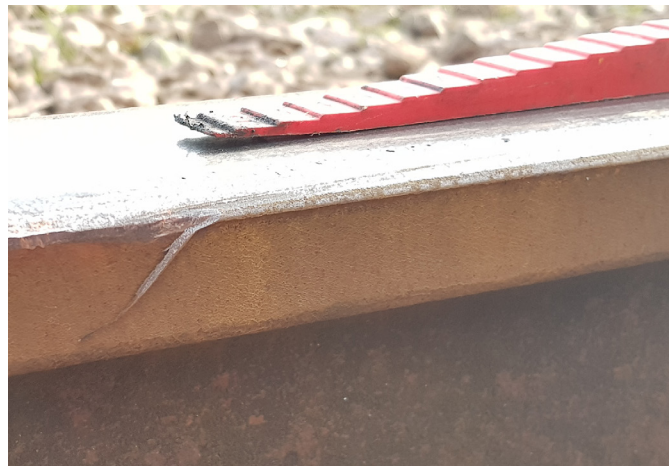
- 28 Rail marks showed that the right-hand wheels of several wagons dropped off the head of the right-hand rail, into the four-foot, at this location, referred to as the point of derailment (figure 8). These wheels then ran derailed, with their corresponding left-hand wheels still on the left-hand rail, for several metres until reaching the switch heel. This is the location where the movable switch rail is fixed, via a heel block, to its outer stock rail (figure 7). Rail marks showed that the left-hand wheels on the derailed wheelsets climbed over the left-hand rail into derailment and the right-hand wheels remained derailed.

Figure 8: Wheel mark on the inside edge of the right-hand rail showing the first drop-in at the point of derailment (the red step gauge is only present to indicate the point of derailment)

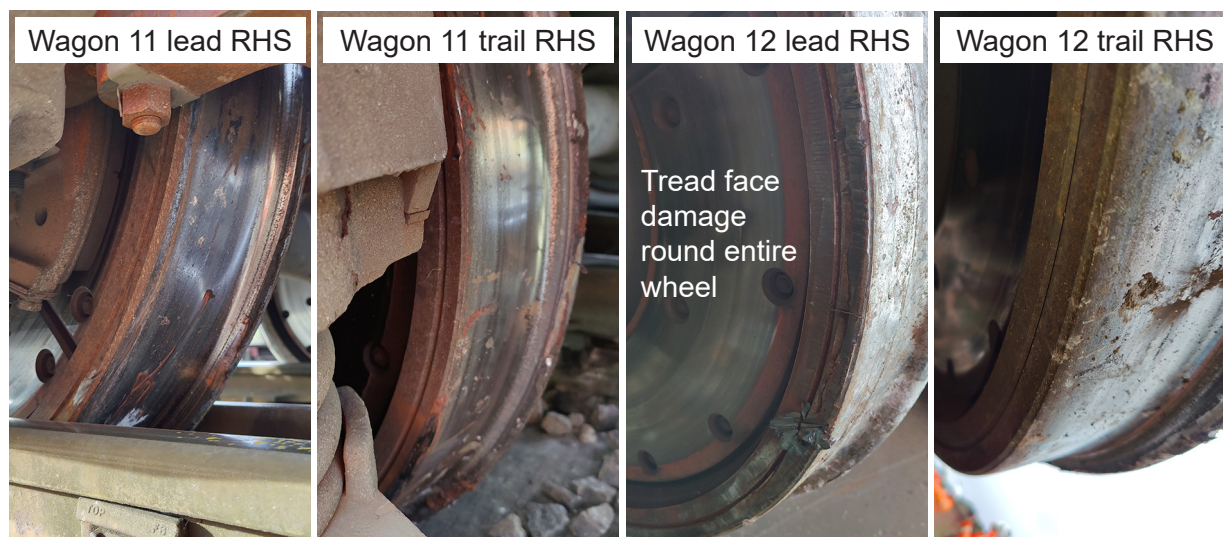
- 29 Examination of the derailed wagons showed damage on the outside face of the wheels consistent with several right-hand wheels having dropped into the four-foot (figure 9). The leading right-hand wheel of wagon 12 suffered the worst damage, indicating that it is likely to have been the first to derail into the wide gauge. Subsequent wheels also dropped into the wide gauge, but the damage was less severe. Their derailment was made more likely by the gauge having been further widened by the derailed leading wheelset on wagon 12 dropping in ahead of them.

Figure 9: Tread face damage on the right-hand leading wheel of wagon 11 compared to wagon 12

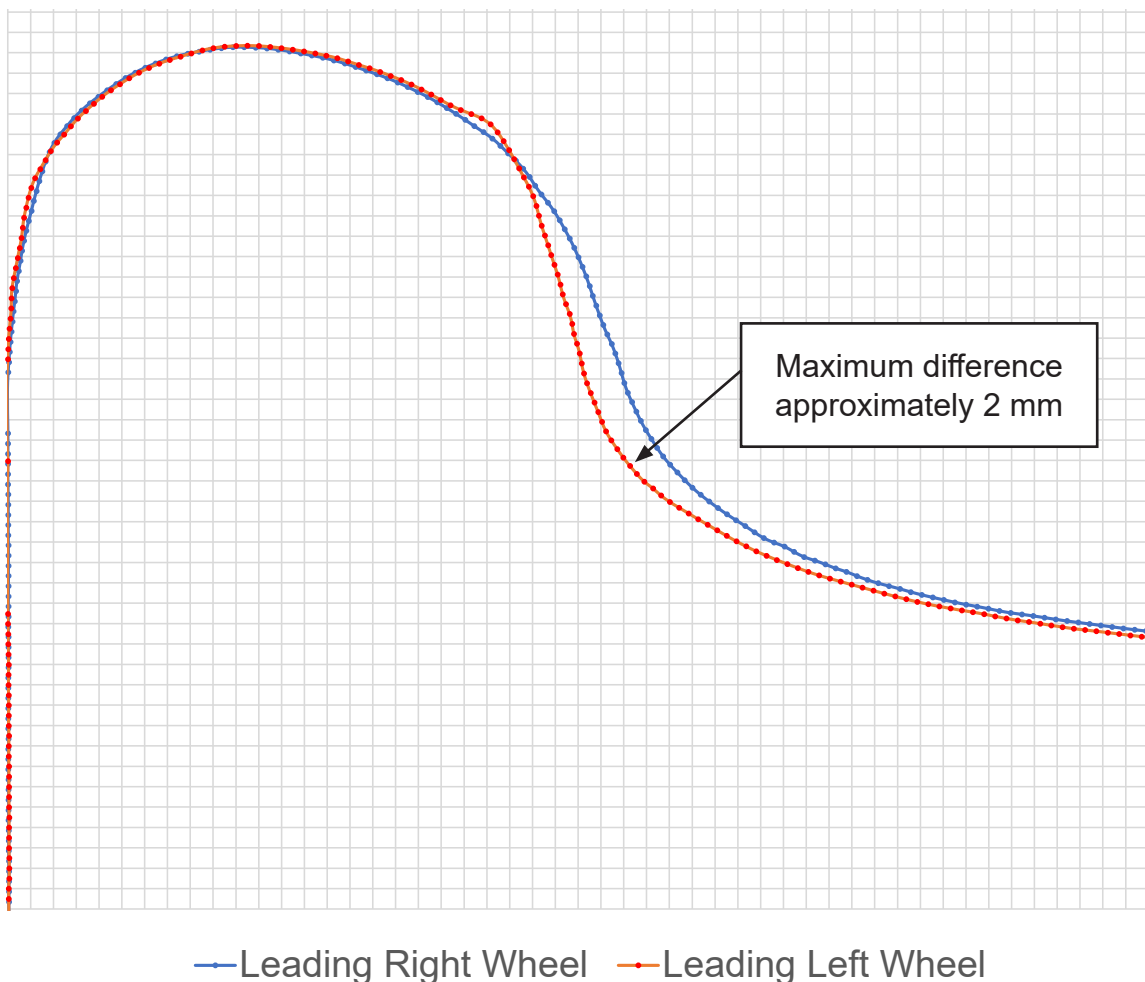
- 35 It was noted that the wheel flanges on the left-hand wheels on both wheelsets were slightly thinner than those on the right-hand wheels (figure 10). However, they were all well within the acceptable maintenance specification limits. It is possible that a thinner left-hand wheel flange could result in the wheelset being positioned slightly further to the outside rail on a right-hand curve, such as at the point of derailment. This means that the associated wheel tread corner on the right-hand wheel would also be positioned slightly closer to the four-foot on the right-hand rail, and so be fractionally more at risk of derailment (figure 11). The estimated difference in position on the twelfth wagon is only about 1-2 mm.

Figure 10: Comparison of wheel flange thicknesses on wagon 12

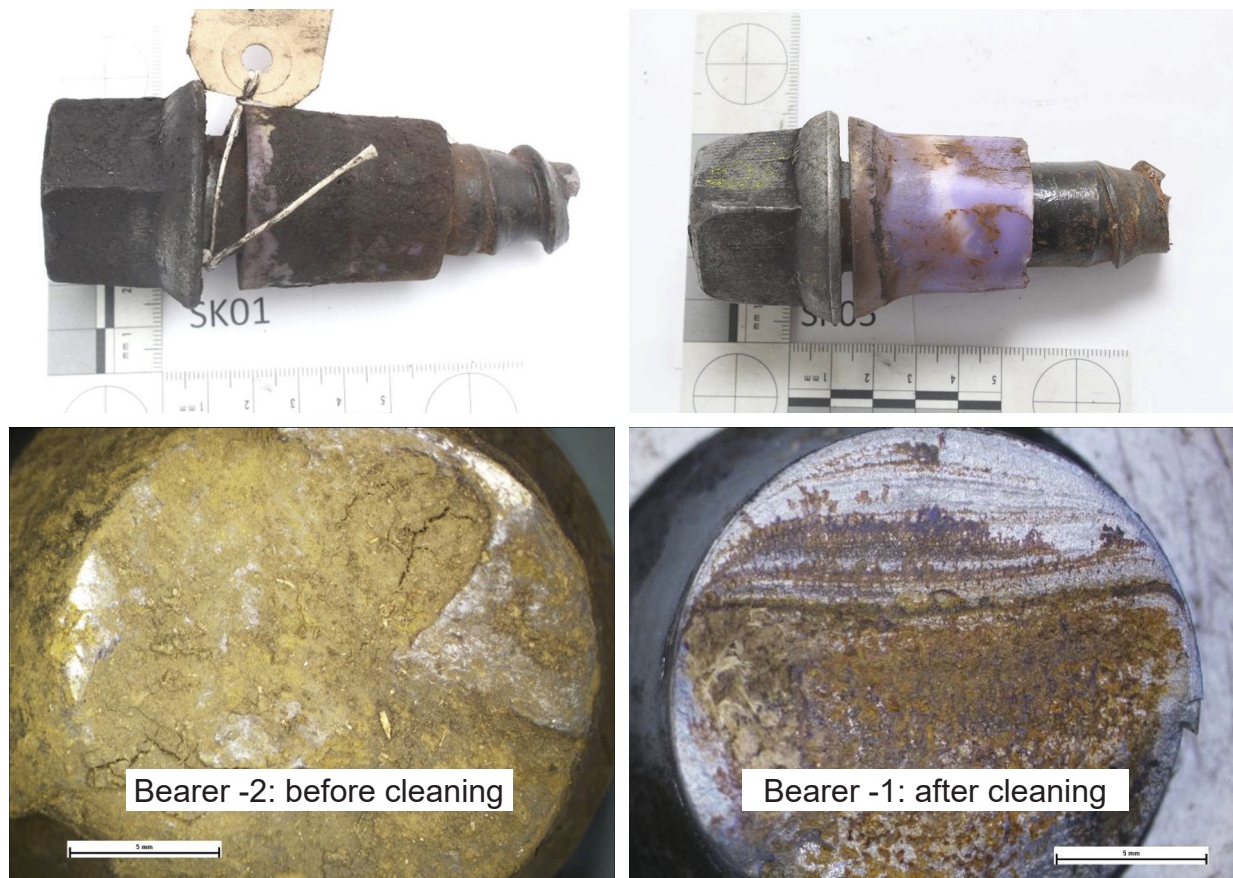
- 46 The amount of corrosion on the fracture face surfaces indicated that the breaks had occurred weeks, or perhaps months, before the derailment (figure 15). This was further evidenced by the presence of marks showing repeated relative movement between the two fracture faces on each screw. None of the screws had failed immediately prior to the derailment.

Figure 15: Examples of broken track screws, showing fracture surfaces during examination

- 47 Although not conclusive, the amounts of corrosion observed on the fracture faces suggested that the first failures started near to the crossing of 4062 points, at bearer -3, with subsequent failures moving sequentially towards the point of derailment at bearer 0.
- 48 The examination also concluded that all the screws had broken at approximately the same position, below the head near to the expected stress concentration point at the top of the threaded portion. This position would have been a few millimetres below the top of the timber bearers and was consistent with the screws having experienced a cyclical lateral force being transferred from the outer rail, through the supporting baseplates into the screws.

- 51 In summary, the repeated lateral loading of the outer rail under the passage of loaded freight trains led to fatigue cracking of the track screws and subsequent failure over an extended period, despite the track screws being compliant with standards.

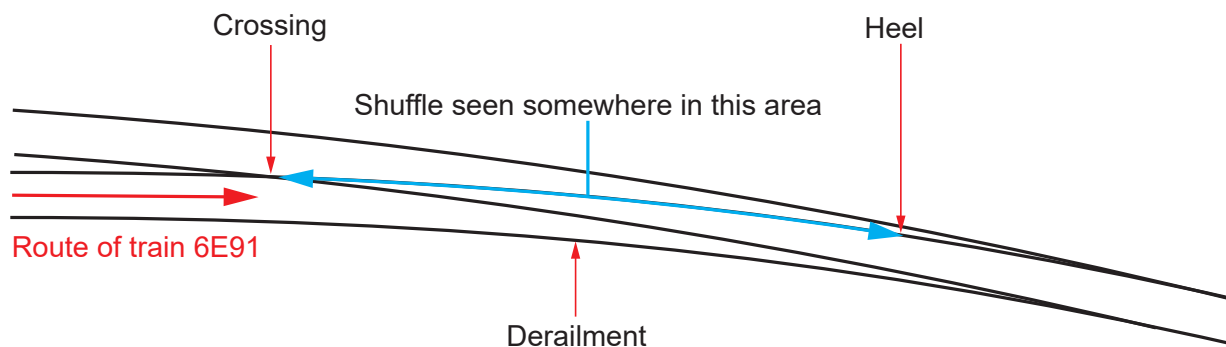
- 59 On the last four BVI record sheets, no defects were recorded as having been found at 4062 points. These were undertaken on 4 November and on 28, 21 and 14 October. However, the BVI patroller's record for 7 October noted that there was 'baseplate shuffle at the heel of 4062 points'. Baseplate shuffle is a term used to describe the wear marks on a timber bearer that indicate that a baseplate has been moving relative to the bearer it is fastened to. Witness evidence indicated that the note referred to shuffle located between the heel of the points (at the fixed end of the movable switch rail) and the crossing (figure 16). However, from the evidence available, RAIB has not been able to determine the exact location of the shuffle within this 15 to 20 metre distance, or the amount of shuffle, although this was likely to have been less than 10 mm. It is worth observing that the BVI on 7 October was undertaken by a patroller who does not routinely patrol Sheffield station, and was therefore perhaps more likely to record all defects and not omit any minor defects that were repeatedly present during previous inspections.

Figure 16: Approximate location of the identified shuffle in 4062 points on 7 October 2020

- 60 This BVI record was reviewed by a supervisor, and a maintenance intervention to address the observed shuffle was entered into the depot's list of forthcoming work. This intervention was due to be completed within a period of three months from the BVI on 7 October 2020.

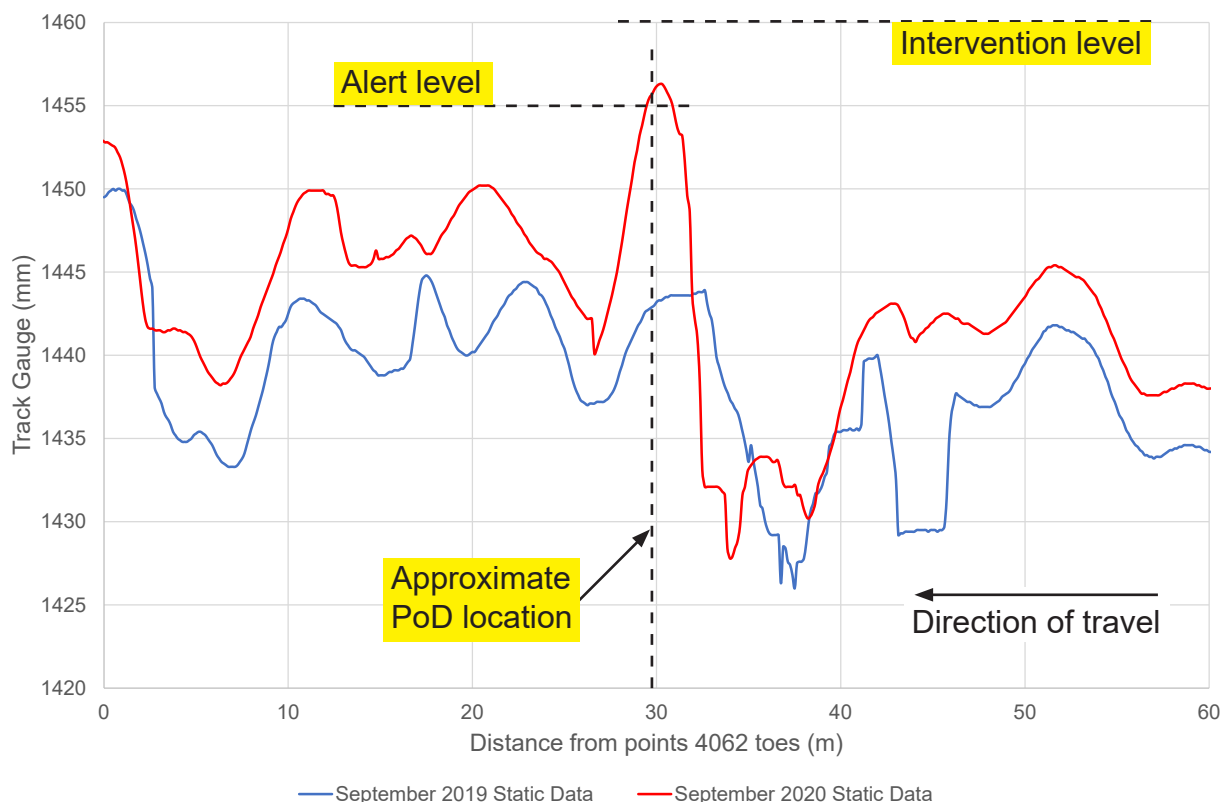
69 It is notable that there is an apparent calibration difference between the two recordings, with the run in September 2020 recording approximately 3 mm wider gauge, throughout the 300 metre length, than that recorded in September 2019. However, such a discrepancy would not be apparent to the user taking the recording on either date, as it is only evident when the two graphs are compared against each other.

70 There was a slight exceedance of the alert limit (1455 mm) in the vicinity of the point of derailment in September 2020. Alert limit faults are not allocated a timescale by which they need to be repaired, but they are intended to be corrected as part of the planned maintenance activities. Sheffield depot had not undertaken any corrective action in response to this alarm notification prior to the derailment.

Figure 17: Static geometry measurements at 4062 points

- 71 The September 2020 gauge at the point of derailment was approximately 13 mm wider than that recorded at the same location in September 2019. However, this would only have been apparent to the TME if he had carried out a detailed comparison of the data from the two dates. The TME only undertook such comparisons to identify trends where he recognised that there was a risk of deterioration, but this was not recognised as being such a location.

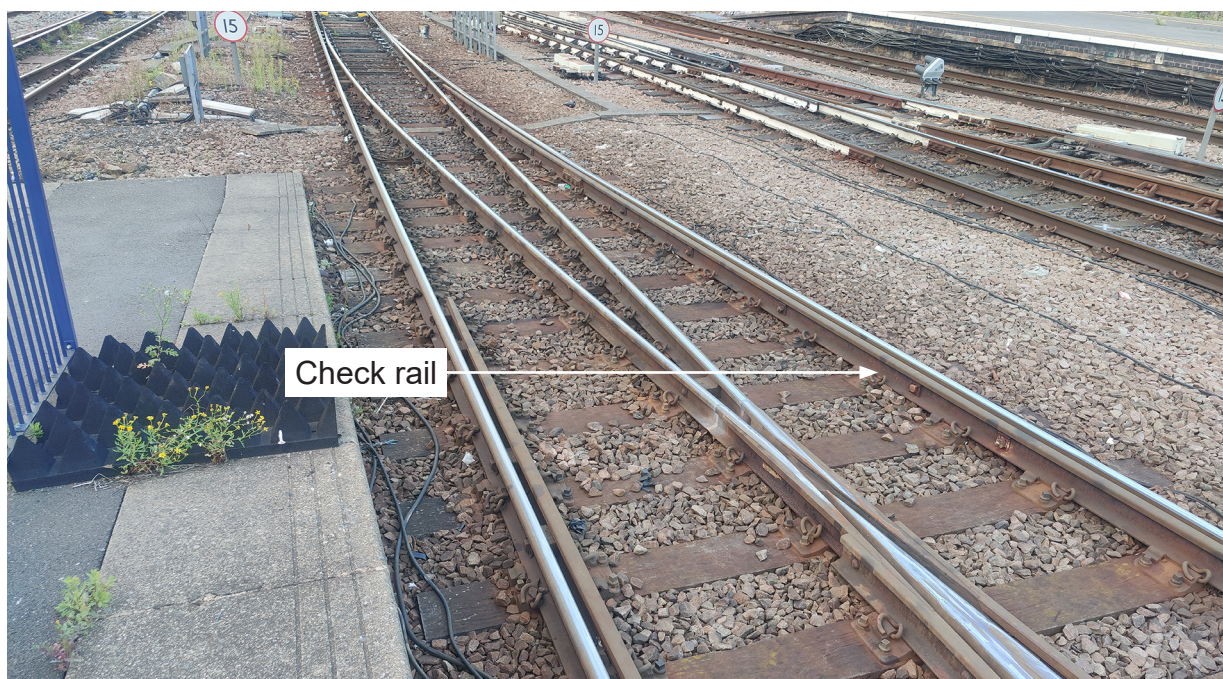
Figure 21: Check rail fitted within 4064 points

111 Check rails are normally fitted to prevent wheel flanges climbing on to the head of the outer rail, by restraining the lateral movement of the back of the wheel on the inner rail, as vehicles negotiate tight radius curves. This was not the cause of the derailment at Sheffield. However, a check rail would have helped in this scenario because it would have limited the lateral movement of the inner wheel and prevented it dropping into the four-foot if the outer rail and wheel moved outwards. Once the outer rail had started to move, due to the deteriorating fixings, the check rail would also have taken some of the lateral force that was being applied to the outer rail. In addition, the evidence of excessive contact of the inner wheel with the check rail might have alerted track patrollers that the outer rail was moving, and prompted investigation of the cause.
