Rail Accident Investigation Branch

Rail Accident Report

Trap and drag accidents at Archway and Chalk Farm stations 18 February and 20 April 2023

Report 06/2024
June 2024

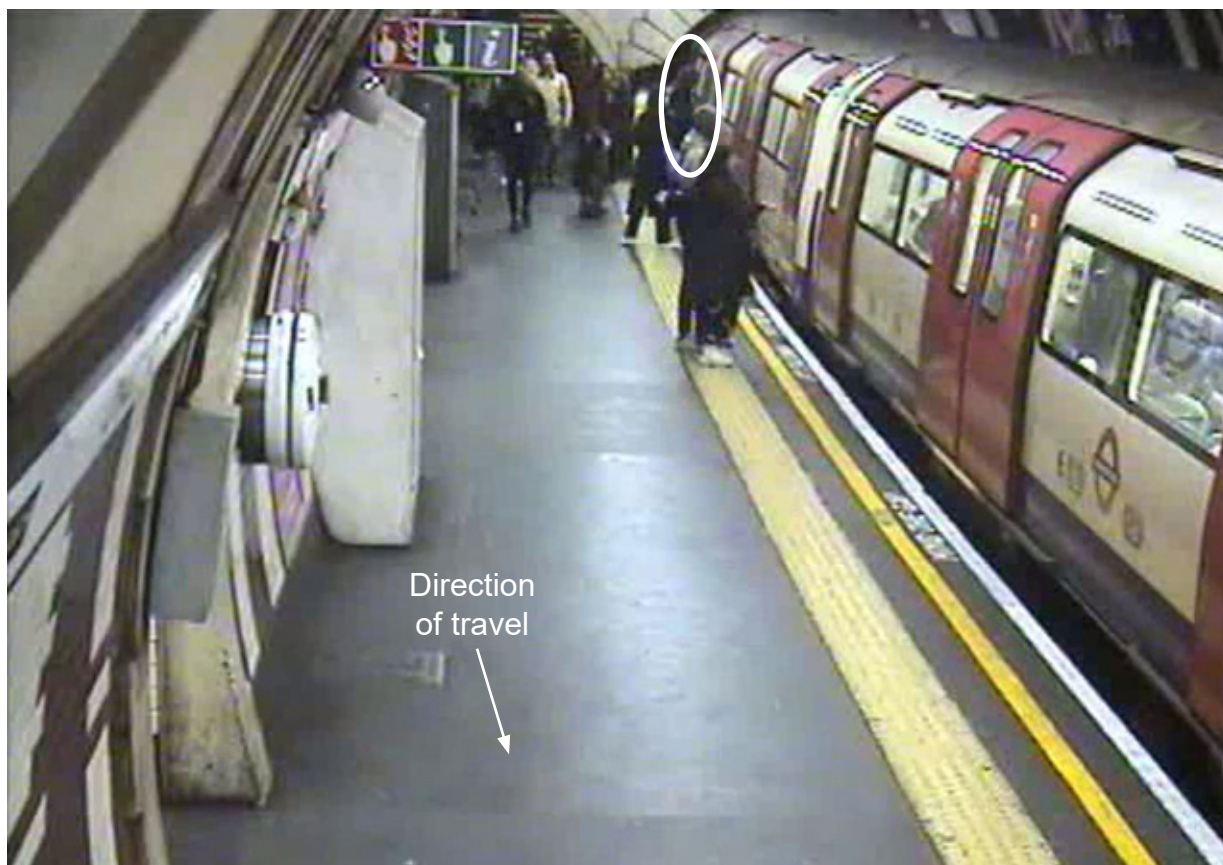
- 121 It is also possible that the check was not effective as the passenger was difficult to detect in the monitors. RAIB observed that the passenger was not conspicuous against the platform background at the very rear of the platform and that they were wearing dark clothing, which did not stand out from the surrounding environment (figure 8).

Figure 8: The passenger close to the train mainly obscured by other passengers and not visible or conspicuous.
