Serious Incident

Aircraft Type and Registration:	Boeing 737-8K5, G-TAWD	
No & Type of Engines:	2 CFM56-7B27E turbofan engines	
Year of Manufacture:	2011 (Serial no: 37265)	
Date & Time (UTC):	20 October 2023 at 1153 hrs	
Location:	Leeds Bradford Airport	
Type of Flight:	Commercial Air Transport (Passenger)	
Persons on Board:	Crew - 6	Passengers - 195
Injuries:	Crew - None	Passengers - None
Nature of Damage:	Main landing gear tyres and nosewheel tyres damaged. Left nosewheel inner axle bearing destroyed	
Commander's Licence:	Airline Transport Pilot's Licence	
Commander's Age:	41 years	
Commander's Flying Experience:	14,250 hours (2,800 hours on type) Last 90 days - not known Last 28 days - 88 hours	
Information Source:	AAIB Field Investigation

Synopsis

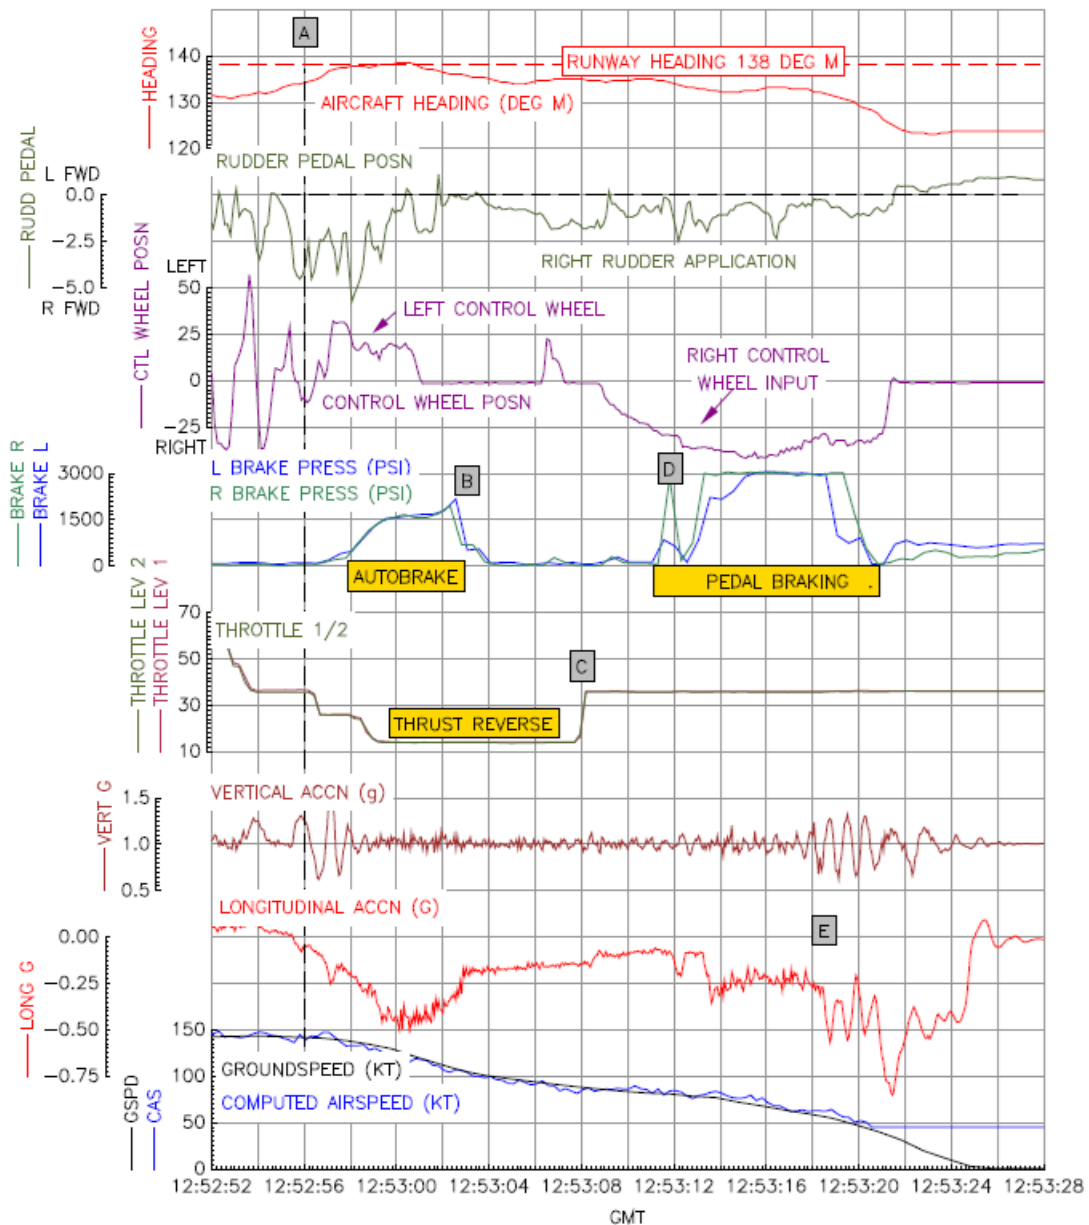
Figure 5

The speedbrakes deployed and autobrake system engaged with the recorded brake pressure rising to approximately 1,600 psi¹ leading to an increase in the longitudinal deceleration² to -0.45 g. Additionally, the throttles were moved to the reverse 2 position, and the thrust reversers operated as expected. The aircraft decelerated, during which right rudder pedal inputs were recorded.

Seven seconds after touchdown at a CAS of 107 kt, the autobrake was disengaged and brake pressure reduced (point B, Figure 5). Six seconds later at a CAS of 86 kt, the throttles were returned to the 'Forward Idle' position and the thrust reversers were stowed. Throughout this time, up to 1.8° right rudder pedal continued to be applied (point C, Figure 5) and the Cockpit Area Mic (CAM) recorded what could be described as a juddering/rattling sound. This was more pronounced from point C onwards.

Once the thrust reversers were stowed, the recorded right rudder pedal deflection periodically returned to zero and the control wheel was progressively increased up to 42° to the right. Three seconds after the reversers were stowed, pedal braking was applied which was the same time the CVR recording captured the commander vocalising concerns (point D, Figure 5). Braking application was briefly asymmetric with a demand for full right braking after which the pedal demand for left braking increased to maximum to match that of the right brake pedal (point D, Figure 5). The aircraft deviated to the left of the runway and the recorded longitudinal and vertical acceleration deviations showed it departed the left side of the runway (point E, Figure 5) at approximately 64 kt CAS (groundspeed 55 kt), stopping six seconds later. Nosewheel steering position was not recorded.

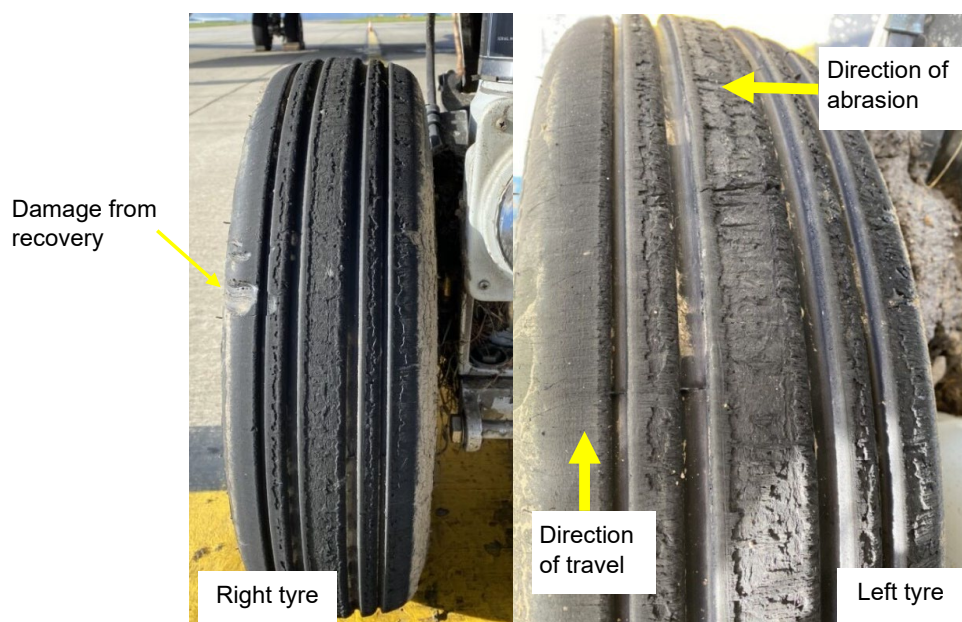
Figure 6
Nosewheel tyre damage

Both nosewheel tyres had abrasion surface damage around their entire circumference. The type, direction and quantity of damage indicates it occurred when the nosewheels were turned nearly perpendicular to the direction of travel (to the right), and that the wheels were still rotating (Figure 6). Neither nosewheel tyre showed damage corresponding to a locked wheel condition or rubber reversion in the un-abraded sections of their surface.

The nosewheel tyre damage is consistent with abrasion scrubbing from being turned to an angle nearly perpendicular to the direction of travel whilst the tyres were rotating and in contact with the runway; also demonstrated by the runway marks left by the nosewheel tyres. The angle of the nosewheels could only be achieved by use of the tiller rather than rudder pedal steering alone, and this corresponds with the commander's account of events.

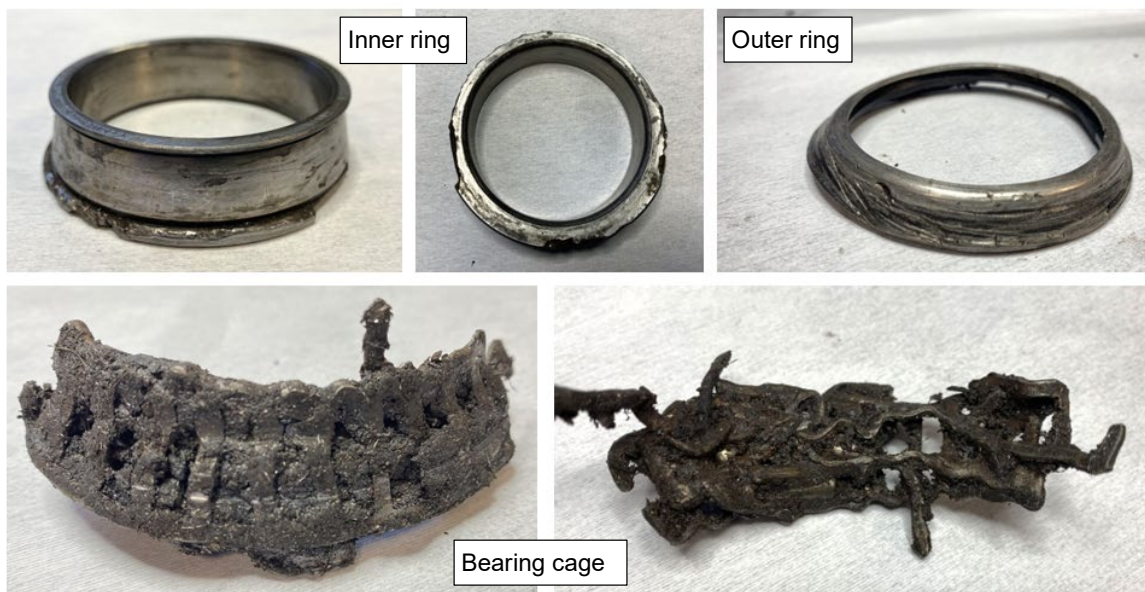
Figure 7

The left nosewheel was removed which revealed that the inner axle bearing had failed (Figure 7), while the outer axle bearing was undamaged. Each nosewheel has an inner and an outer axle bearing which are replaced on condition and do not have a fixed service life. This bearing was fitted during a routine wheel overhaul in September 2022.

Prior to removal, the left nosewheel had significant play on the axle but was free to rotate. It is probable that the play of the nosewheel on the axle occurred during the recovery process as, had it been present during the landing roll, significant damage to the outer bearing and further damage to the wheel and axle would have been expected.

It could not be confirmed when the nosewheel bearing began to fail, but it is likely that it suffered catastrophic failure during the rollout at LBA and was contributory to the vibration through the rudder pedals as felt by the commander. The failure of the bearing did not prevent the nosewheel from rotating nor did it affect the ability to steer the nosewheels.
