SB2/2024

JUNE 2024

**Fatal injury to a recreational diver  
after contact with the recreational diving support boat  
*Karin*  
in Scapa Flow, Orkney Islands, Scotland  
on 28 September 2023**

## MAIB SAFETY BULLETIN 2/2024

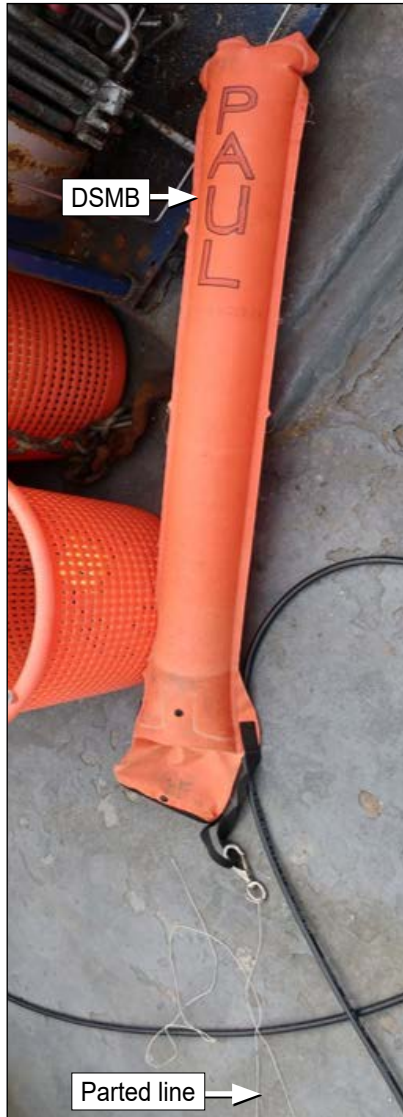
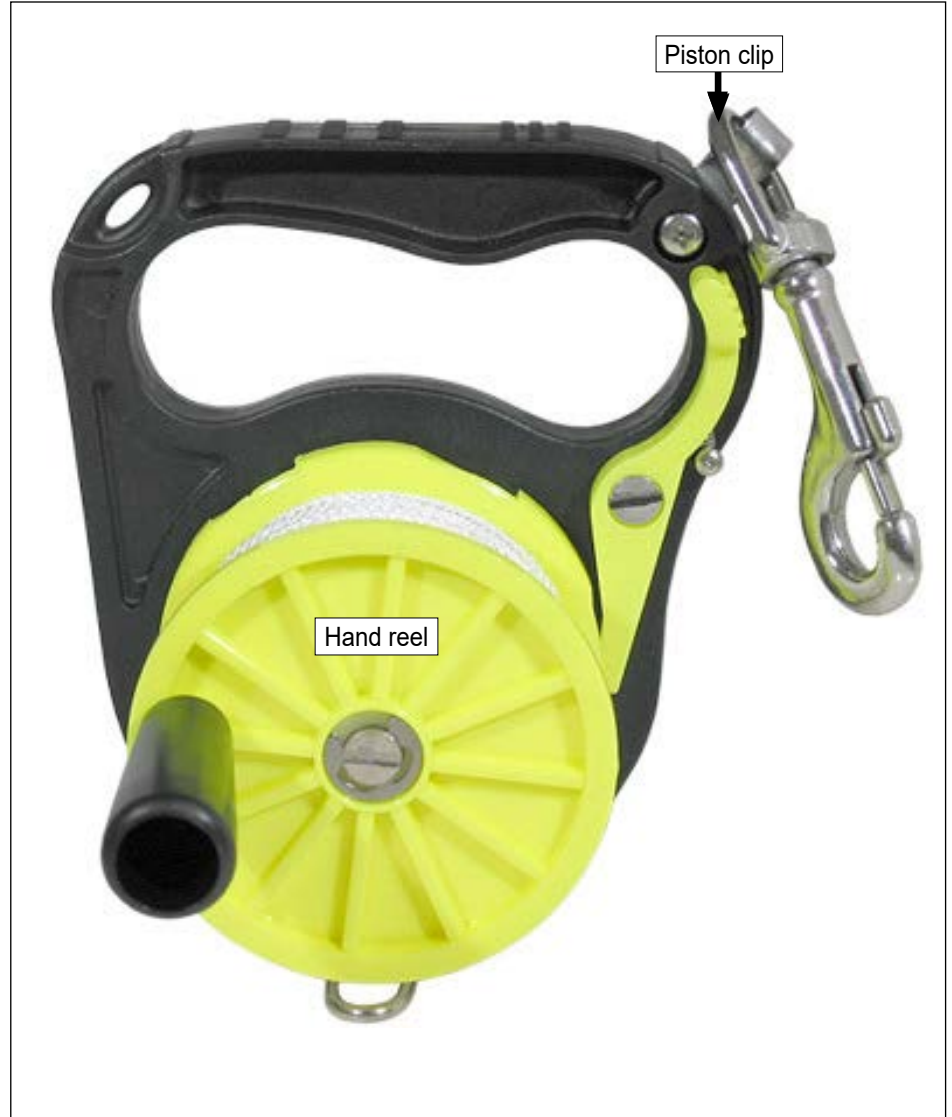
The diver and their dive buddy had ascended to their final scheduled decompression stop 3m below the surface. The divers were conducting a drift decompression away from the available shot line<sup>1</sup> but their presence was indicated by their delayed surface marker buoy (DSMB)<sup>2</sup>, the line of which was clipped to the casualty's dive vest (**Figure 2**). The DSMB was visible to the second dive boat waiting on the other side of the wreck site, but it was not sighted by *Karin*'s crew before *Karin* motored over it.

The crew of the second dive boat saw the DSMB disappear under *Karin*. Subsequently, one of the two divers failed to resurface. The coastguard was notified and an extensive 2-day air and sea search of the area was conducted, but without success.

**Figure 2:** Diver 1's marked DSMB with its parted line and hand reel of a similar type to that used by diver 1

- Divers using a DSMB should hold the line in their hand, as recommended by the British Sub-Aqua Club, rather than attach it to their person. In the event that the DSMB becomes snagged by a passing craft, the diver can then release the line to avoid entanglement and potentially being drawn to the surface or into contact with the craft.
