Fatal injury to a recreational diver after contact with the recreational diving support boat

Karin

MAIB SAFETY BULLETIN 2/2024

The Marine Accident Investigation Branch is carrying out an investigation into the fatal injury to a recreational diver after contact with the recreational diving support boat *Karin*.

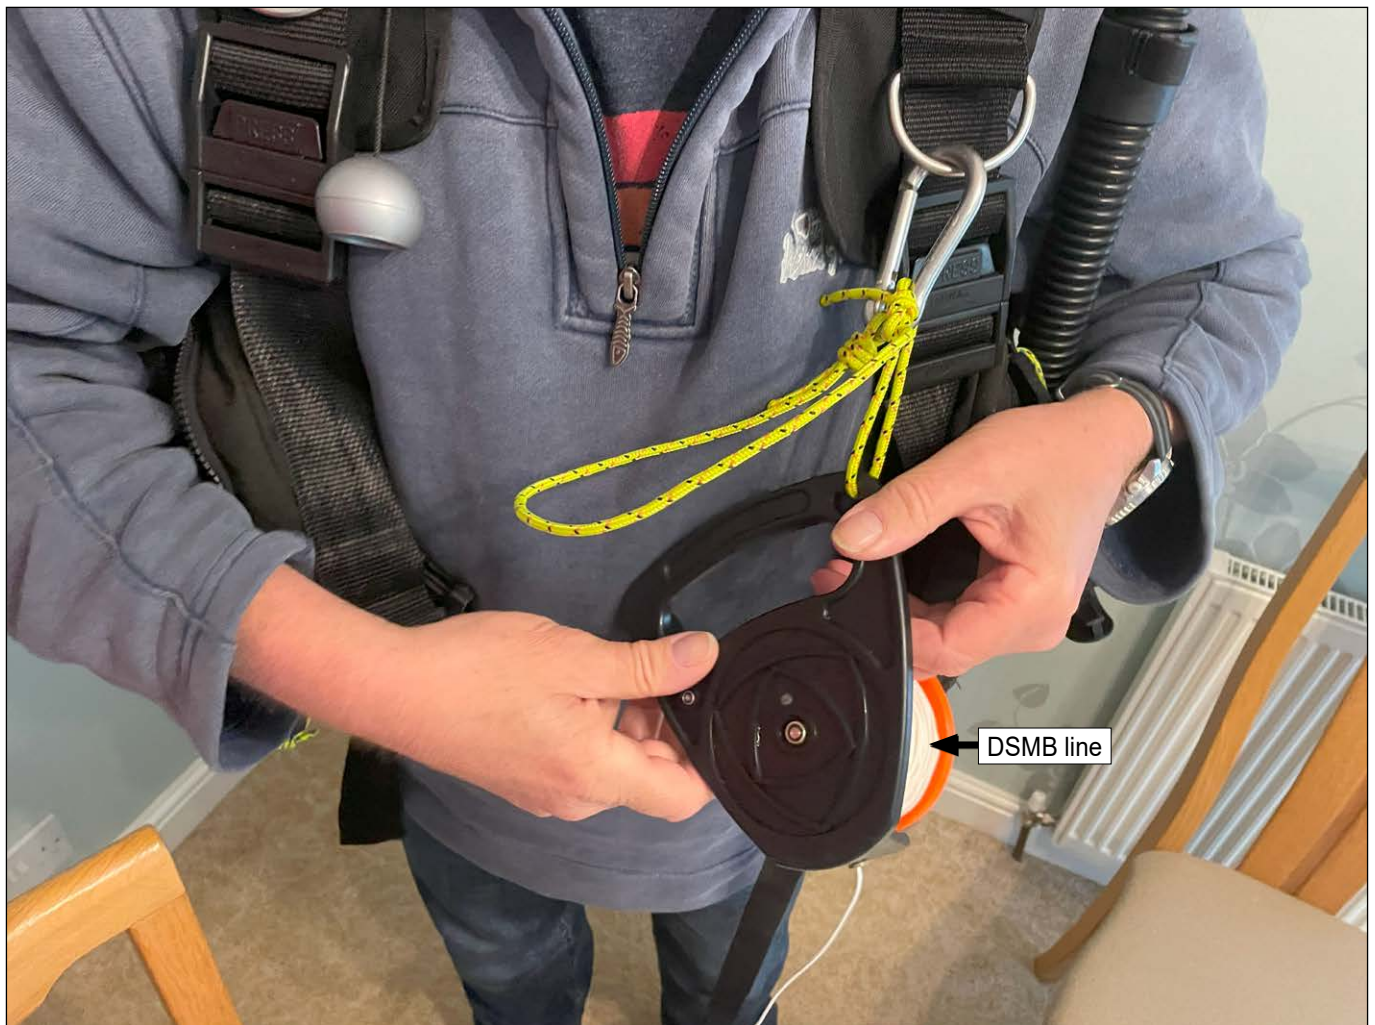
Figure 2: DSMB line attached to harness

The diver and their dive buddy had ascended to their final scheduled decompression stop 3m below the surface. The divers were conducting a drift decompression away from the available shot line¹ but their presence was indicated by their delayed surface marker buoy (DSMB)², the line of which was clipped to the casualty's dive vest (**Figure 2**). The DSMB was visible to the second dive boat waiting on the other side of the wreck site, but it was not sighted by *Karin*'s crew before *Karin* motored over it.

- Divers using a DSMB should hold the line in their hand, as recommended by the British Sub-Aqua Club, rather than attach it to their person. In the event that the DSMB becomes snagged by a passing craft, the diver can then release the line to avoid entanglement and potentially being drawn to the surface or into contact with the craft.
