SB3/2024

Fatal man overboard from the fishing vessel

Kingfisher (DH110)

MAIB SAFETY BULLETIN 3/2024

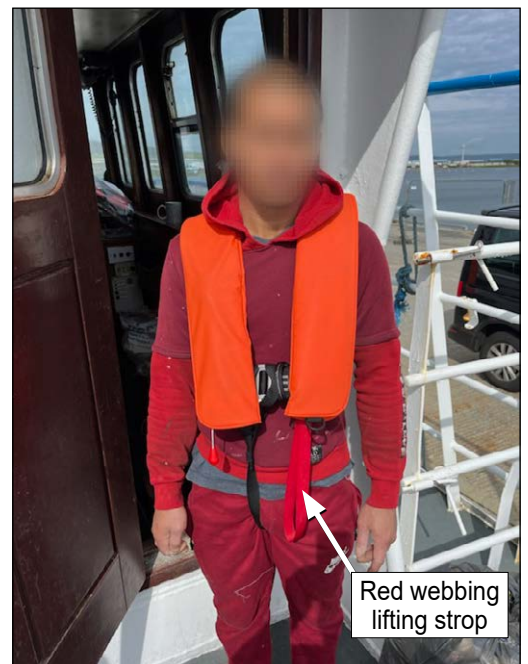
The ongoing investigation has found that the vessel's risk assessment required a PFD to be worn when working on deck. The PFD worn by the deckhand was compliant with EN ISO 12402-2:2020¹ and had a red webbing lifting strop sewn onto the harness (see **figure**) that hung freely below the stole.

After the recovery of the deckhand, it was found that the leg rope of the last creel that had been shot away was threaded through the PFD's red webbing lifting strop. This had connected the deckhand to the running backrope and caused him to be pulled overboard. It is probable that the deckhand had inadvertently passed the toggle on the creel's leg rope through the red webbing strop while connecting the creel to the backrope.

Figure: The red webbing lifting strop on the PFD

risk assessment. However, the red webbing lifting strop hanging on the front of the deckhand's PFD harness presented a risk of entanglement when working creels that had not been identified or mitigated by the risk assessment.

Although some crew cutting the lifting strops from their PFDs removed the risk of entanglement it created another, as their PFDs no longer had the lifting strops necessary to recover them from the water if they fell overboard. Unauthorised modification of a PFD can cause damage, render it inoperable and invalidate its certification; this practice must be avoided.

S2024/129M Immediately communicate through its members the need for owners and crew of creel fishing boats to review their deck working risk assessments to ensure that:

- the hazards associated with shooting and recovering creels, such as the risk of entrapment in a running backrope, are fully mitigated;
- when working deck PFDs are provided, they are of the required standard and are appropriate for the work being undertaken by the deck crew; and
- when new hazards are identified, such as the risk of entanglement from loose lifting strops on PFDs, they share the information among the crew and source alternative PPE as soon as possible.
