SB4/2024

Foundering of the fishing vessel

Argos Georgia

MAIB SAFETY BULLETIN 4/2024

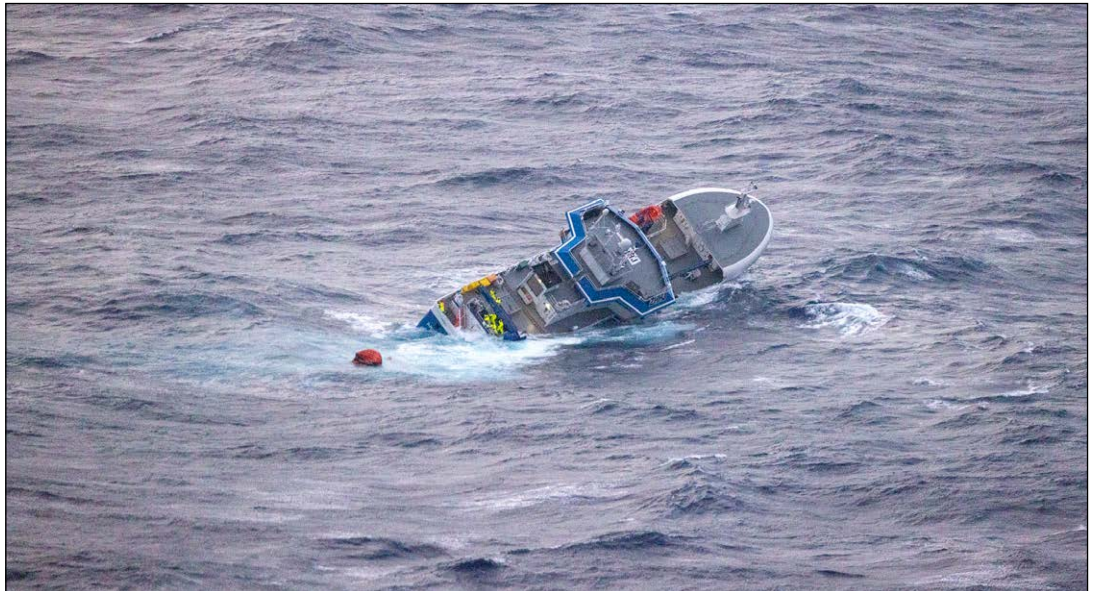
Argos Georgia foundering

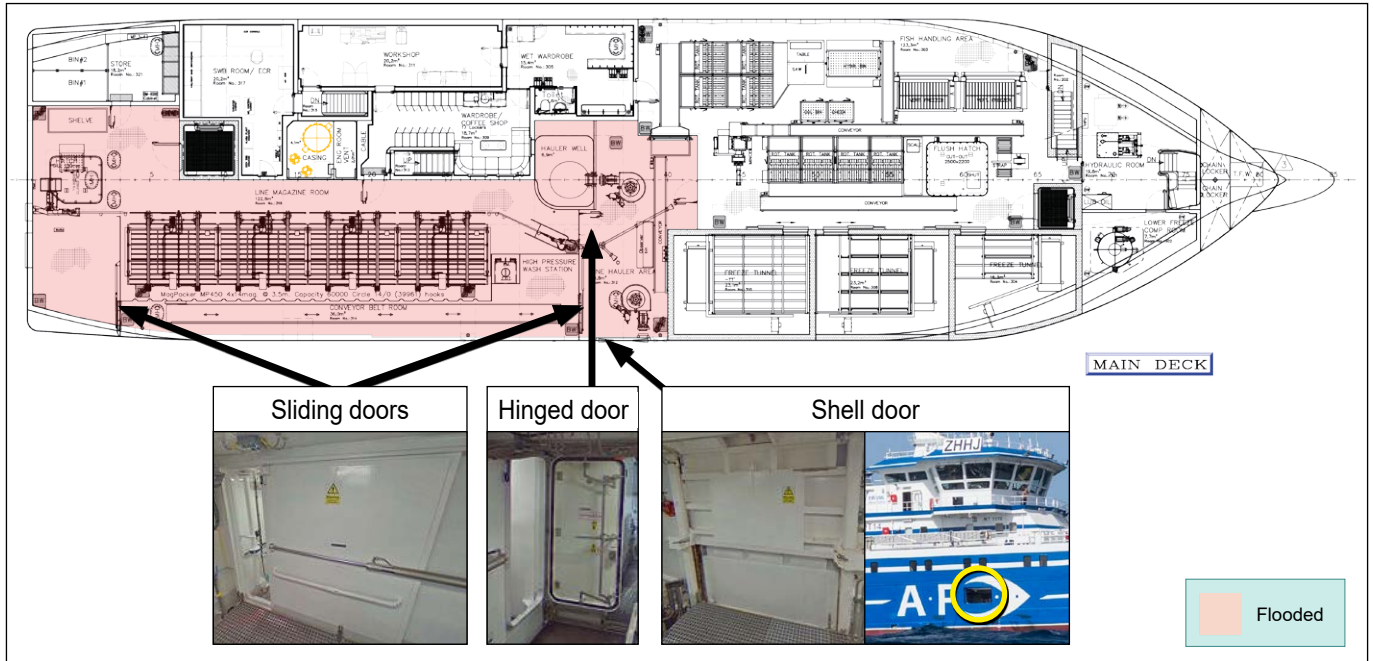
At about 1230¹, in a position approximately 190 nautical miles east of Port Stanley, *Argos Georgia* suffered an uncontrolled ingress of water through the shell door into the hauling compartment on its starboard side. Water then entered other areas aft of the hauling compartment (see **Figure**) and the vessel took on a starboard list. *Argos Georgia* was turned into the weather and the master raised the alarm via a colleague on a fishing vessel operating in the same region. This alarm was relayed to the authorities in the Falkland Islands and a SAR operation initiated using air and sea assets, supported by other fishing vessels.

Figure: Plan of *Argos Georgia* main deck, showing the extent of the initial flooding

The ongoing investigation has found that, before the accident, the shell door in the starboard side of *Argos Georgia* was raised in the closed position. At the time of the accident the door was observed on closed-circuit television to descend slowly into the fully open position. This allowed significant quantities of water to enter the vessel. The crew were unable to close the shell door once it had opened.

Internal doors leading from the hauling compartment were open. This allowed water to flow unhindered into other areas of the vessel, causing a significant list that progressively increased as more water entered. The crew were unable to control the passage of water into other spaces in the vessel, which increased the list still further until the vessel foundered.

S2024/137M Urgently ensure that a suitable and sufficient assessment of the risk of water entering the vessel through a side shell door has been undertaken and documented, noting the safety issues identified in this safety bulletin, and that:

- mitigations identified are immediately implemented to reduce the risks associated with a failure of a shell door;
- where a risk of consequential flooding between compartments exists, appropriate measures including maintaining internal doors in the closed position are taken; and
- the crew are informed of the findings of the risk assessment and the measures taken for their protection.
