Report on the investigation of
the fatal crush accident to a bosun during cargo
operations on board the roll-on/roll-off cargo vessel

Clipper Pennant

at Gladstone Dock, Liverpool, England

REPORT NO 16/2024

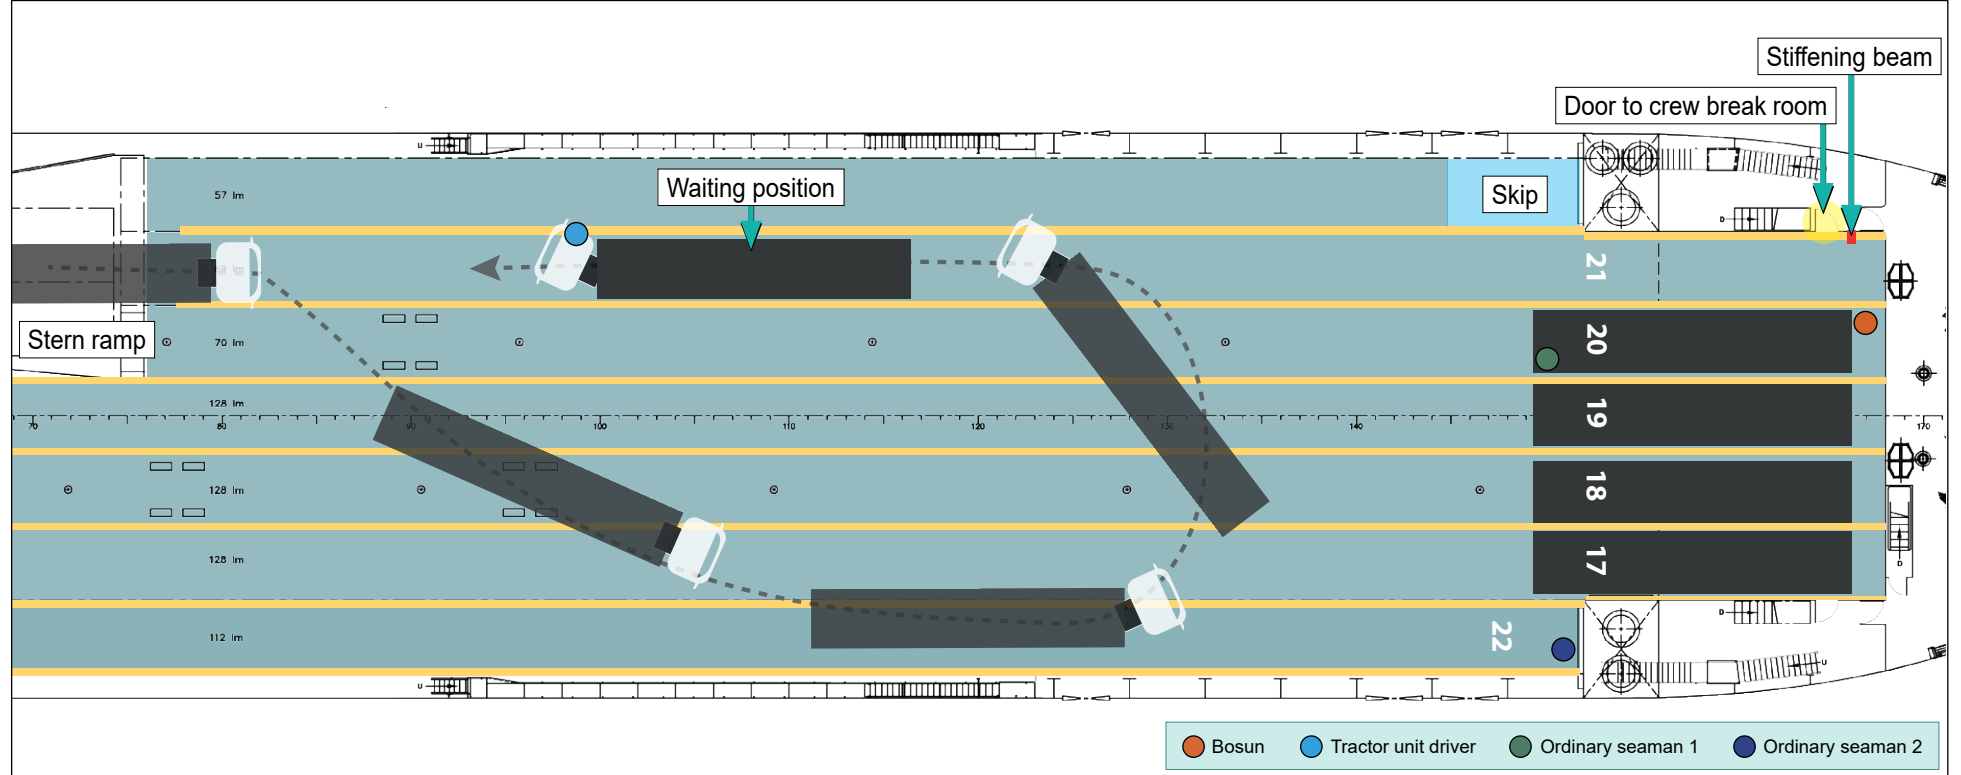
Figure 3: Plan view of the upper vehicle deck, showing the semi-trailer's manoeuvring sequence and the bosun's position in stowage space 20

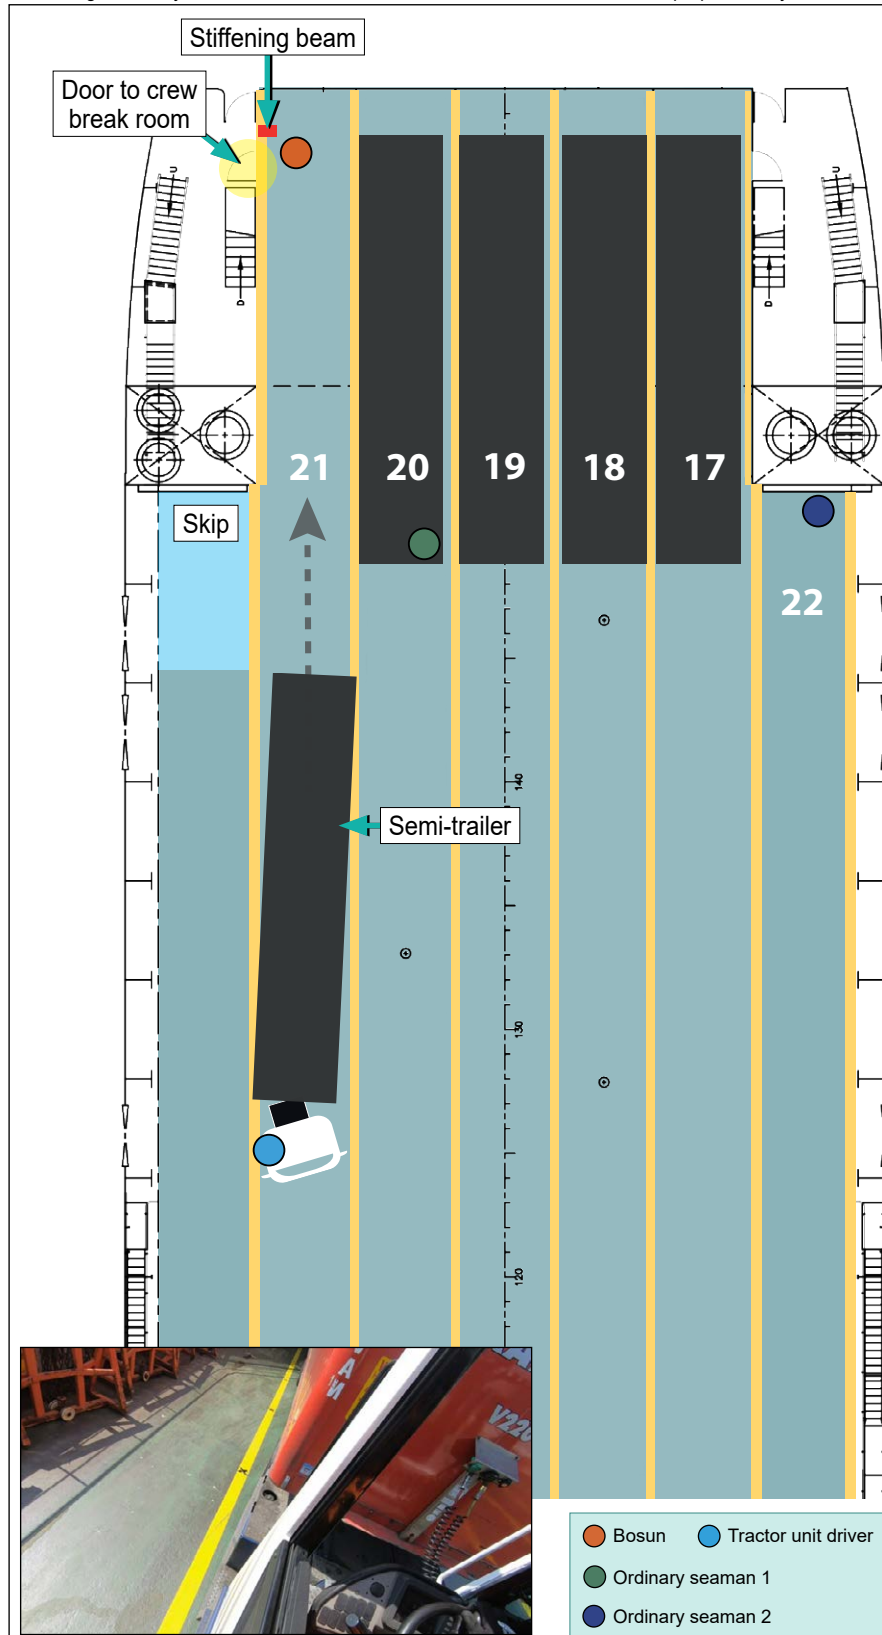
blast and stopped the semi-trailer in stowage space 21 (**Figure 6**). The tractor unit driver applied the handbrake and raised the semi-trailer so that OS1 could slide a trestle beneath it and lower it onto the trestle. The tractor unit driver disconnected the air brake system, rotated the seat assembly to face forwards and drove away to collect the next load.

Figure 5: Plan view of the tractor unit pushing the semi-trailer into stowage space 21 and (inset) a reconstruction of the driver's view

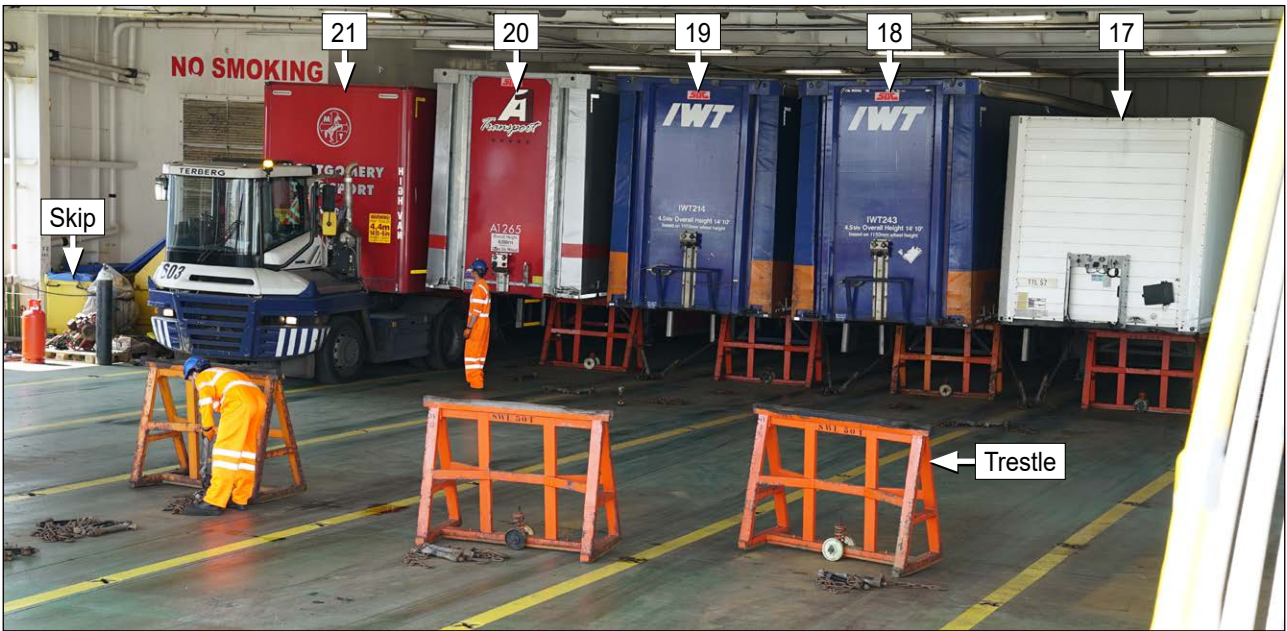
Figure 6: Reconstruction of a semi-trailer parked in stowage space 21

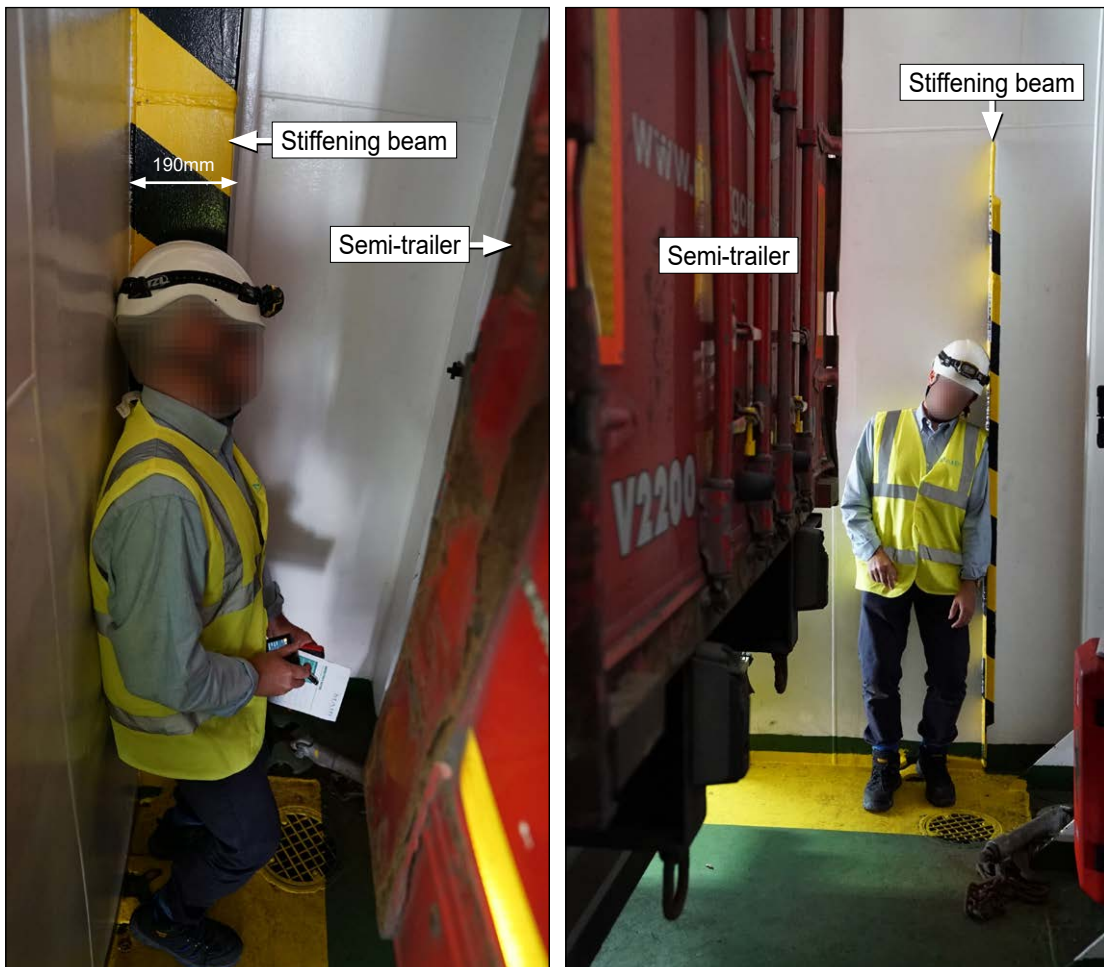
At 1355, OS1 secured the first chain in the process of lashing the front of the semi-trailer and then moved to the opposite side, near the port bulkhead. As OS1 attached the second chain they noticed that the semi-trailer had been parked with its rear right-hand side tyres resting on the painted yellow walkway. OS1 looked up and found the bosun trapped between the right-hand rear corner of the semi-trailer and a stiffening beam, which protruded from *Clipper Pennant's* superstructure (**Figure 7**).

Figure 7: Reconstruction of the bosun's position when he became trapped

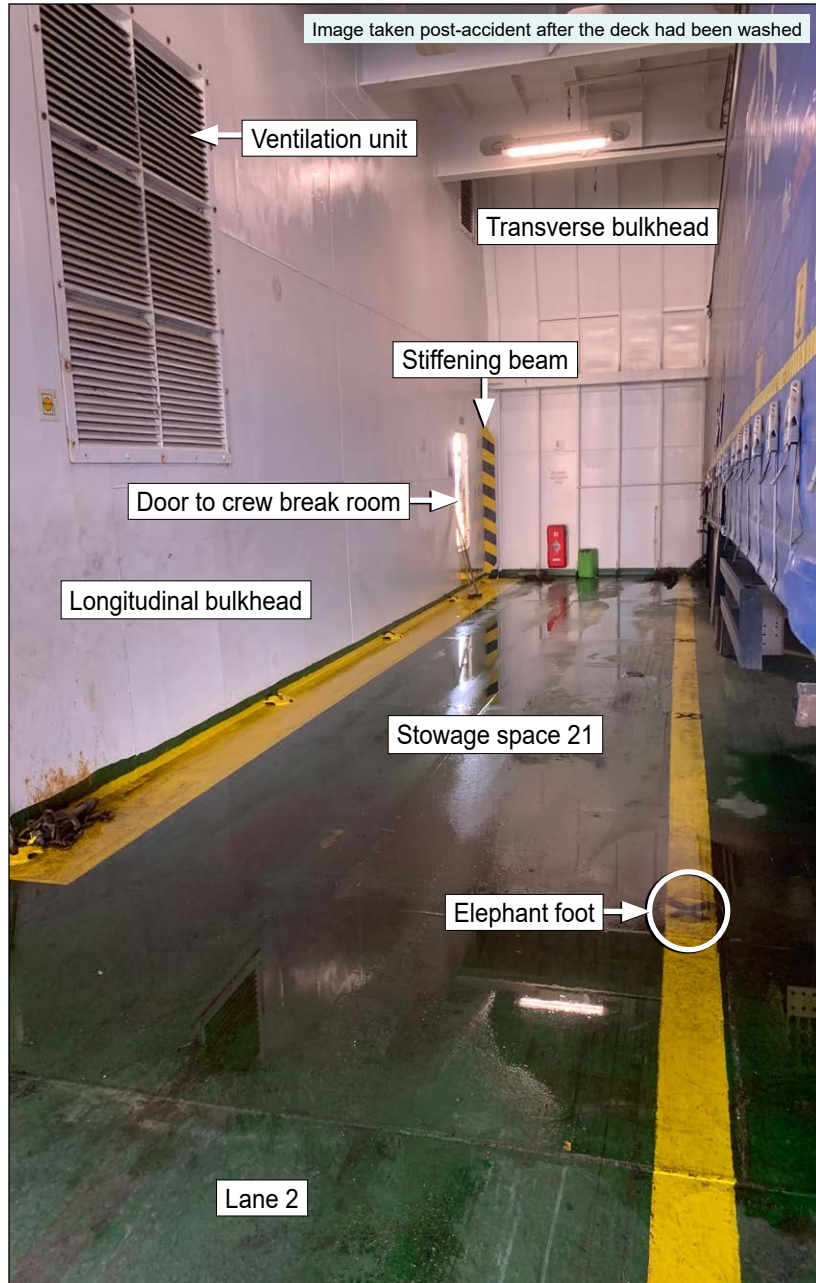
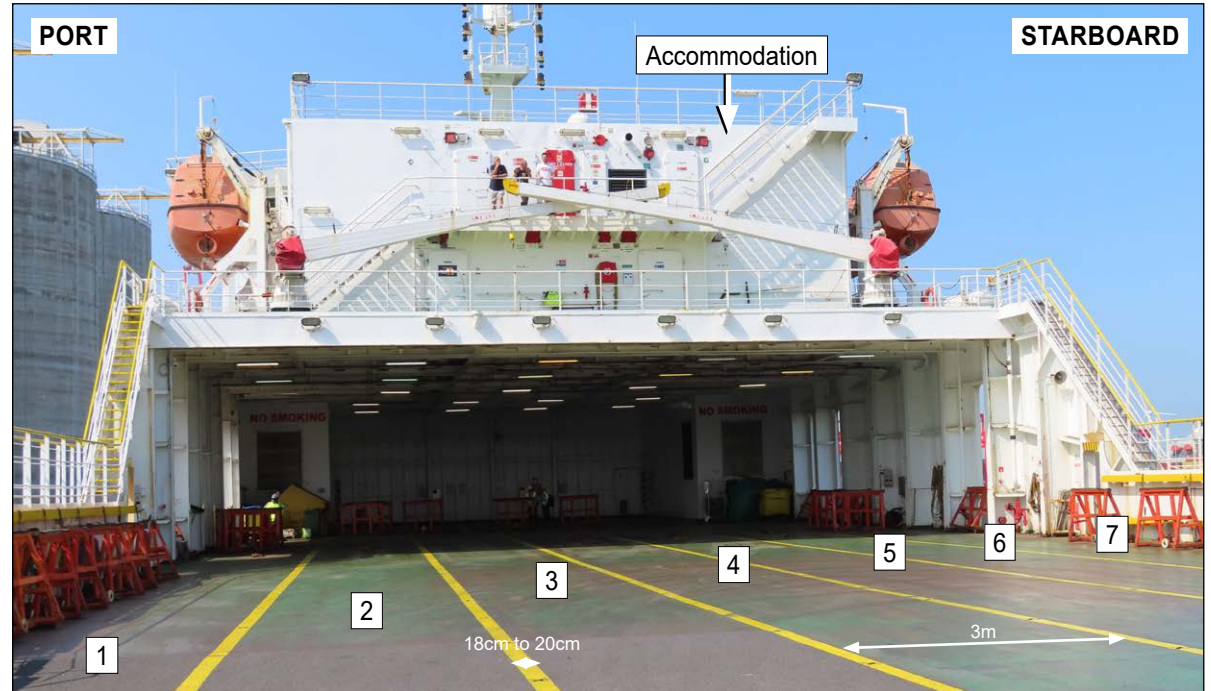
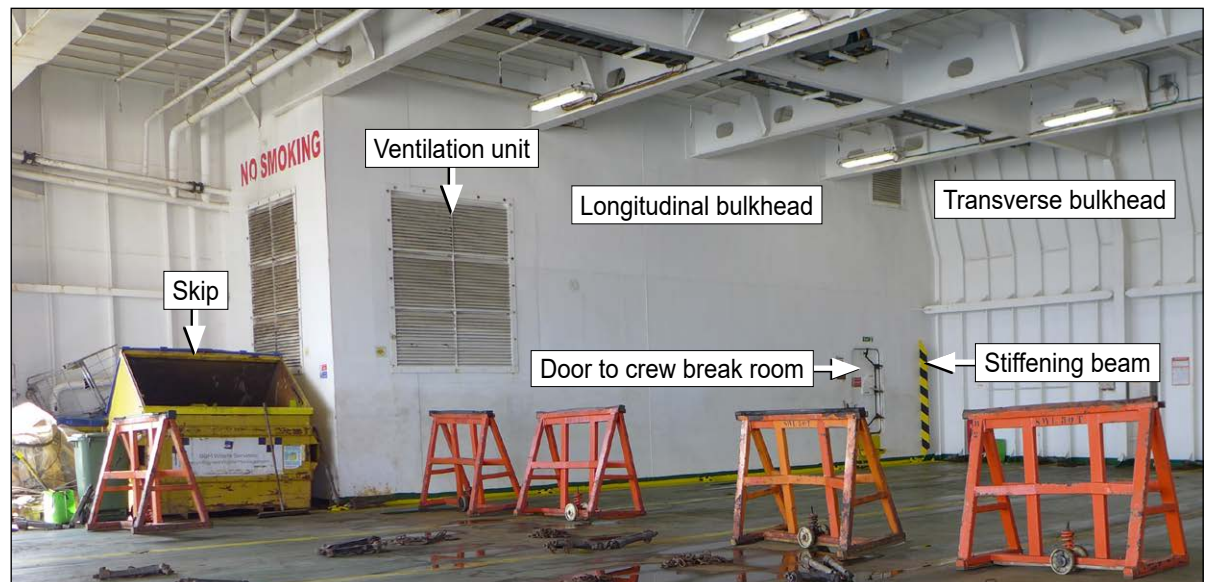
Figure 9: The accident location, showing the vehicle lane dimensions and elephant's feet positions

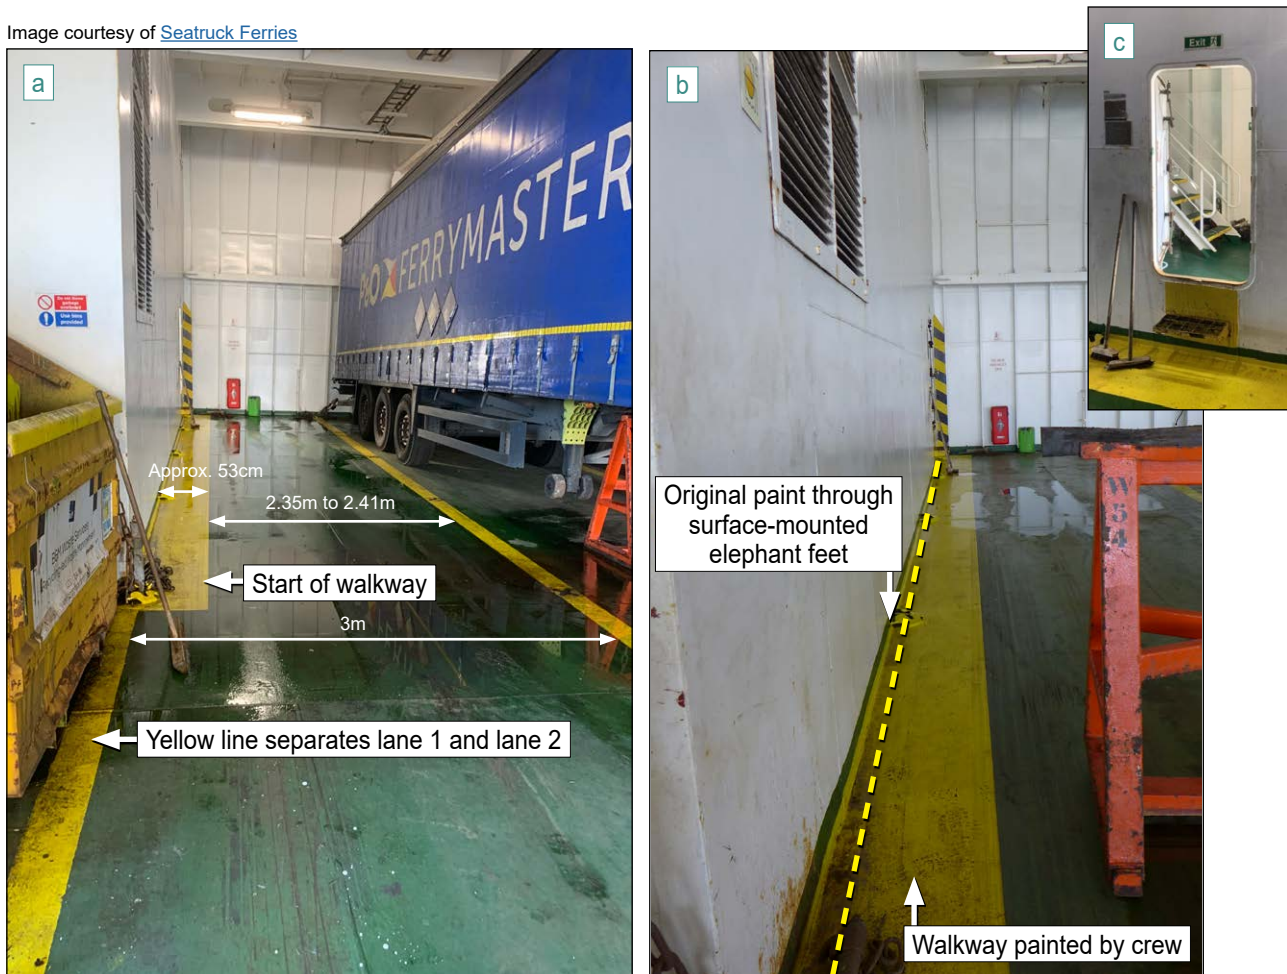
The walkway reduced the effective vehicle lane width in stowage space 21 from the inside of the yellow lines to between 2.35m and 2.41m⁸. The athwartships distance between the fixed elephant's feet on either side of the stowage space remained 3m (**Figure 11**). When a semi-trailer was secured, the lashings crossed the walkway and connected to the elephant's feet running along the bulkhead.

Figure 11: The painted yellow line separating lane 1 and lane 2 (a), a close-up of the painted walkway (b), and a close-up of the crew break room access door (c)

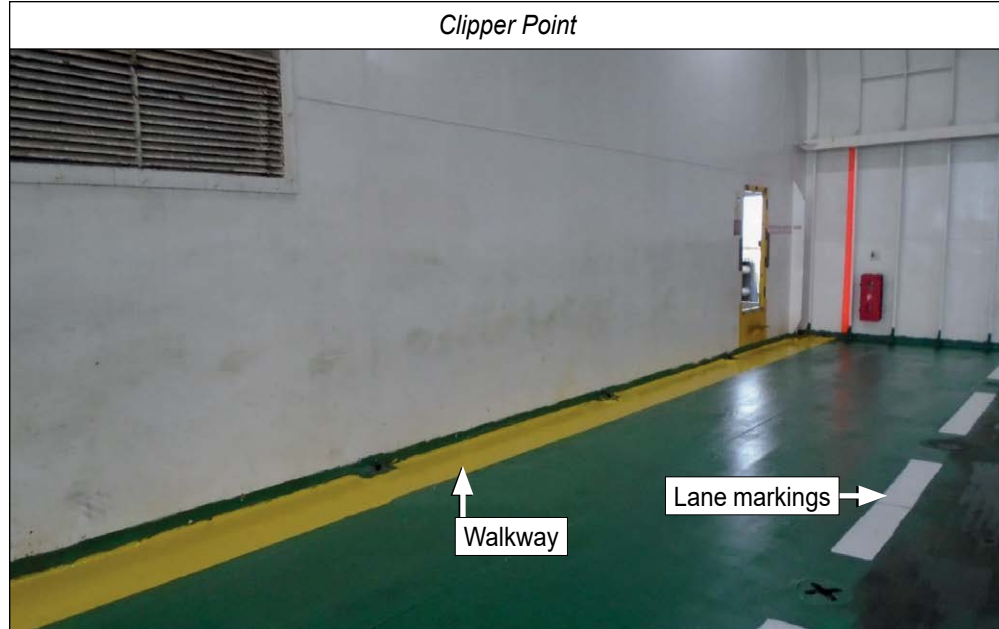
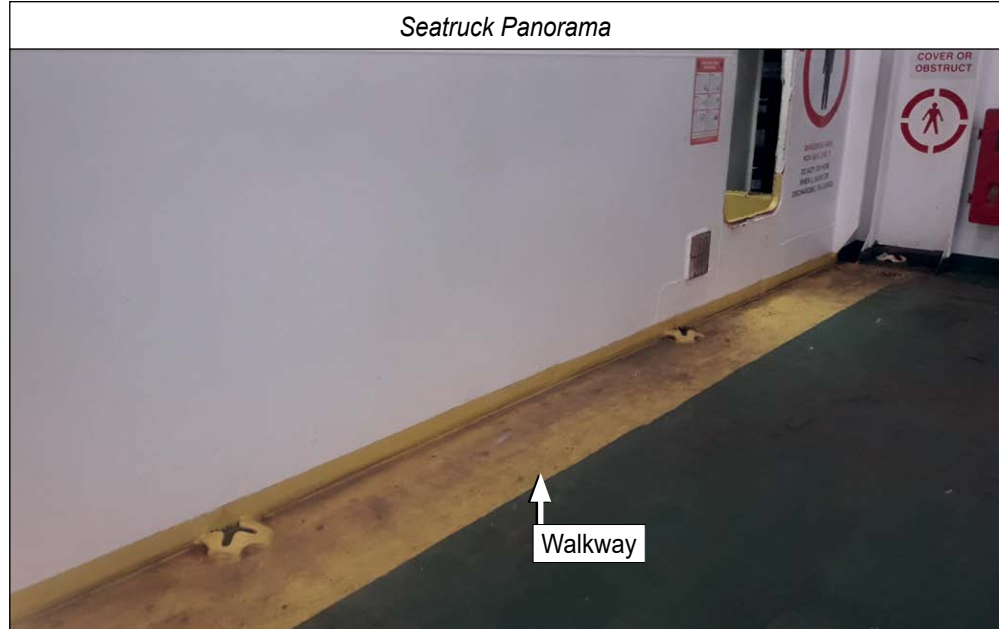
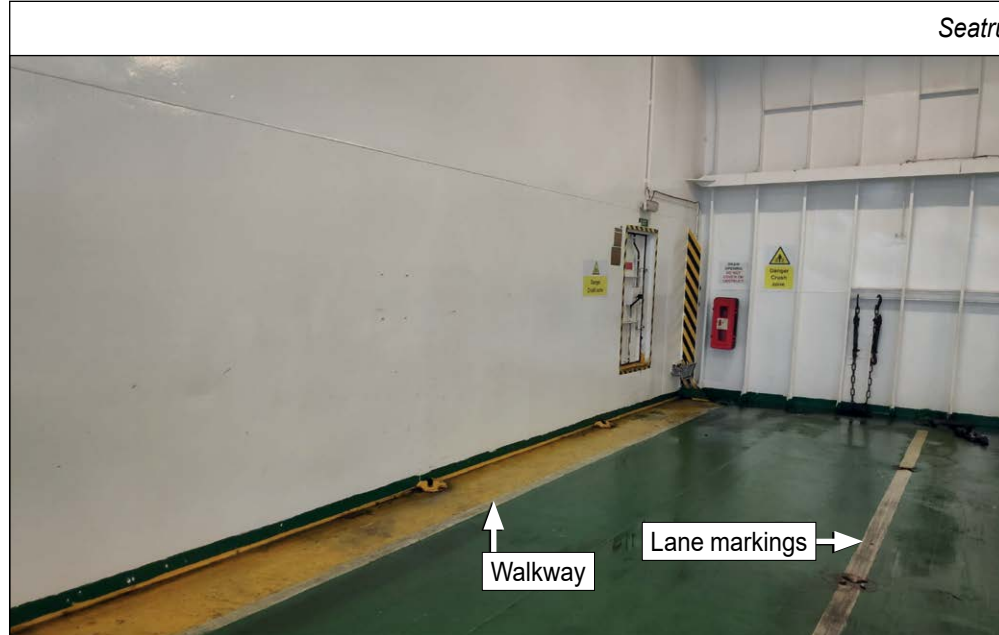
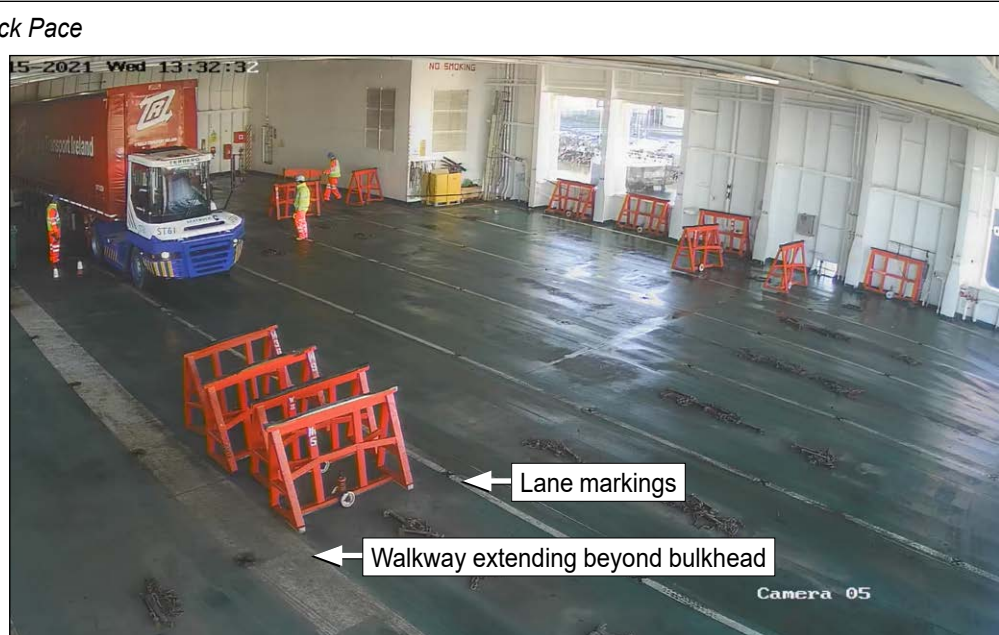
Figure 12: Comparison of the painted walkways on the P-Class ferries

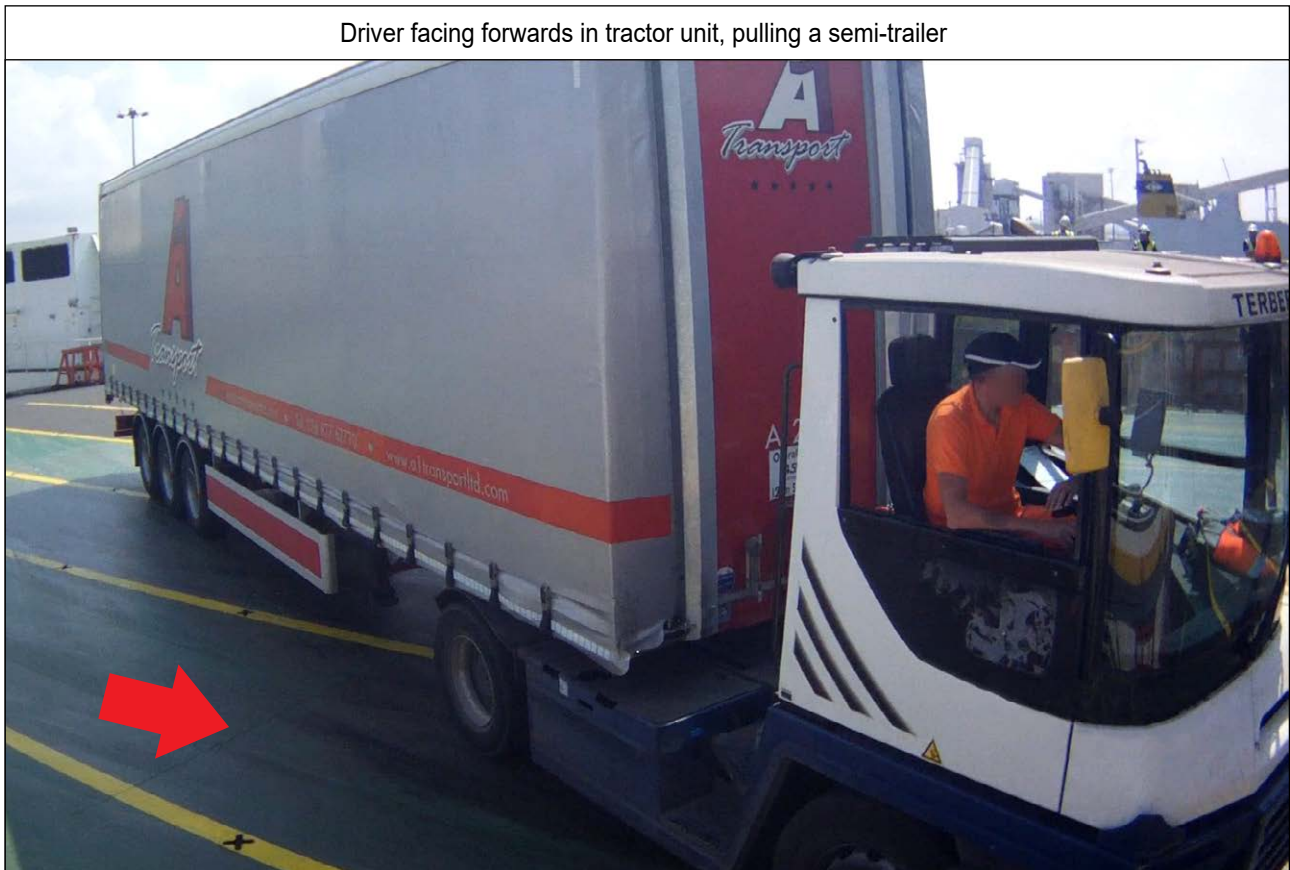
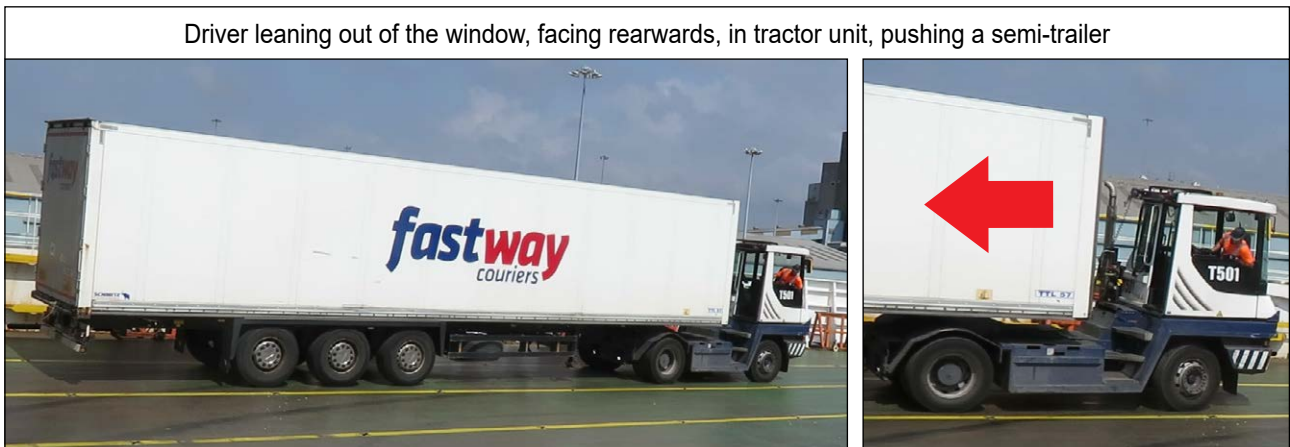
Tractor unit drivers faced forward to pull a semi-trailer and had an unrestricted view ahead. For pushing, the cab was designed with an offset and a driver's seat and steering console that could be rotated through 180°. To start pushing a semi-trailer, tractor unit drivers turned their seat assembly to face the front end of the semi-trailer. The tractor unit driver's view in this position was restricted by the semi-trailer and they would therefore lean their head out of the window to achieve visibility down the semi-trailer's right side (offside for UK road vehicles). The tractor units were fitted with wing mirrors on the opposite side to enable the drivers to achieve visibility down the semi-trailer's left side (nearside for UK road vehicles) (**Figures 14 and 19**).

Figure 14: Reconstruction of the tractor unit driver positions when pulling and pushing a semi-trailer

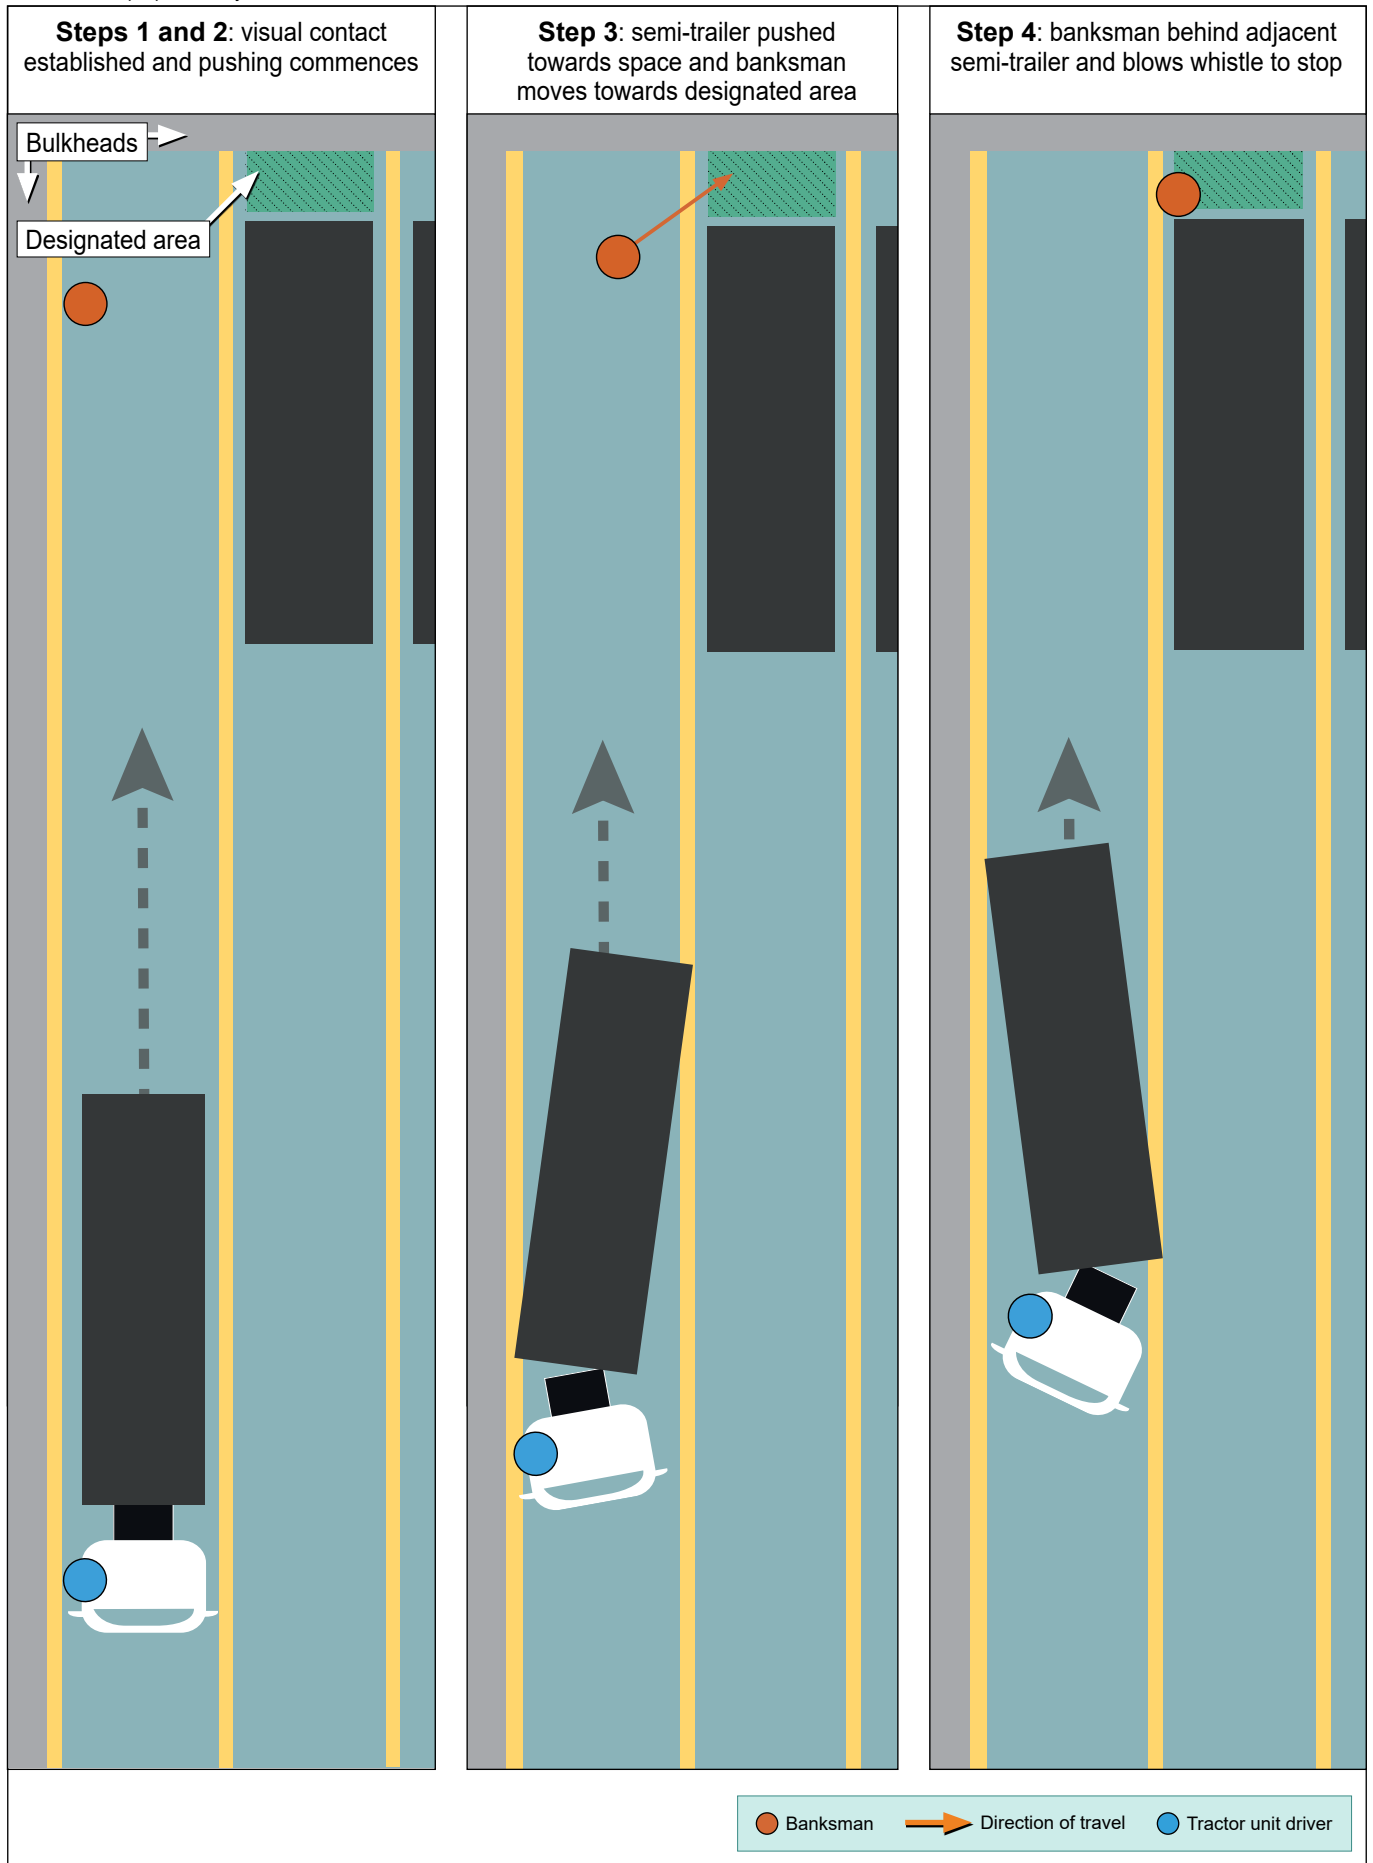
Figure 20: A representation of the undocumented sequence for loading a semi-trailer into a partially enclosed stowage space

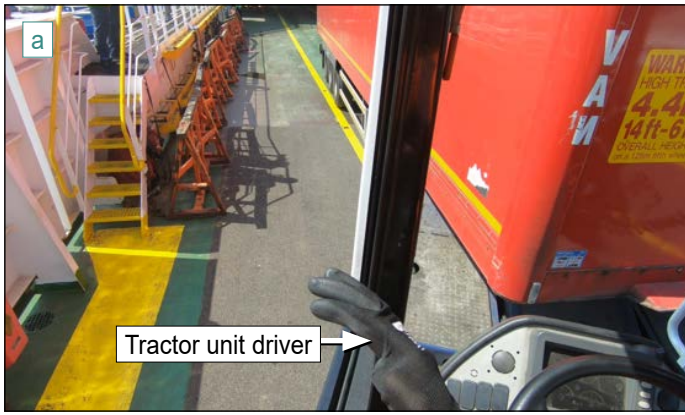
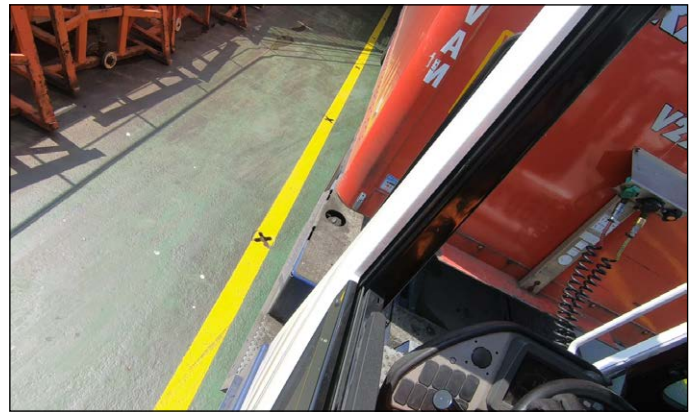
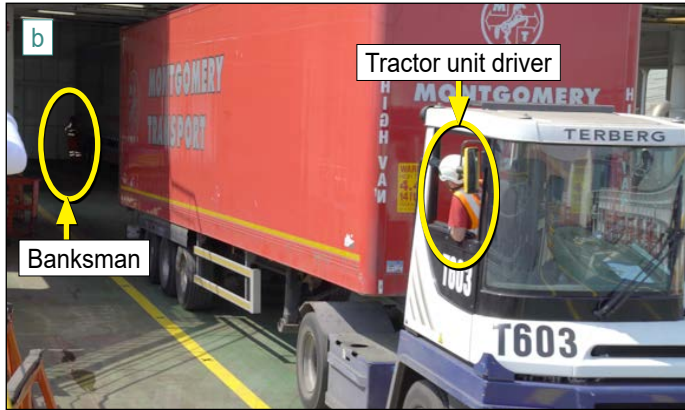
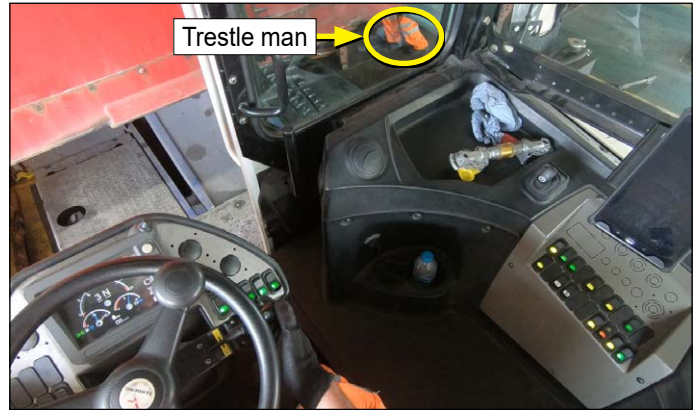
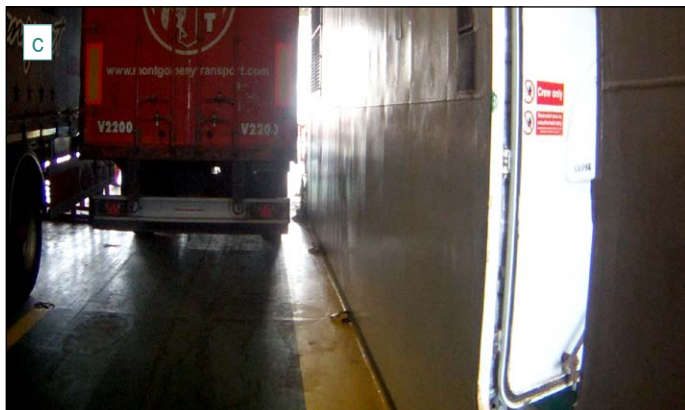
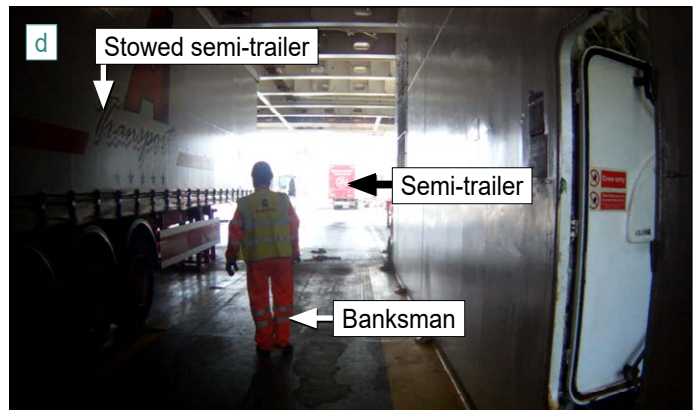
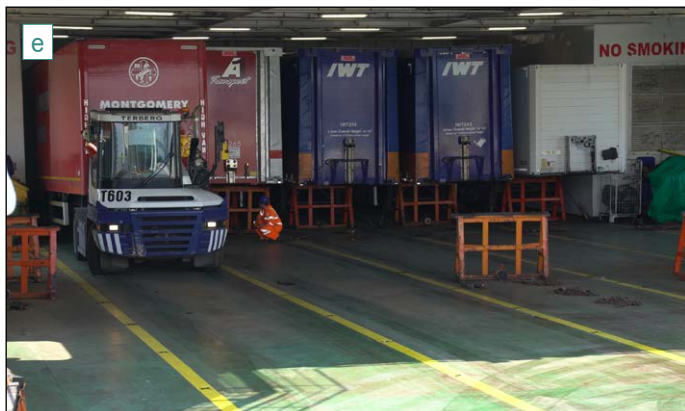
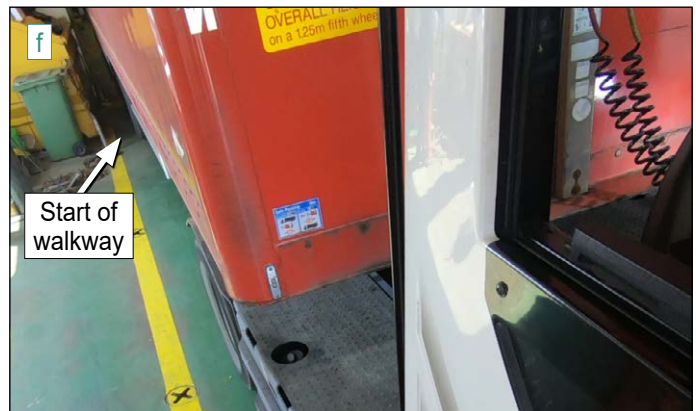
- the walkway only became visible when the rear of the semi-trailer passed the point at which the lane marking widened into a walkway (**Figure 21f**).
- the deck rating positioning the trestle did not monitor the position of the bosun during the manoeuvre (**Figure 21e**).
- the whistle signal could be heard across the deck.

Figure 21: Stills from the MAIB reconstruction

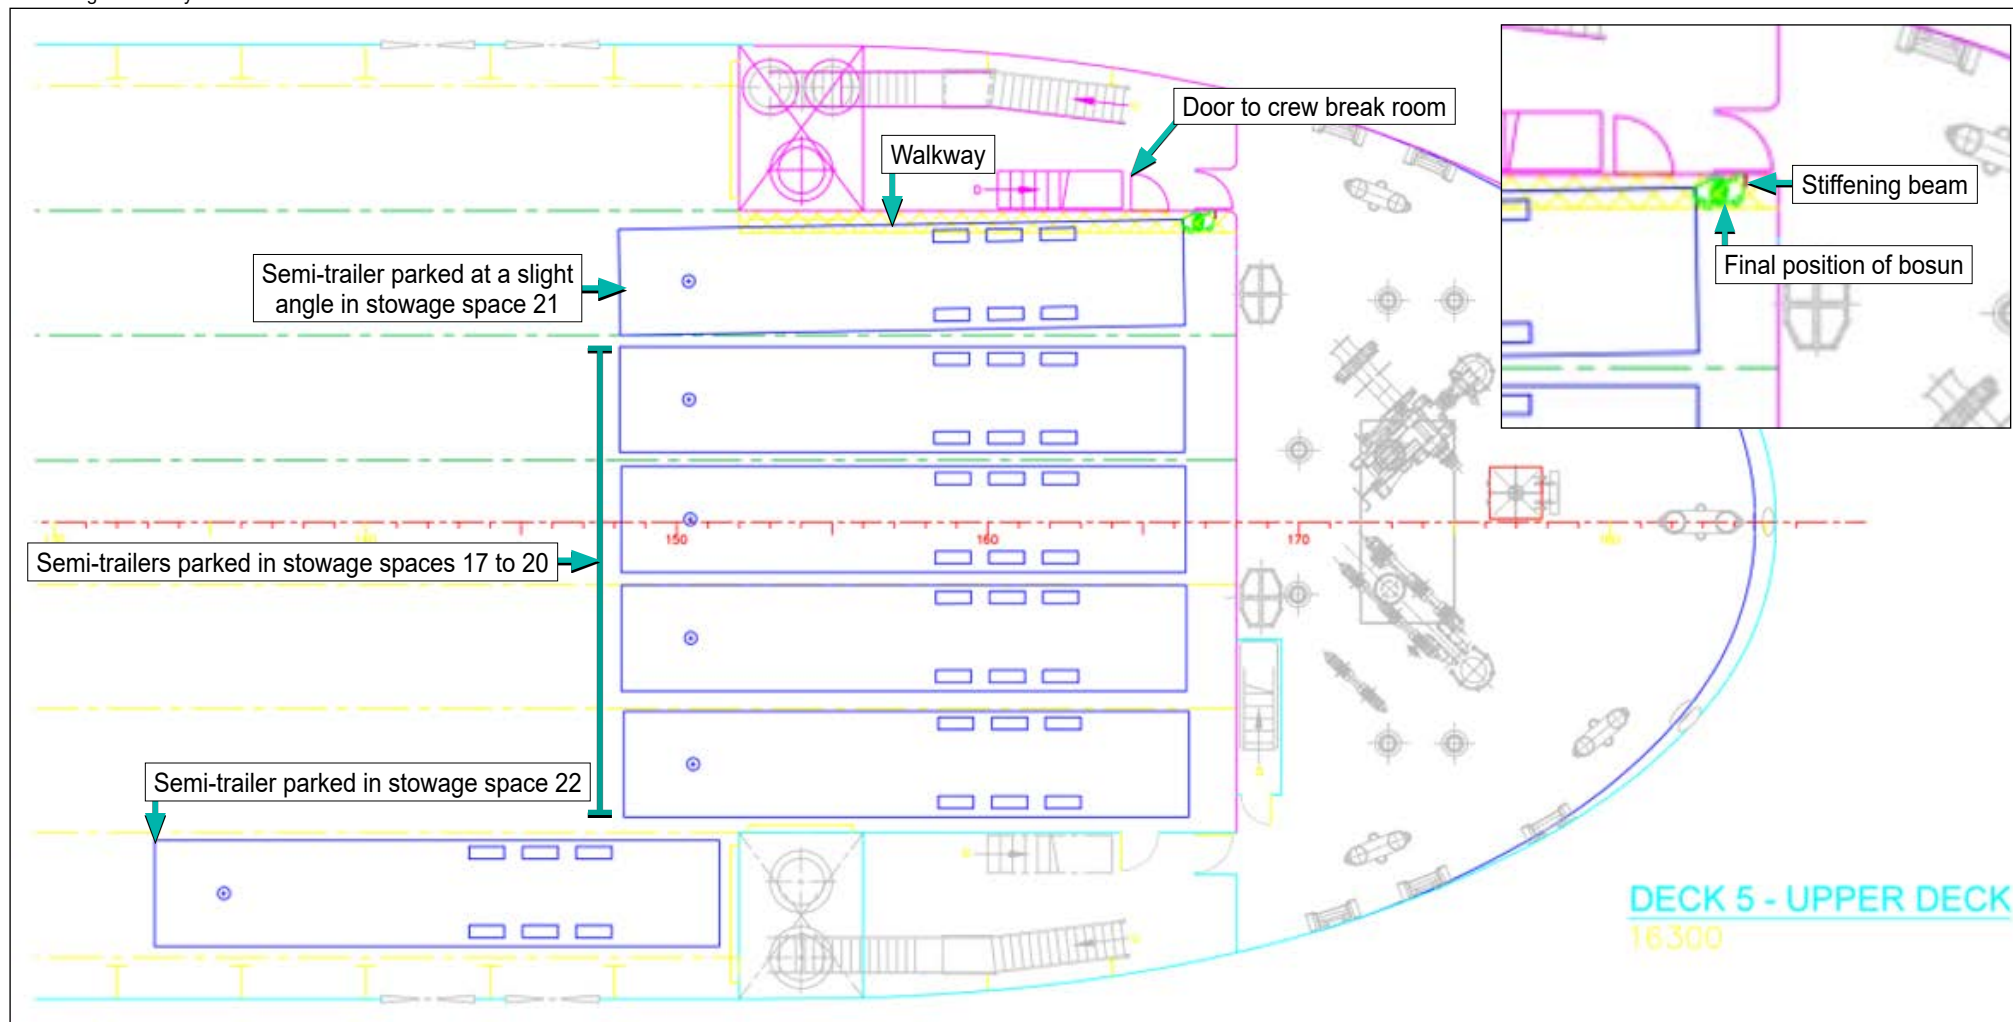
The bosun's exact movements during the loading of stowage space 21 could not be determined; however, he was seen near the accident location gesturing to the tractor unit driver to start pushing the semi-trailer less than 30 seconds before the accident. This suggests that either he did not move from this position near the stiffening beam as the semi-trailer approached or he briefly moved away then returned.

Figure 22: Post-accident plan view of the parked semi-trailer and (inset) the bosun's position

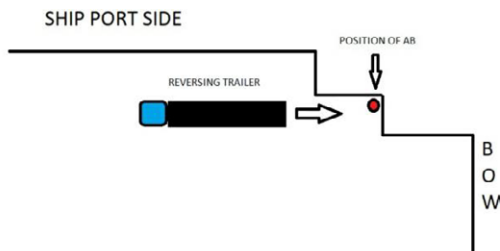
A recent Near Accident during loading involved a crew member, who while marshalling a trailer into position was stood behind the reversing trailer in an area with no escape.

The AB stated he was standing in this position to maintain visual contact with the Tug Master driver and when the trailer is at a safe distance of about 10 meters he goes to the other 'safe' side.

The AB should not be stood here at all and he should not cross behind a reversing trailer.

During the loading of trailers, crewmembers must not stand behind the trailer. **Never walk behind a moving vehicle** or position yourself outside the sight of the tug driver.
