Report on the investigation of
the fatal crush accident to a bosun during cargo
operations on board the roll-on/roll-off cargo vessel

Clipper Pennant

at Gladstone Dock, Liverpool, England

REPORT NO 16/2024

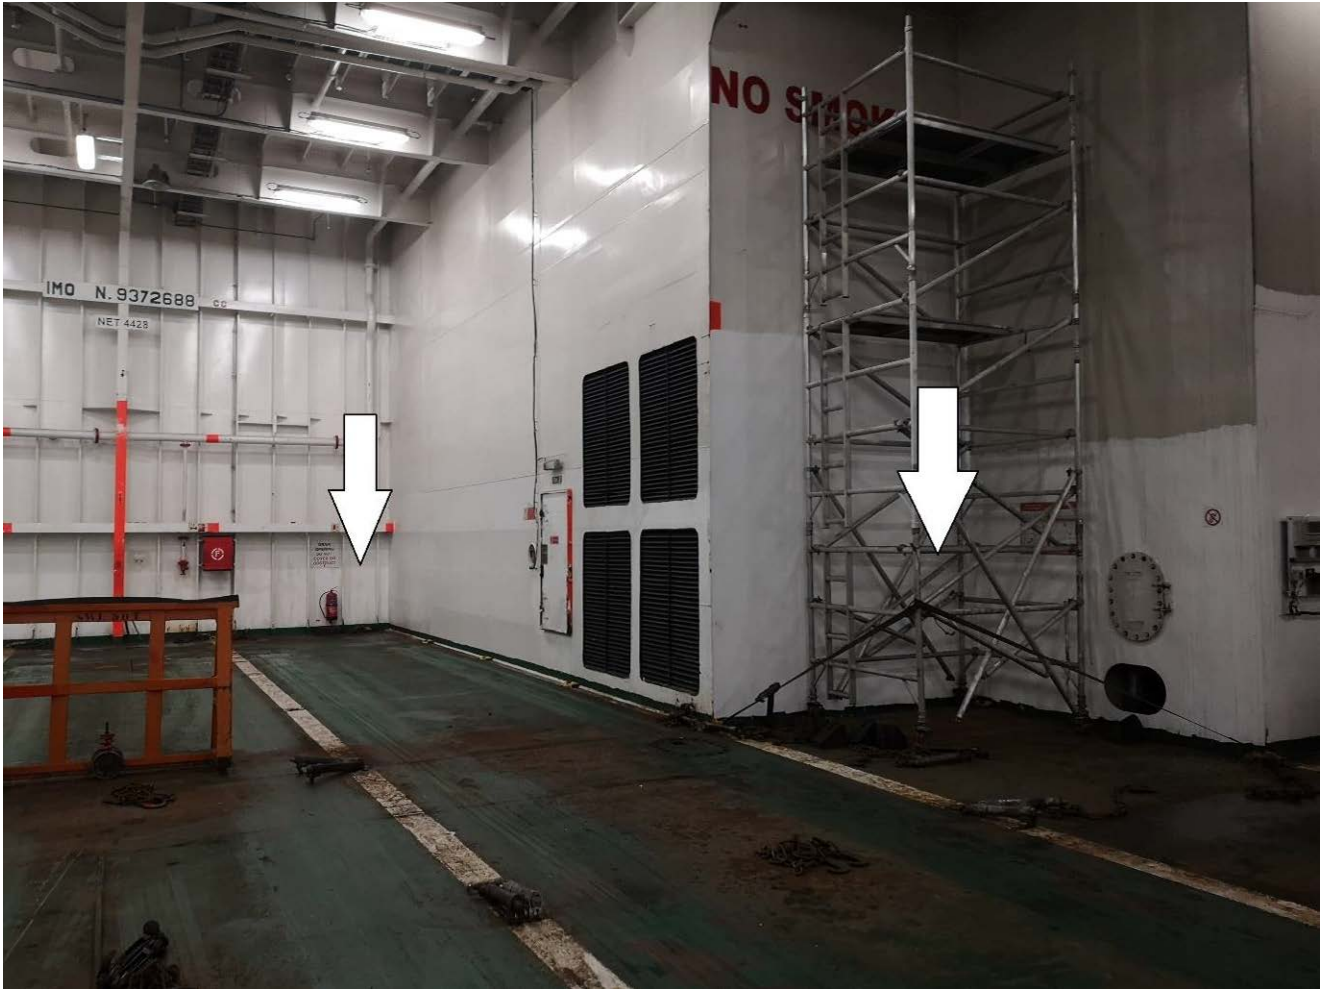
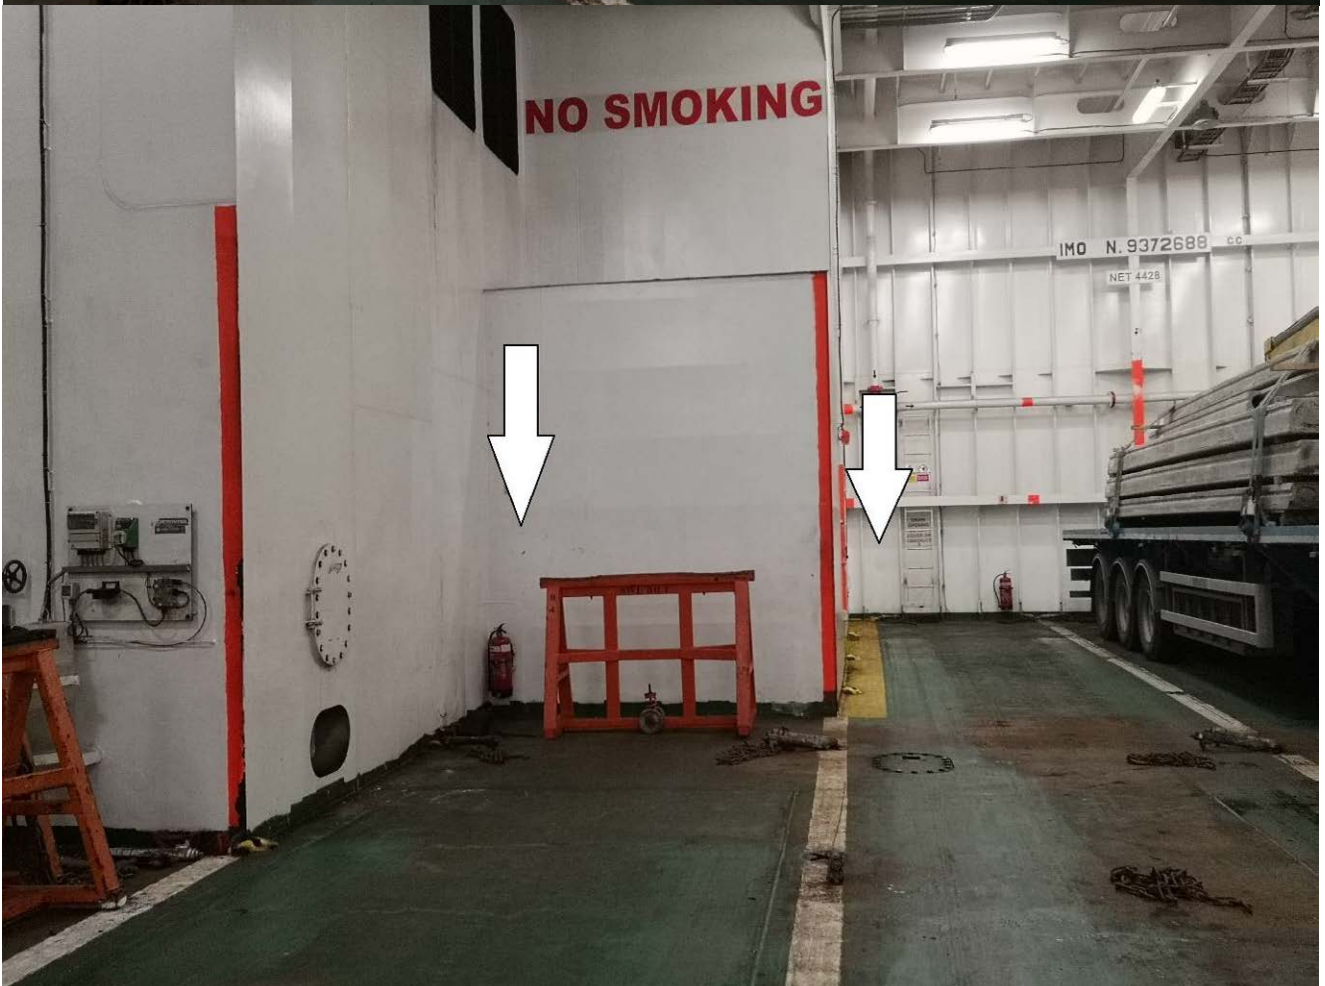
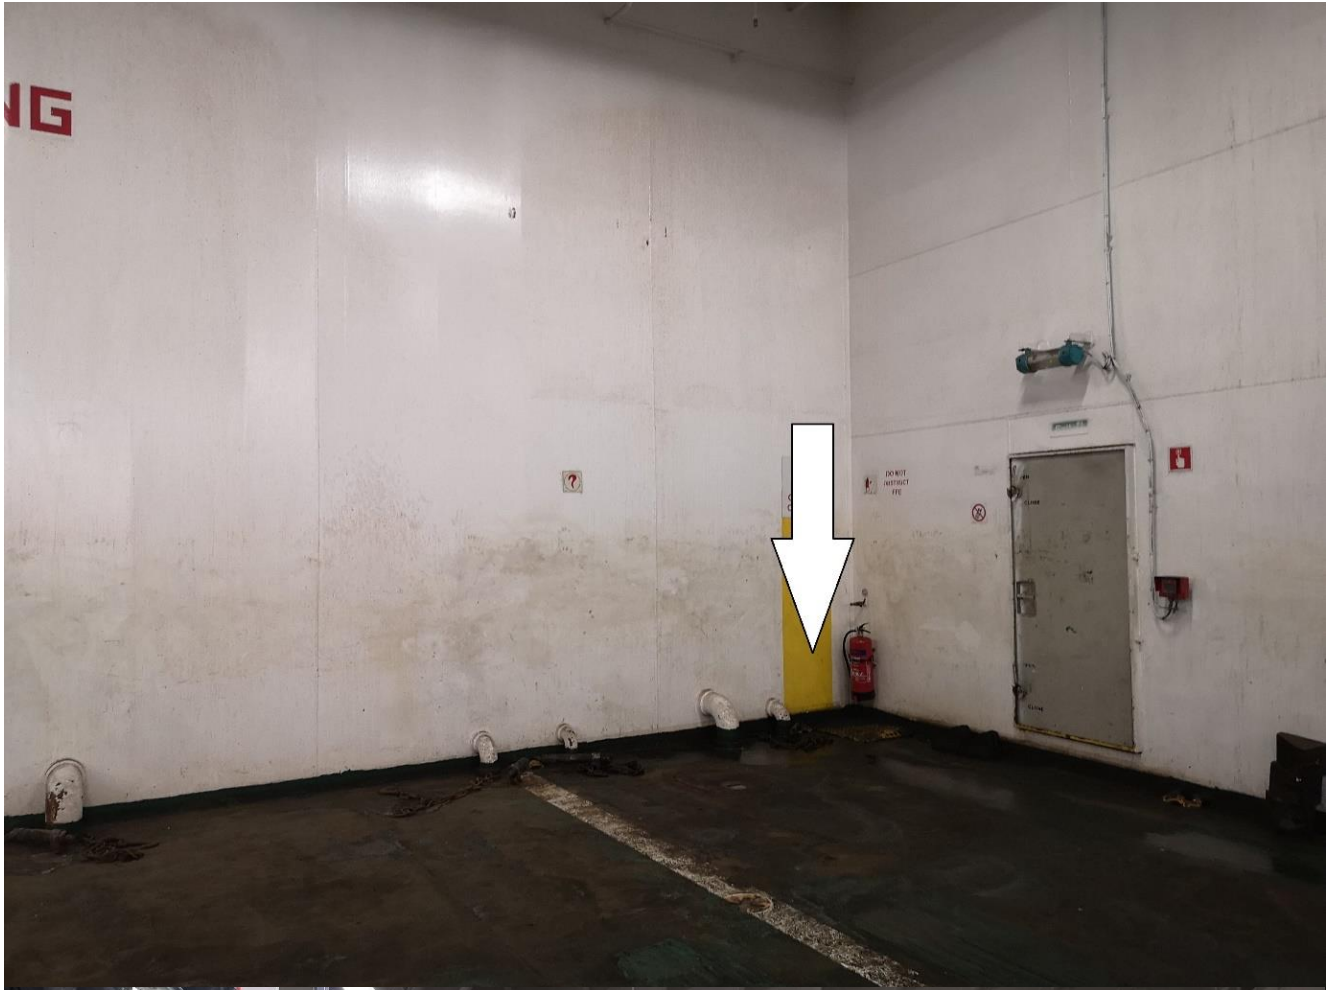
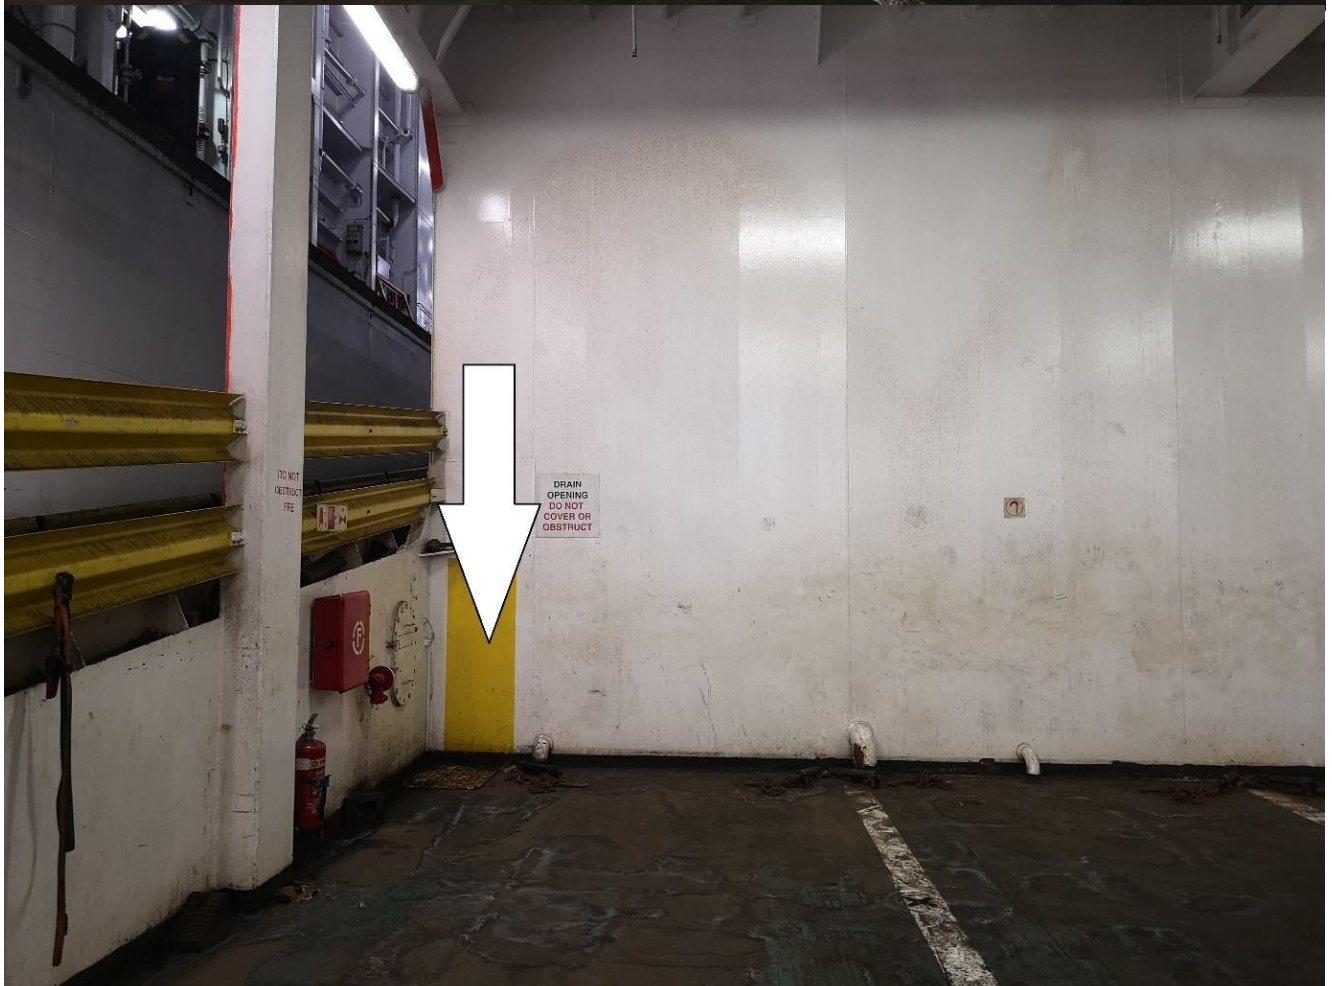
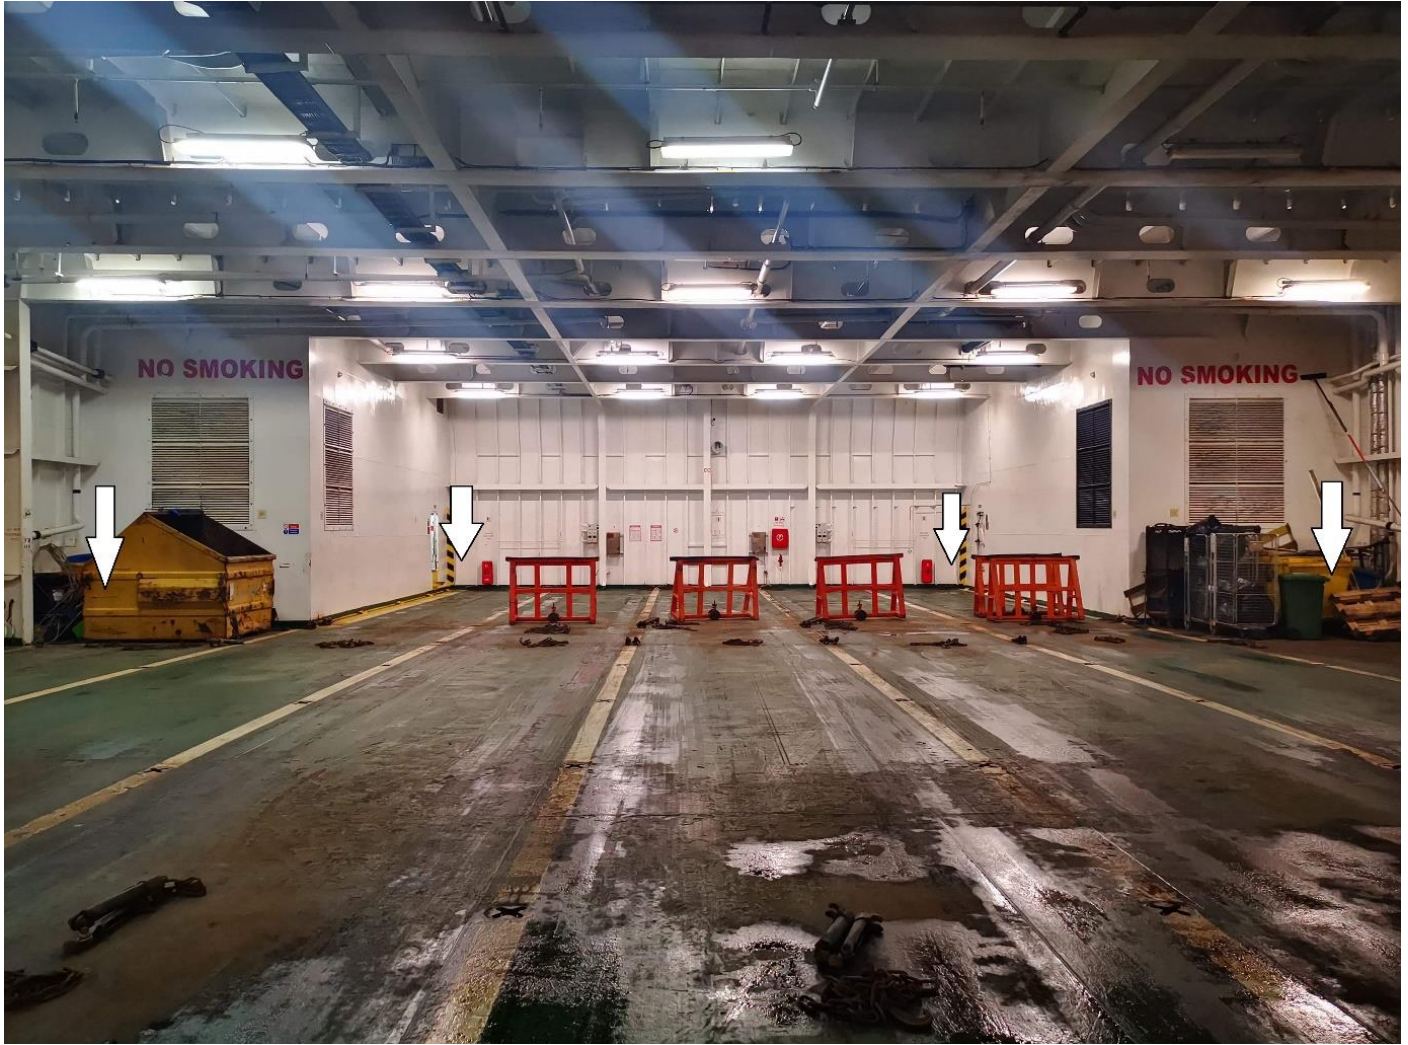
Photographs of the hazardous areas with no escape identified on board *Clipper Pennant*

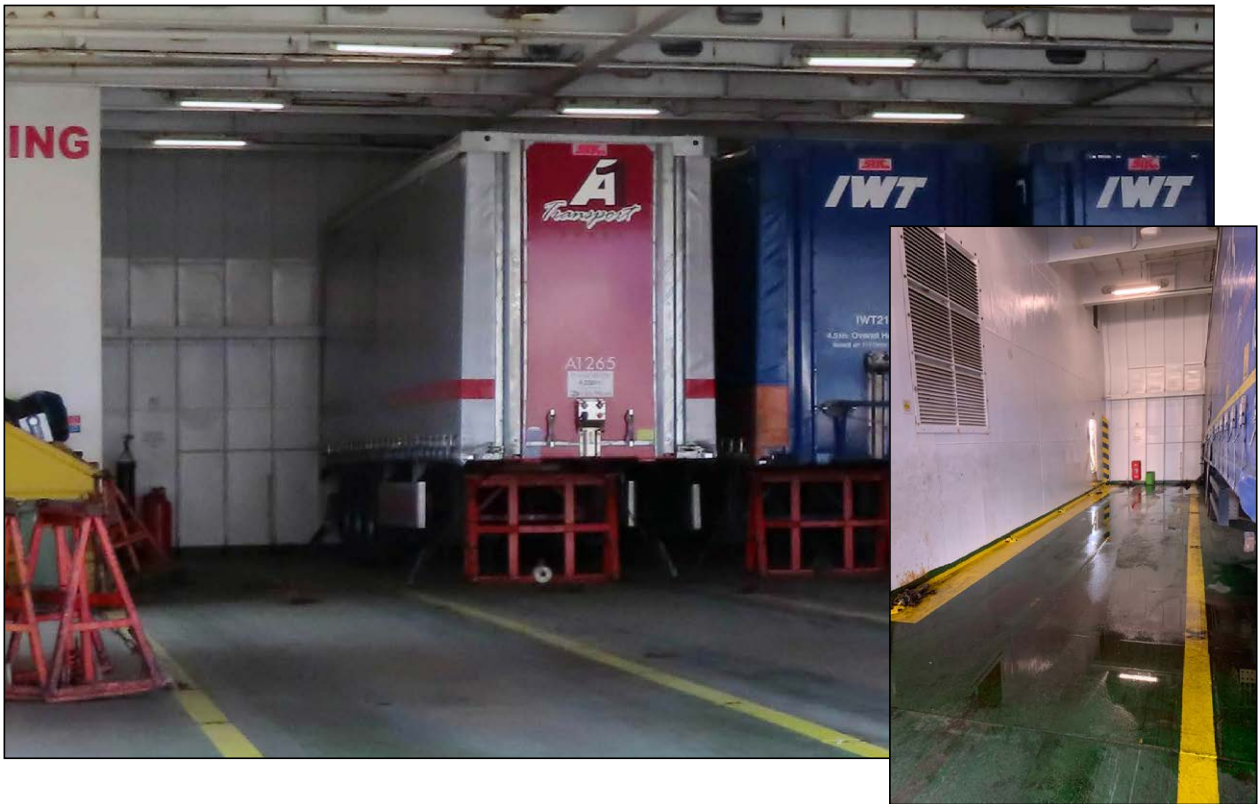
Figure 1: Reconstruction of the semi-trailer parking arrangement, with inset view of the space (post-accident)

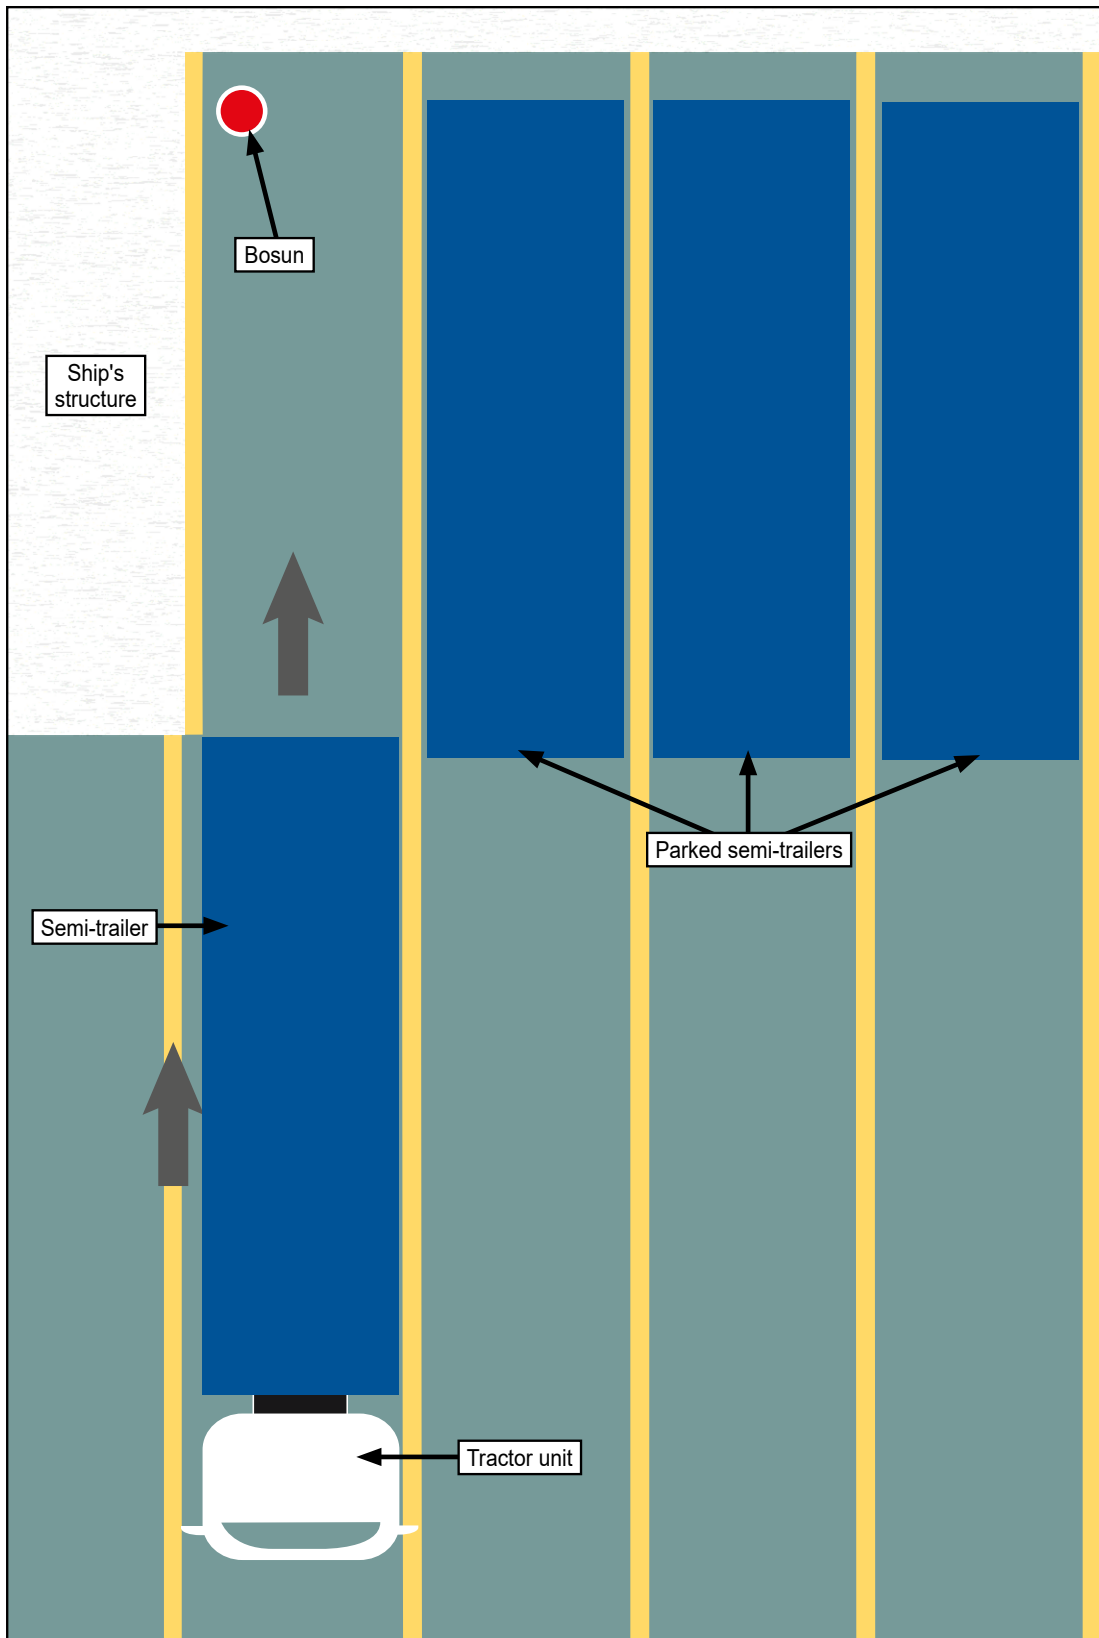
Figure 2: Graphic showing plan view of the semi-trailer's approach to the parking space
