Accident

Aircraft Type and Registration:	Rotorsport UK Cavalon, G-CKYT	
No & Type of Engines:	1 Rotax 914-UL piston engine	
Year of Manufacture:	2018 (Serial no: RSUK/CVLN/027)	
Date & Time (UTC):	12 November 2020 at 1250 hrs	
Location:	Farmland between Avoch and Munloch, Black Isle	
Type of Flight:	Solo training flight	
Persons on Board:	Crew - 1	Passengers - None
Injuries:	Crew - 1 (Fatal)	Passengers - N/A
Nature of Damage:	Aircraft destroyed	
Commander's Licence:	Student private pilot	
Commander's Age:	67 years	
Commander's Flying Experience:	117 hours (of which 46 were on type) Last 90 days - 20 hours Last 28 days - 6 hours	
Information Source:	AAIB Field investigation

Synopsis

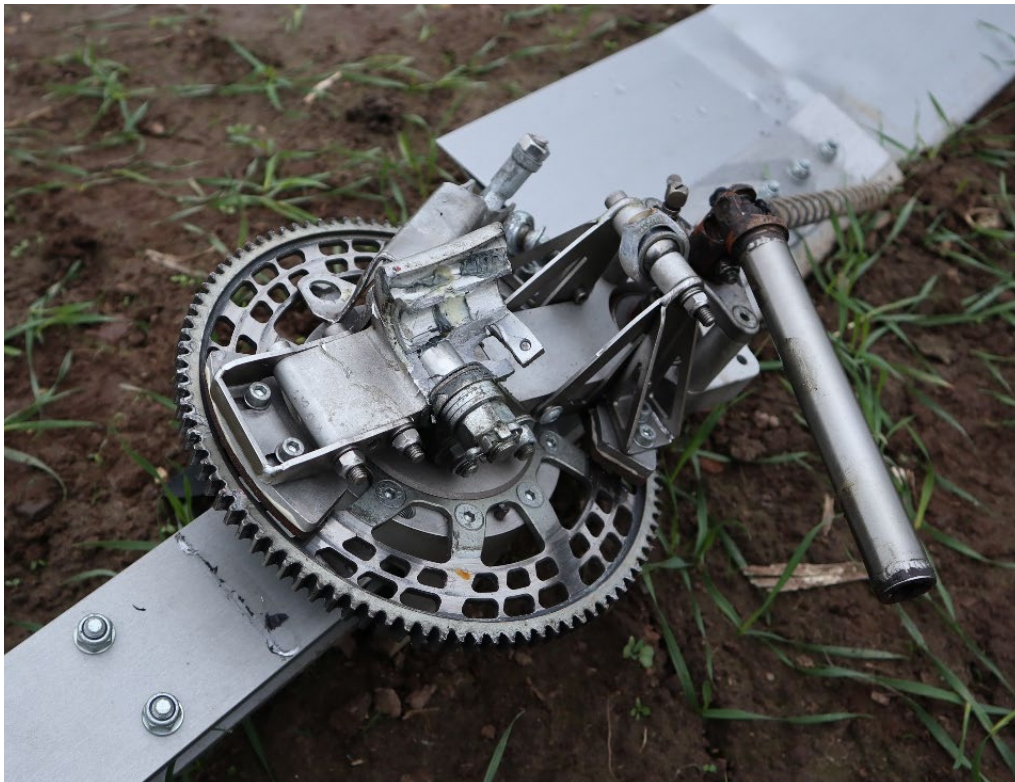
Figure 13

The gimbal block had failed where two cracks joined. One ran vertically through the roll bolt hole and down the length of the block. The other fracture surface ran horizontally through the centre of the pitch bolt hole for half the width of the gimbal block until it met the vertical fracture surface. The pitch bolt was retained in place and secured the largest section of the gimbal block to the rotor head (Figure 13). The other smaller section of gimbal block was missing and despite an extensive search, could not be located on the accident site or the surrounding fields.

Rotor head showing gimbal block failure, rotor blade deformation and teeter stop contact mark

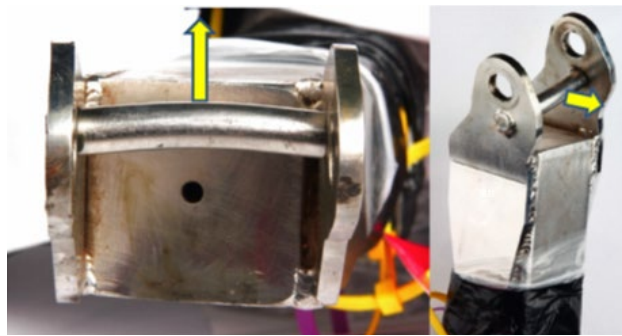
Figure 14

The roll bolt remained fitted to the top of the mast section. The roll stop bar in the mast had deformed to become curved, rather than straight (Figure 14).

Deformation of mast roll stop bar (with roll pivot bolt removed)

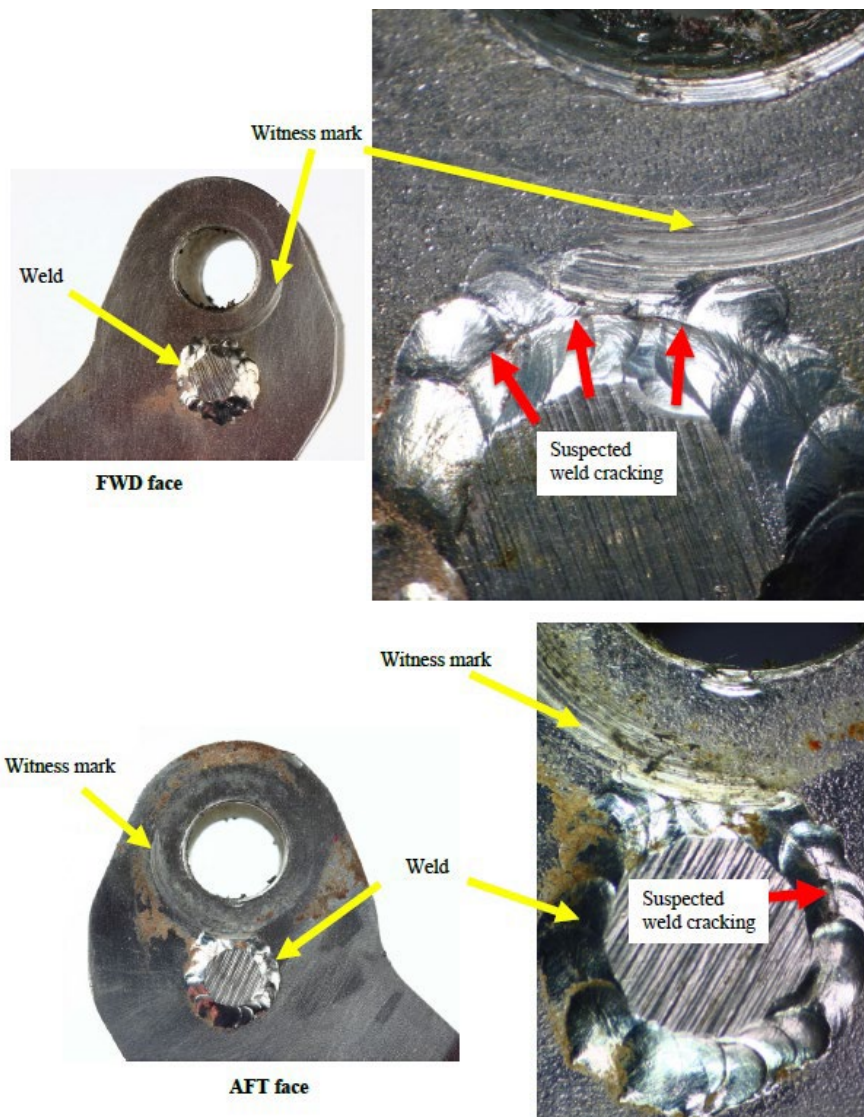
Figure 15

Detailed inspection of the roll stop bar end welds

Detailed inspection of the mast welds showed witness marks on both external faces of the mast. The manufacturer subsequently stated that these were machining marks, where a flat surface was machined during manufacture to accommodate the washers used in the assembly of the pivot bolt. The inspection also indicated that cracks were present in the weld on both sides (Figure 15).

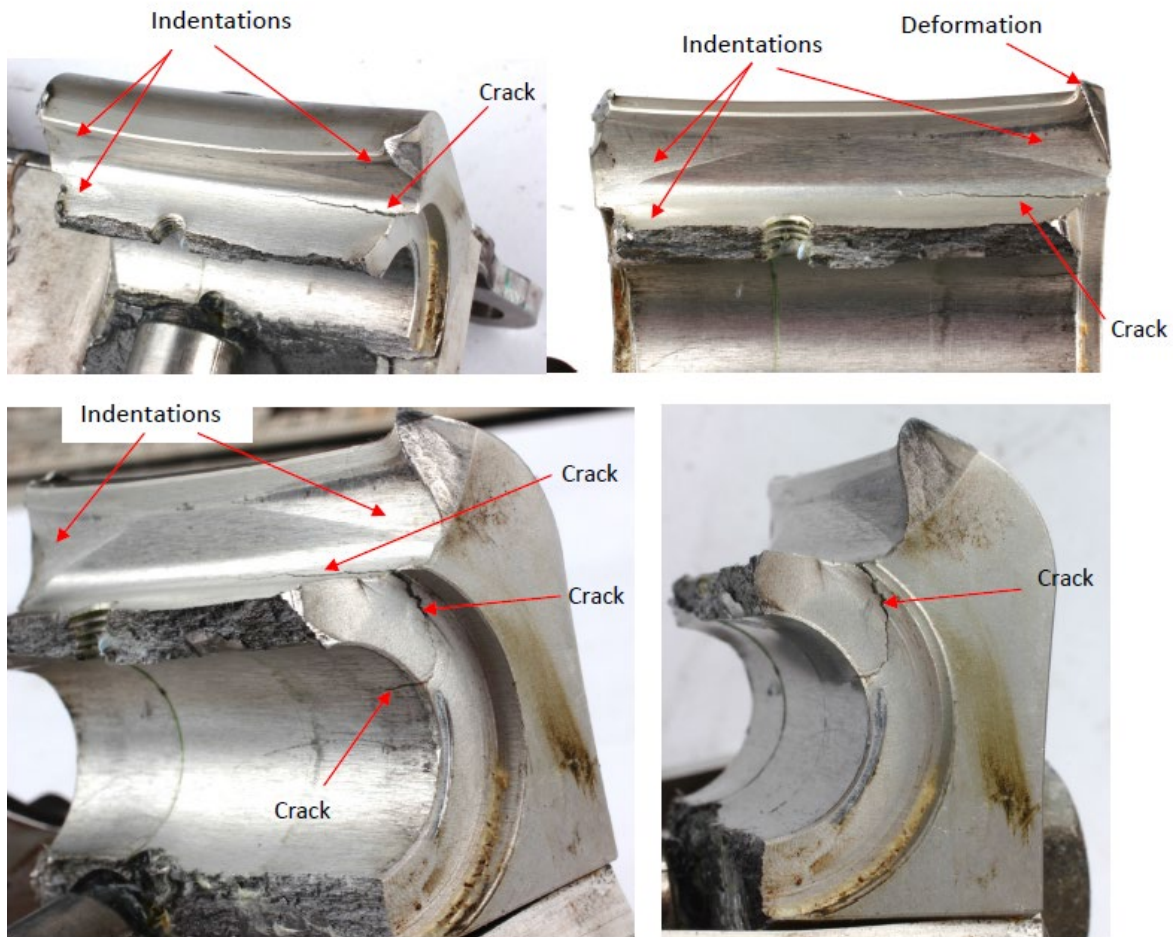
Figure 16

The rotor bridge, gimbal block and mast were removed from the wreckage and sent for metallurgical analysis. Detailed inspection of the gimbal block showed evidence of additional cracks at one end of the block. There was also a curved indentation in the side wall at each end of the channel that acted as a roll stop (Figure 16). The extent of the missing material is shown in Figure 17.

Additional cracks and deformation of the gimbal block

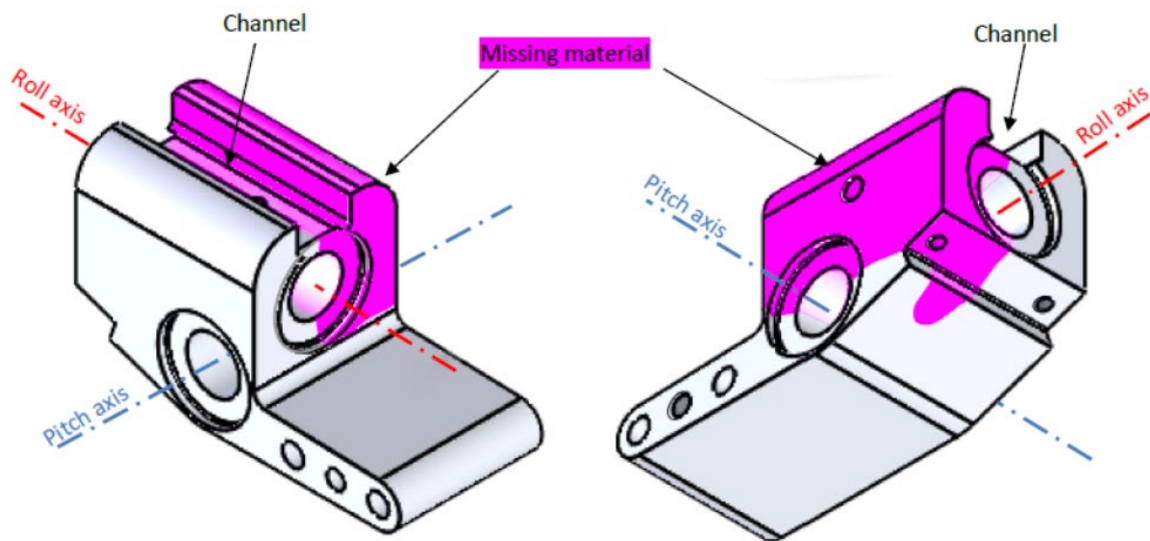
Figure 17

Extent of missing material from the gimbal block
(shown inverted relative to its installed orientation)

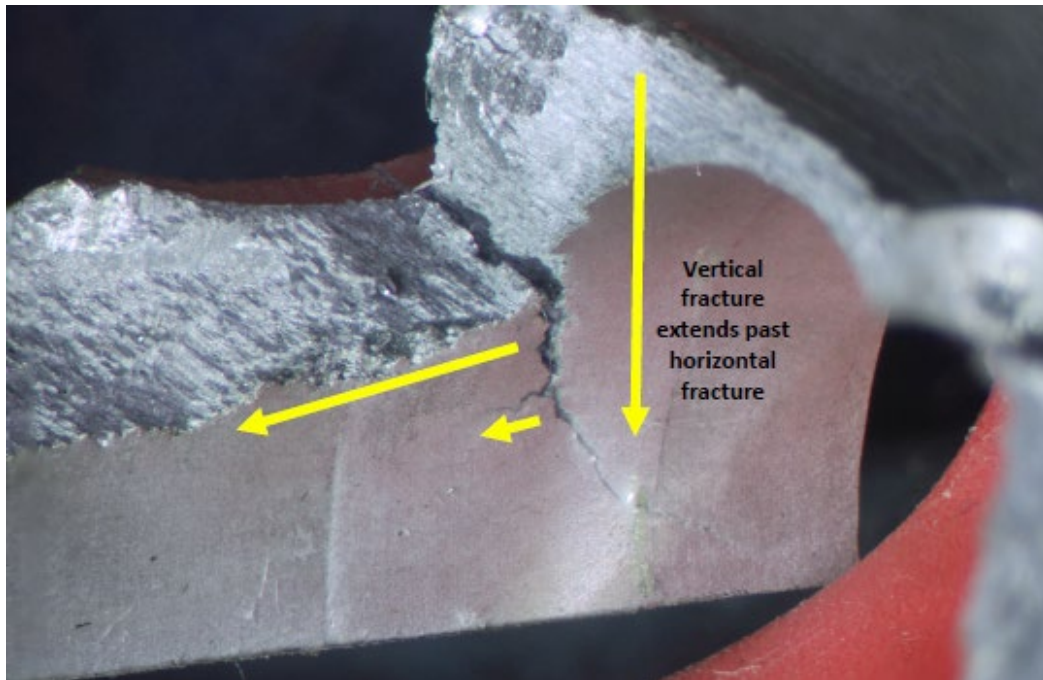
Figure 18

Visual analysis of the fracture surfaces showed that the vertical fracture was the primary crack as it extended past the point where it was joined by the horizontal fracture surface (Figure 18). Inspection using a Scanning Electron Microscope (SEM) confirmed that all the fracture surfaces were the result of a single continuous overload, with no evidence of fatigue present. Analysis of the failed flight control attachments confirmed they had also failed in overload.

Image showing the vertical fracture surface extending past the horizontal fracture

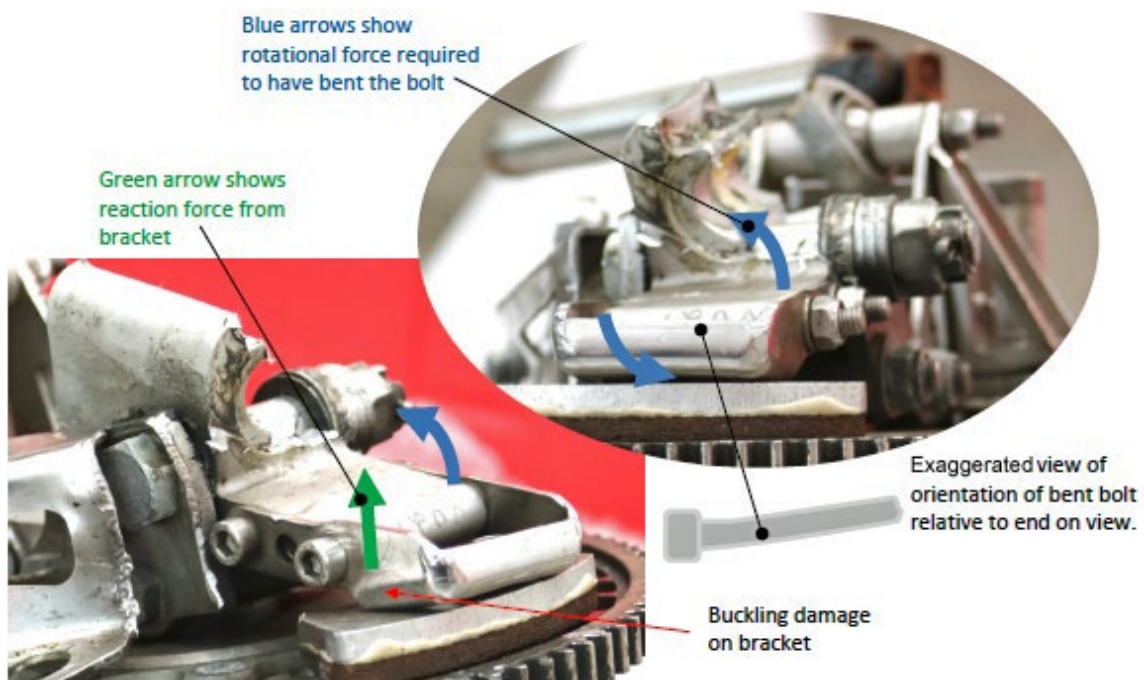
Figure 19

The side plates which attached the gimbal block to the rotor bridge on both sides were significantly distorted and the bolt holes were elongated. The bolts and bracket attaching the front brake pad assembly to the gimbal block were also distorted, indicating a rotational force on the gimbal block (Figure 19).

Images of the distorted brake pad bracket and bolts indicating a rotational force

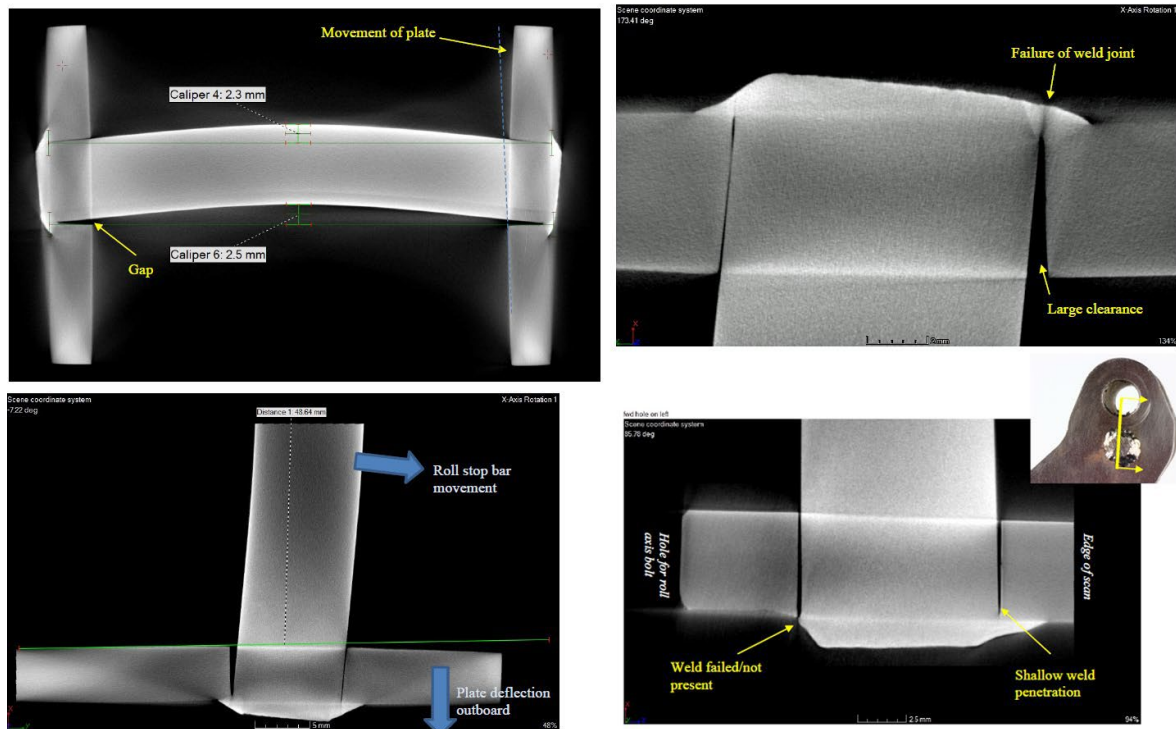
Figure 20

A CT¹¹ scan was carried out on the mast, which confirmed the extent of the roll stop bar distortion and the distortion from vertical of the side plates which supported the bar and the roll pivot bolt. The orientation of the bend in the bar was consistent with the indent marks on the gimbal block. It also showed that the end welds fixing the roll stop bar in the side plates were surface welds on the exterior of the plates, with very little penetration into the plate material. The welds on both sides of the plate had failed or on one side the weld may not have extended across the hole in the plate originally (Figure 20).

CT scan showing the distortion of the bar and side plates, the shallow weld size and weld failure on both sides

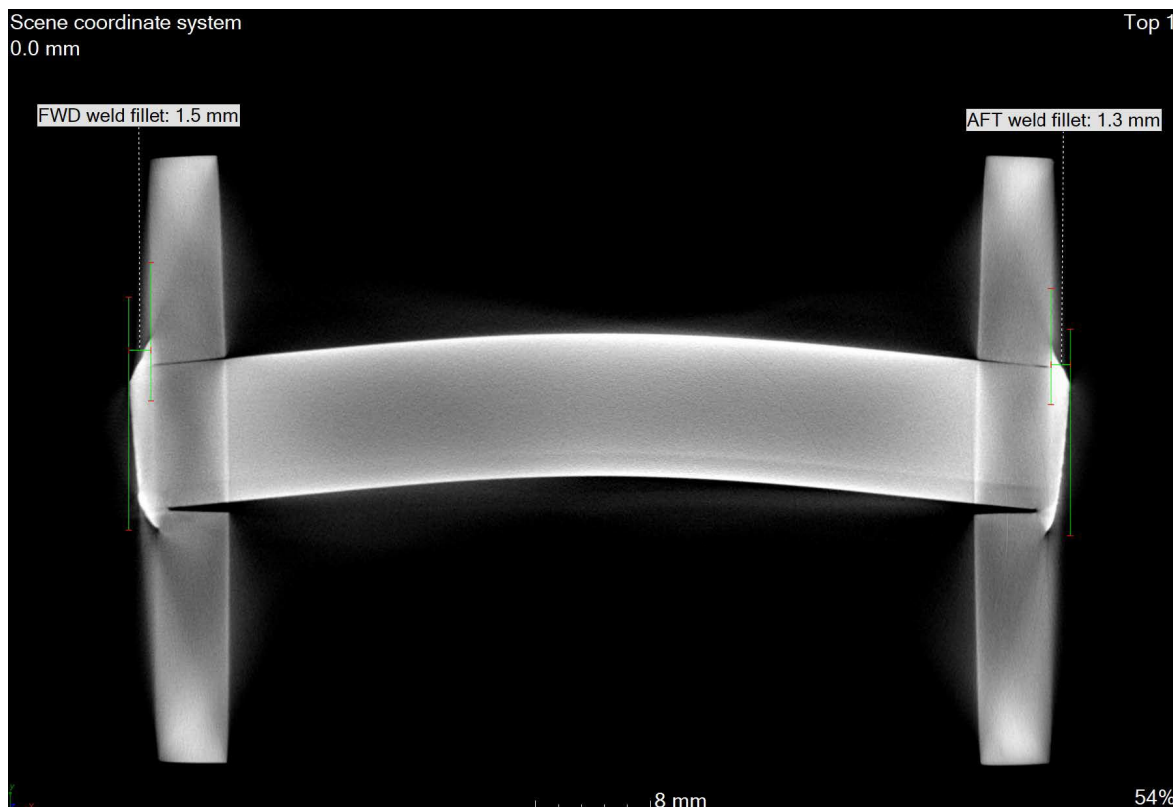
Figure 21

CT scan measurement of roll stop bar extension beyond the mast side plates

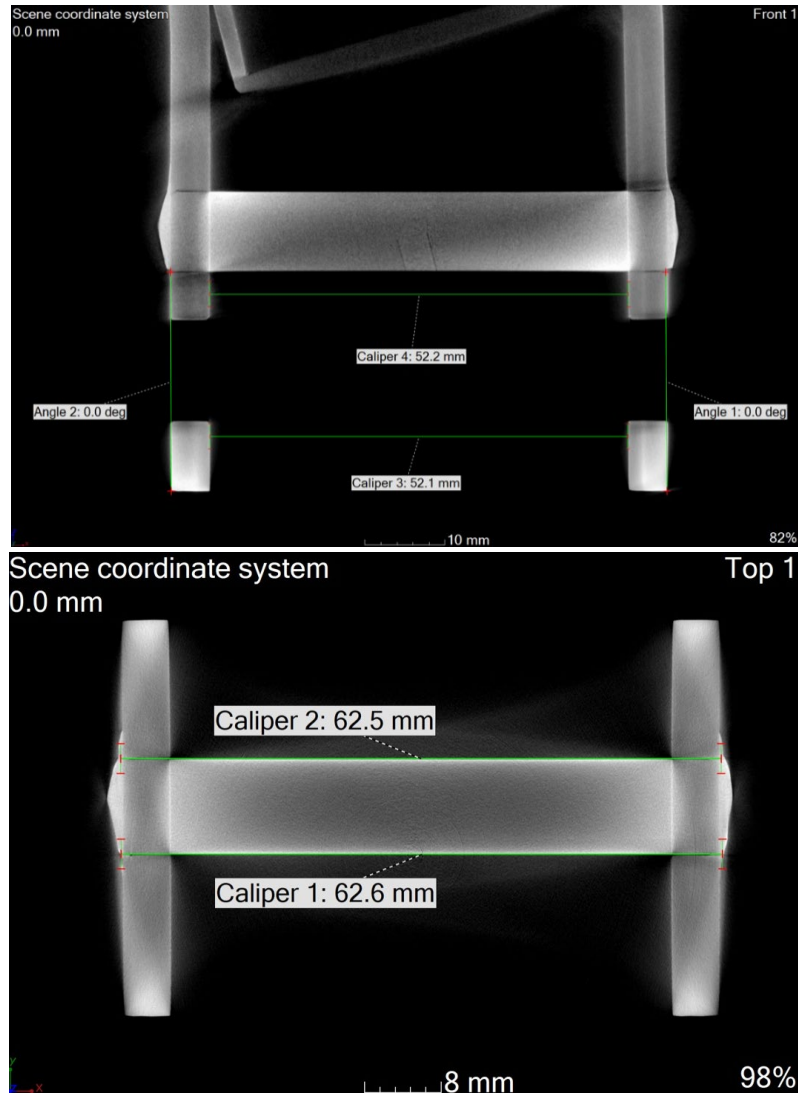
In order to assess the geometry of the mast interface found on G-CKYT, a new production mast was purchased directly from the manufacturer for comparison. This mast had not been used in operation. It was CT scanned to determine the interface dimensions and weld penetration on the roll stop bar. Figure 25 shows that the internal distance between the side plates is 52.2 mm, which was within the drawing tolerance. It also confirmed that the side plates were flat and aligned at 90° to the roll stop bar, which was straight, but the bar measured 62.5 mm, rather than the specified 65 mm.

CT scan of new production mast top

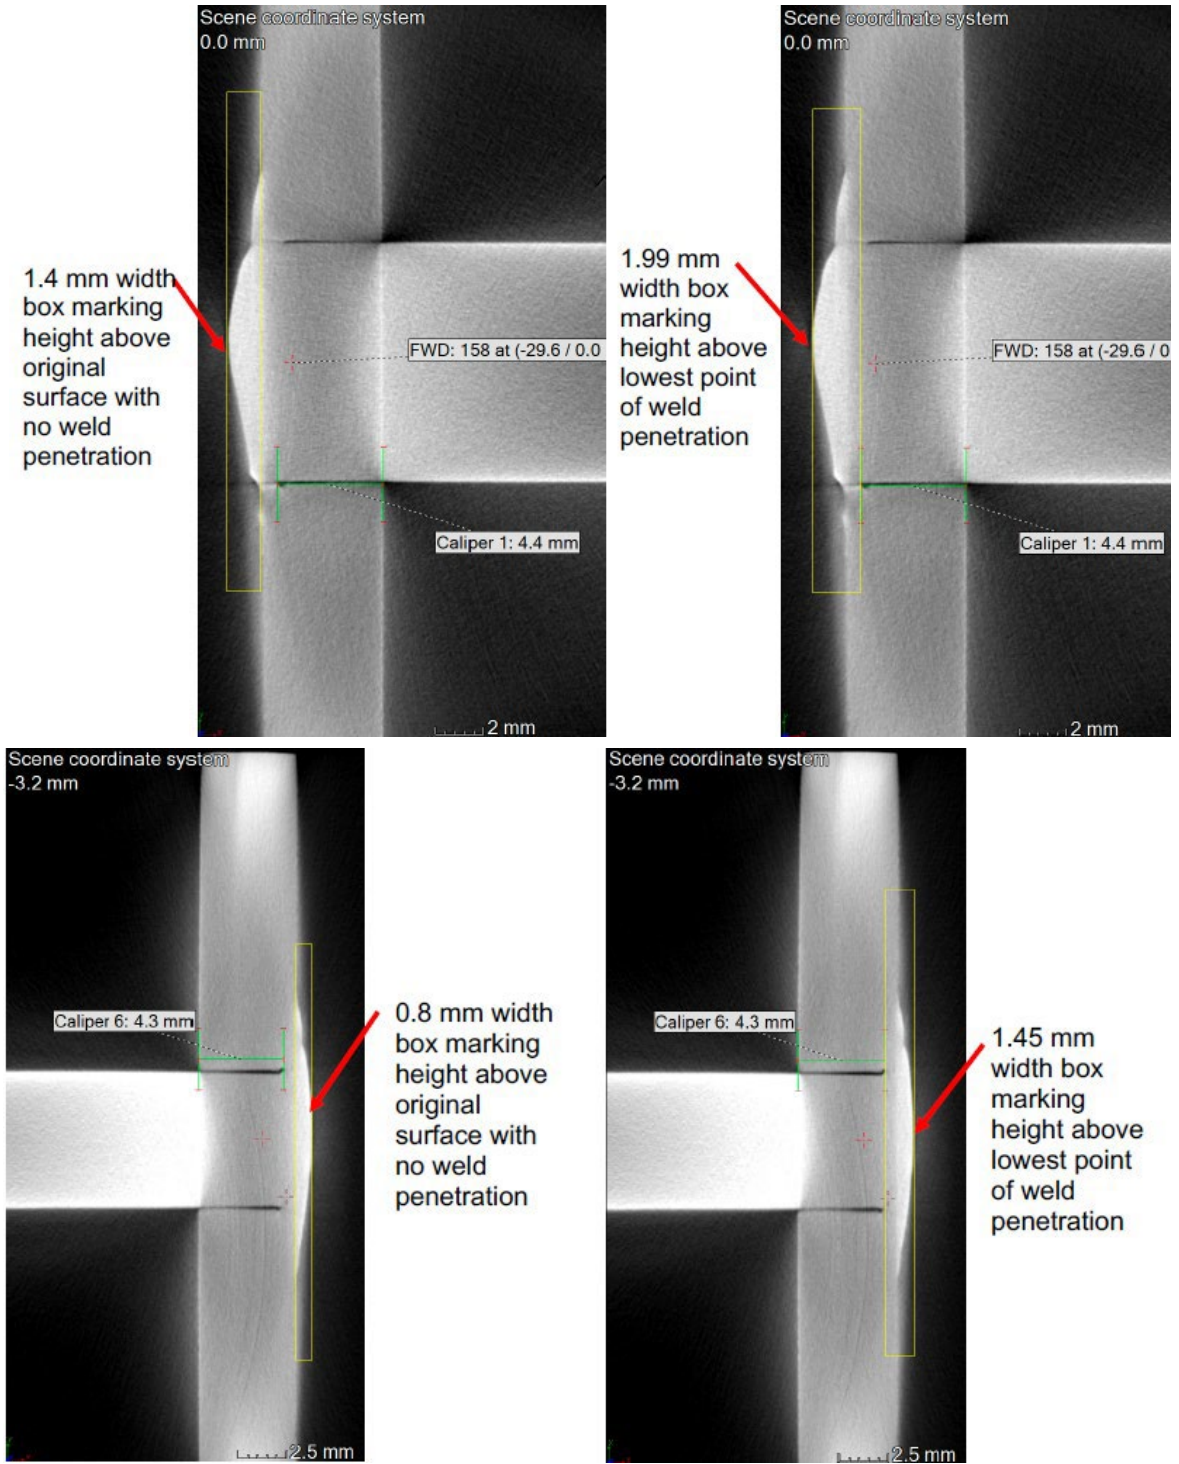
Figure 26

Measurements taken from the scan showed that the roll stop bar at its highest points extended beyond the external face of the side plates by 1.4 mm on the aft side and 0.8 mm on the forward side, although the measurement dropped significantly away from the peak. The weld depth at its deepest penetration was 1.99 mm and 1.45 mm respectively on each side, but this also varied significantly across its diameter (Figure 26).

CT scan of new production mast top showing the roll stop bar weld (aft side - top images, forward side - bottom images)

According to the design drawing dimensions, for a nominal plate width of 5 mm, the roll stop bar should extend between 1.5 mm and 1.25 mm, depending on manufacturing tolerances.

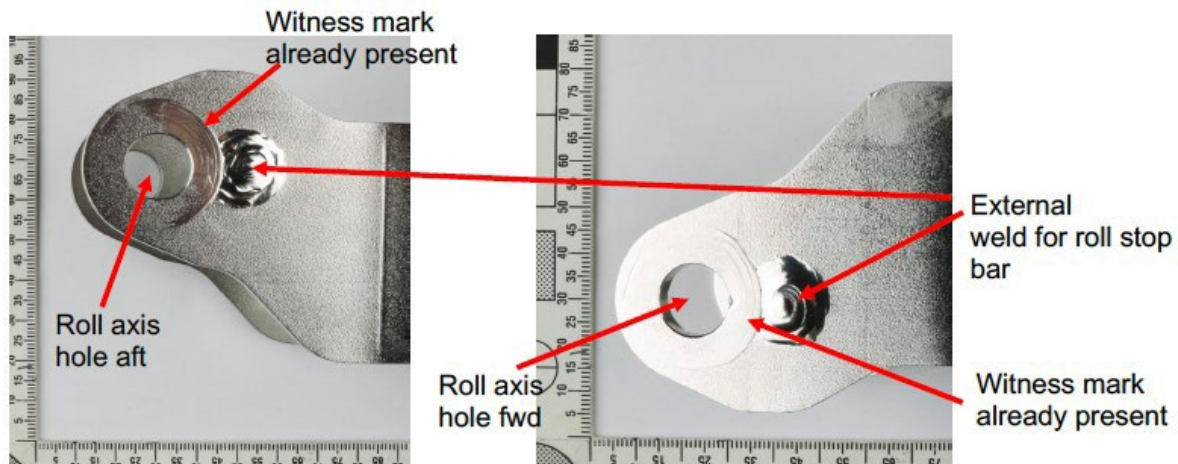
Figure 27

The mast arrived with an existing witness mark on the side plates. The manufacturer confirmed that these were machine marks, where the faces and weld had been machined flat during manufacture to accommodate the washers fitted during assembly of the roll pivot bolt. (Figure 27).

As received part showing damage to weld

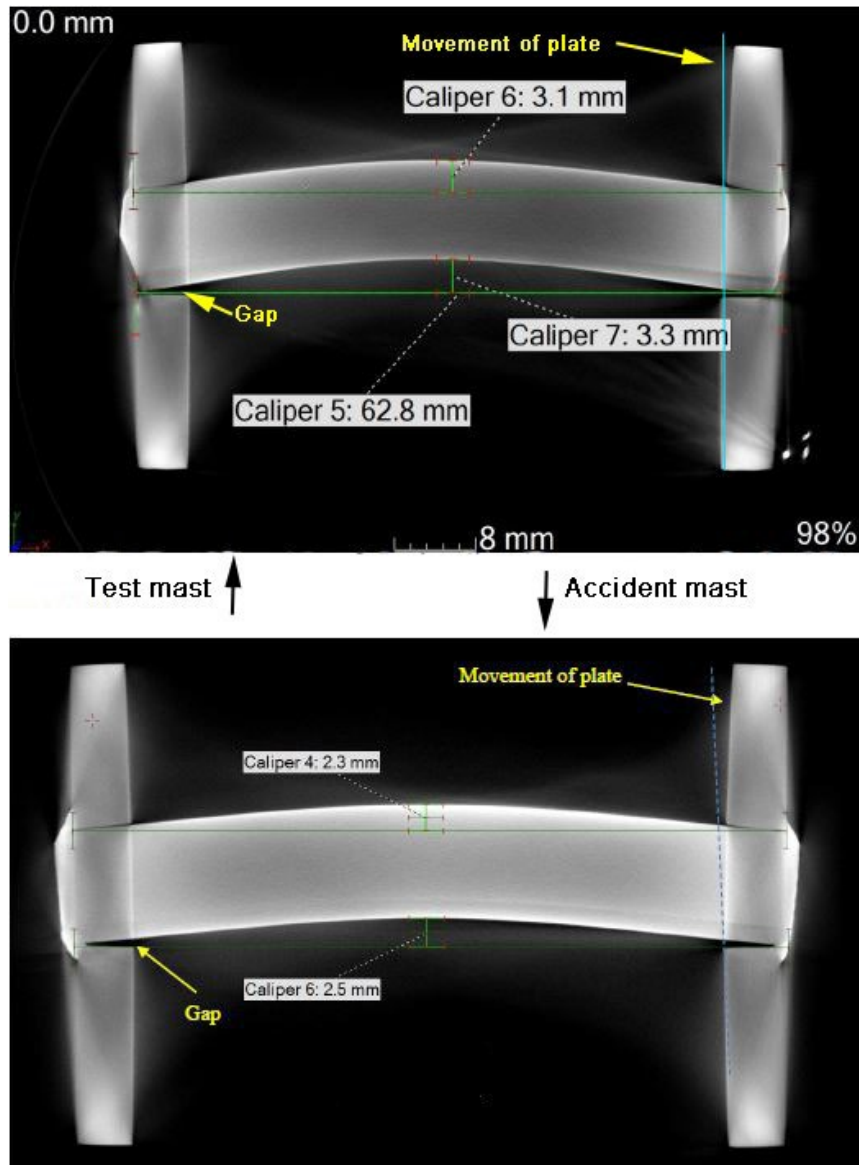
Figure 31

CT scans of the mast following the test confirmed that the bar had deformed slightly more than the accident mast, with the displacement from straight at the centre measuring 3.3 mm compared to 2.5 mm on the accident mast. The side plates were deformed outwards similar to the accident mast and the roll stop bar welds had failed on both sides, producing the same large gaps between the bar and the plate locating hole on the concave side of the bar (Figure 31).

Plastic deformation of the roll stop bar post-test (top)
compared with the accident mast (bottom)

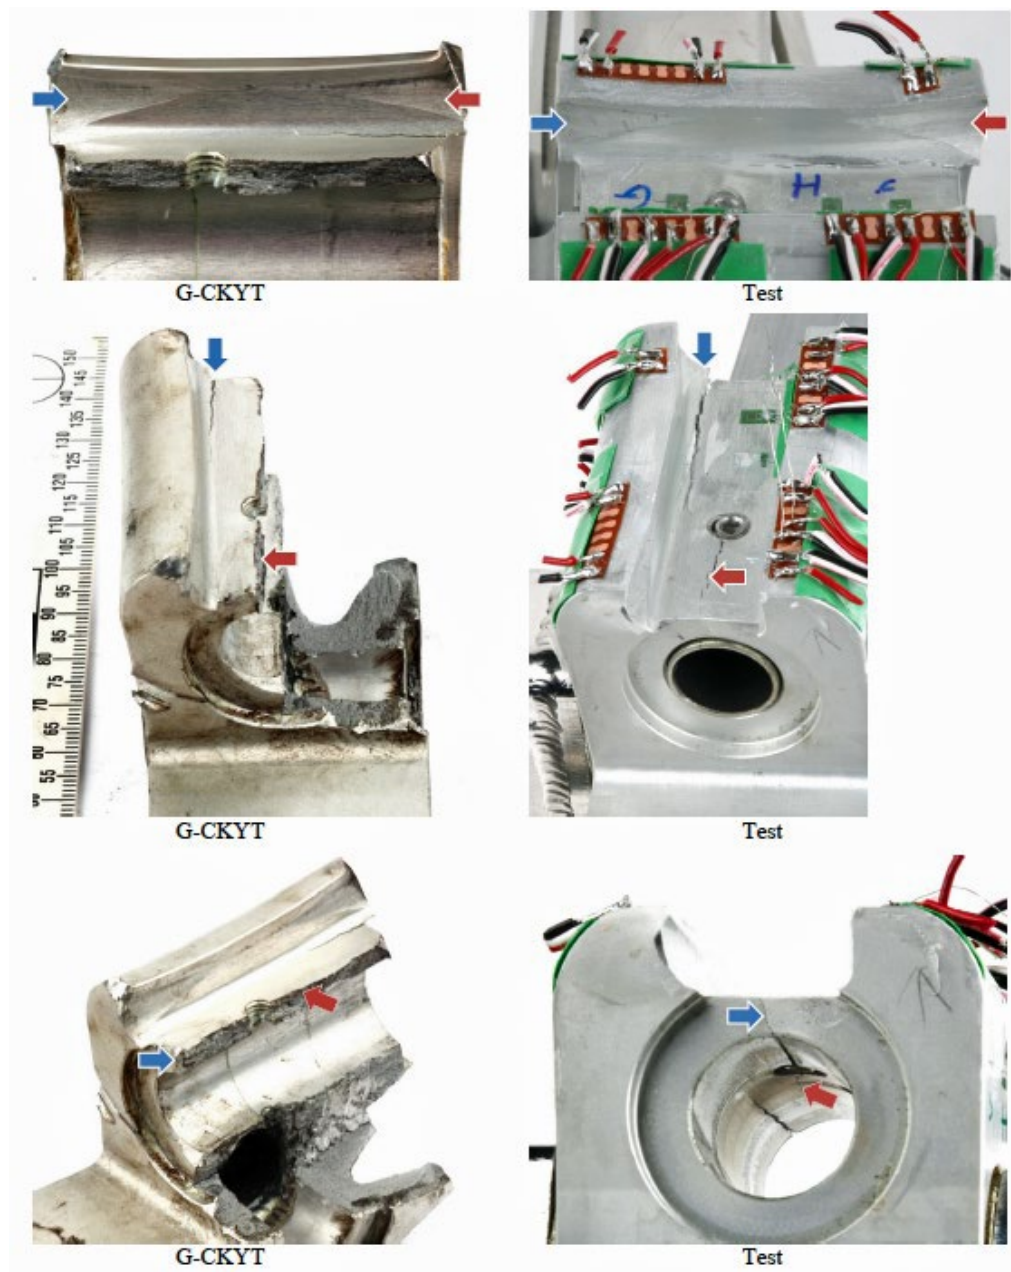
The gimbal block had also failed in a similar manner to the accident block, though as the force applied was only in the horizontal plane, only the vertical cracks were present. However, they were located in the same positions and had progressed to similar extents. Figure 32 shows this by highlighting the same cracks with the same-coloured arrows. It also shows the identical indentation marks and distortion left on the side of the channel by the roll stop bar.

Cracks in the gimbal block post-test compared to the same cracks seen on the accident gimbal block
