Contact between a moving train and an occupied pram at Banbury station, 8 June 2024

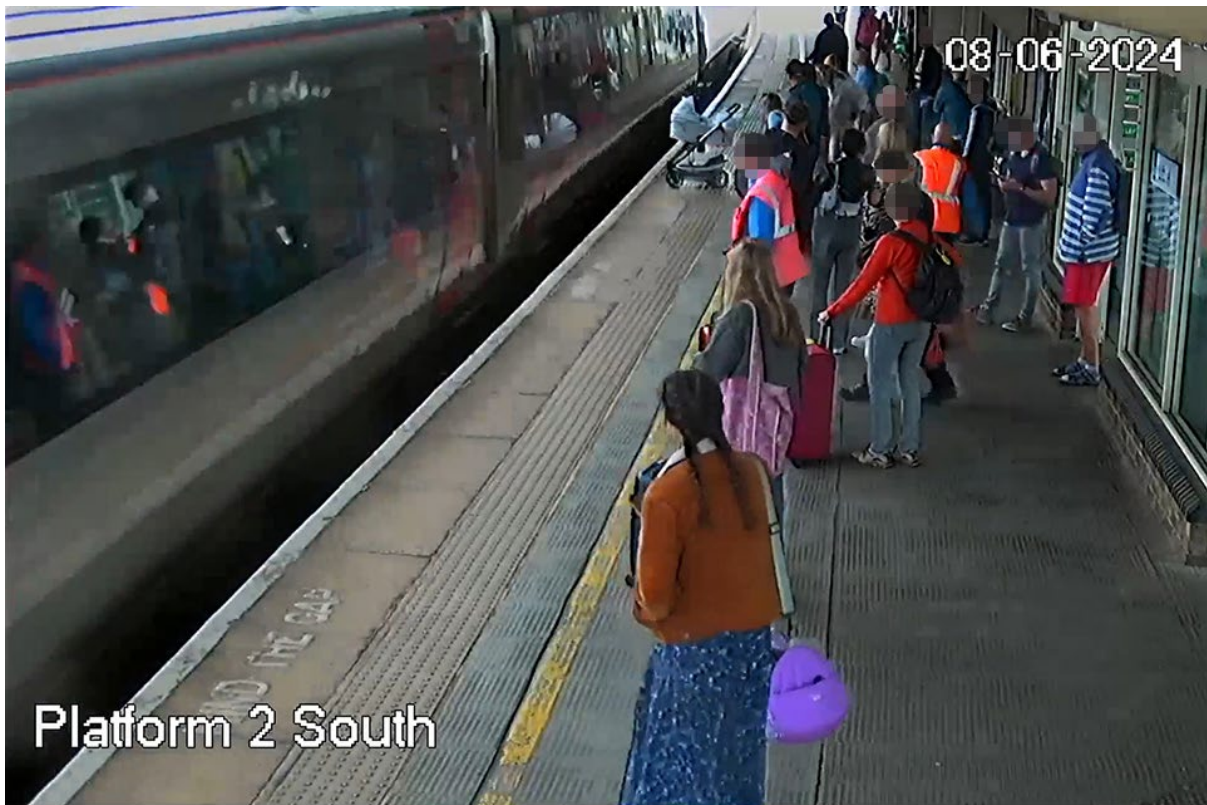
CCTV footage from Banbury station showing the pram and train moments before the accident occurred (courtesy of Chiltern Railways).

The accident occurred because the pram, which had been momentarily released by the infant's parent, rolled along the platform slope, which sloped towards the platform edge at that location.

Around 15 seconds before the accident, the infant's parent started to move the pram closer to the platform edge, intending to board the train. The pram was moved perpendicular to the platform edge and, around 10 seconds before the accident, its front wheels were touching the yellow line with the parent holding the pram's handle with both hands. The infant's parent then leant away from the pram to place one hand on their wheeled luggage and turned to face their relative, momentarily letting go of the pram. Around 6 seconds before the accident, with the parent still facing away from the pram, it began to move towards the platform edge. Around 3 seconds before the accident, the front of the train passed the position where the pram was located, and the pram continued to roll towards the platform edge. Around 1 second before the accident, the relative tried to intervene but the pram contacted the train's bodyside.

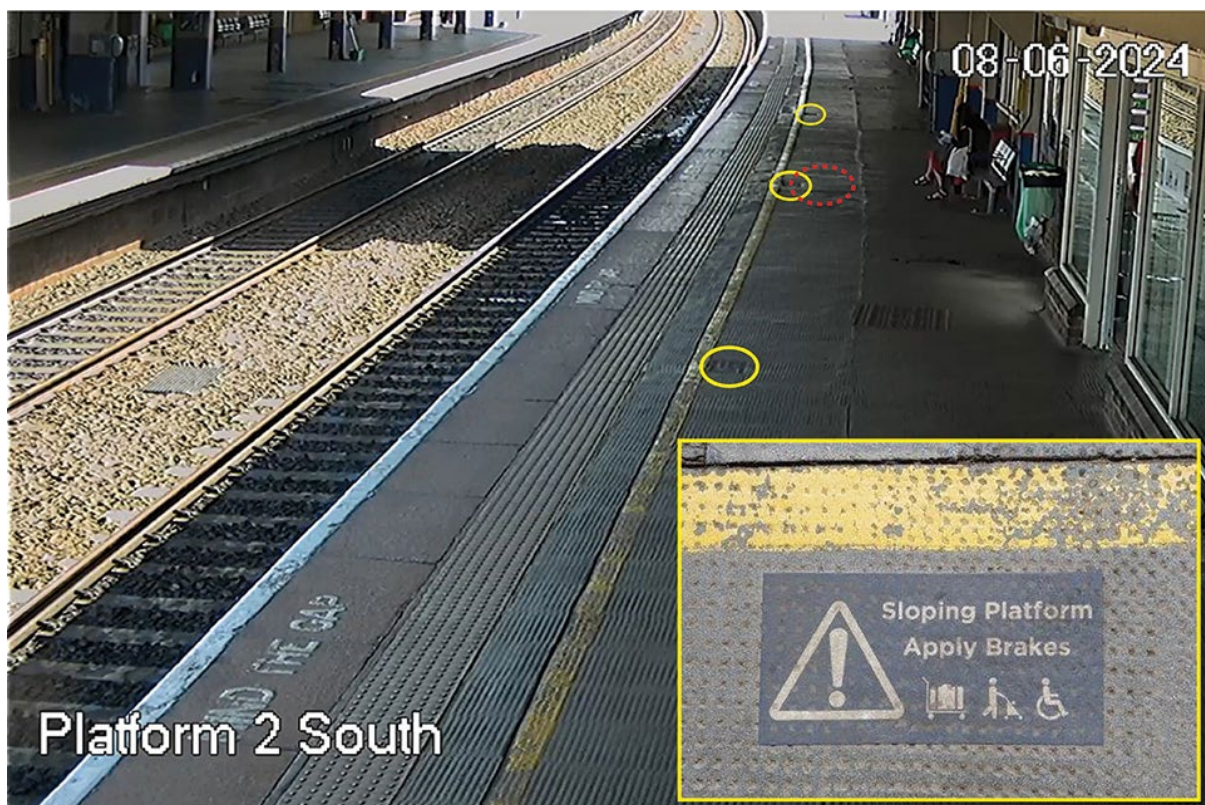
CCTV footage showing the locations of the signs on platform 2 (yellow ellipses) near where the accident occurred. The red dashed ellipse shows the approximate position of the pram 15 seconds before the accident. Inset image shows an example of the signage present (courtesy of Chiltern Railways).

The location where the accident occurred had warning signage on the platform surface, in dark blue and white colour, stating 'Sloping Platform Apply Brakes'. However, the design of the signage was less likely to alert pram users to the hazard, as it did not comply with the general design language (and associated regulations) that are used to convey safety related information. The Health and Safety Executive document '*The Health and Safety (Safety Signs and Signals) Regulations 1996: Guidance on Regulations*', edition 3 dated 2015, outlines that red and yellow colours are used to convey a meaning of warning or danger. The colours that were used would have reduced the conspicuity of the signage against the dark grey colour of the platform surface. It is also possible that the pram or the presence of other passengers on the platform partially or wholly obscured this less conspicuous signage before the accident.

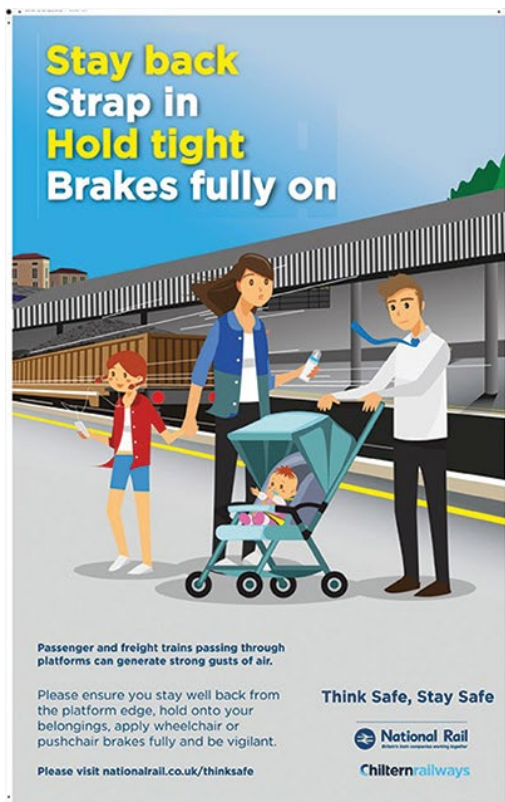
Following the accident, Chiltern Railways installed signage in the customer lifts at Banbury station in addition to reviewing the signage on the platform surface. The signage installed in the lifts draws the attention of passengers to aerodynamic risk from passing trains to passengers on the platform but does not highlight the risk from platform crossfall slopes. Despite this, the instructions provided to passengers in this signage include appropriate actions to help prevent similar accidents (to the one that occurred at Banbury station) from reoccurring.

Sign installed by Chiltern Railways in the customer lifts at Banbury station following the accident (courtesy of Chiltern Railways).
