## SAFETY FLYER TO THE FISHING INDUSTRY

### Grounding and subsequent loss of the stern trawler *Ocean Maid* (BA 55) on Cairnbulg Point, Aberdeenshire, Scotland on 24 October 2022

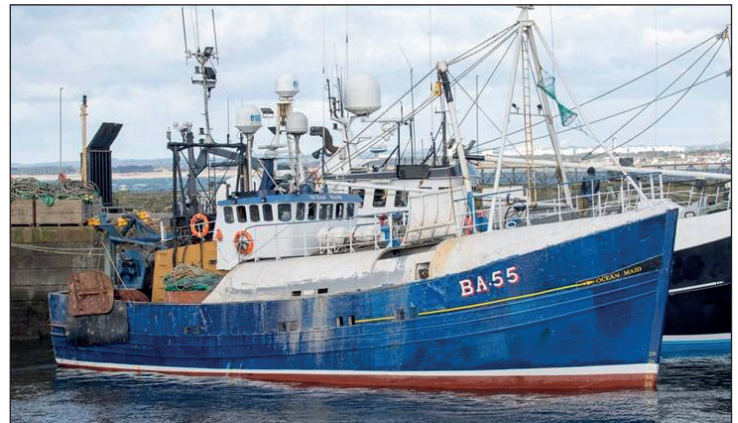
On 24 October 2022, during the early morning and in poor visibility, the stern trawler *Ocean Maid* grounded on Cairnbulg Point near the port of Fraserburgh, Scotland. The vessel later broke up and sank.

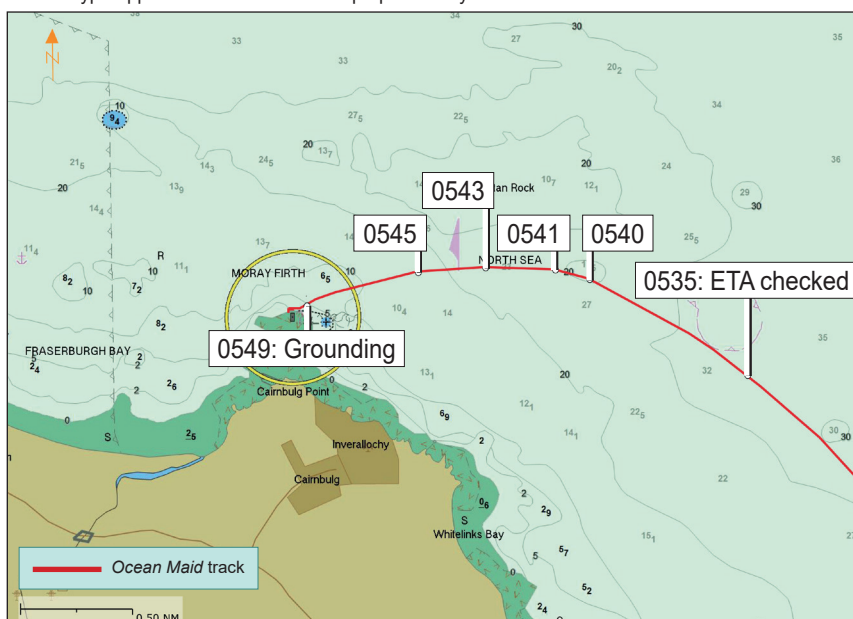
**Figure:** Chart showing the four course alterations leading up to the grounding

*Ocean Maid* was on passage from Eyemouth to Fraserburgh for pre-arranged maintenance and was being navigated by a lone watchkeeper. The navigation equipment in the wheelhouse included three chart plotter displays, one of which the watchkeeper used to navigate by following the past tracks displayed on it and cross-checking these with external visual indicators to judge the vessel's position. In the final few minutes before the grounding the watchkeeper left the wheelhouse at least twice to make tea for the crew, which was a normal task on the vessel's approach into port. Between these visits to the galley, the watchkeeper made several course adjustments that gradually moved *Ocean Maid* towards Cairnbulg Point (see **figure**). The watchkeeper was absent from the wheelhouse at the time of grounding.

2. *Ocean Maid's* watchkeeper had been trained to follow past tracks displayed on a chart plotter, resulting in a reactive and unplanned approach to navigating coastal waters in poor visibility. The Maritime and Coastguard Agency (MCA) require fishing vessels to follow the guidance in Maritime Guidance Note 313 (F), Keeping a Safe Navigational Watch on Fishing Vessels, which outlines that a passage plan includes a plotted course on appropriate scaled charts and that areas of danger should be highlighted.
