Grounding and subsequent loss of the fishing vessel *Ocean Maid* (BA 55) on Cairnbulg Point, Aberdeenshire, Scotland on 24 October 2022

SUMMARY

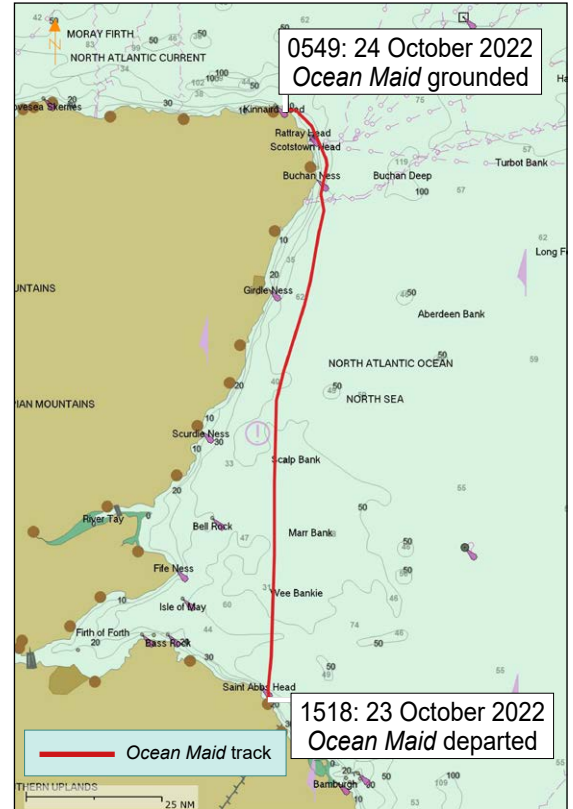
Figure 1: *Ocean Maid*'s route before it grounded near Fraserburgh

At 1518 on 23 October 2022, the fishing vessel *Ocean Maid* left Eyemouth, Berwickshire, Scotland to make the overnight passage to a shipyard in Fraserburgh, Aberdeenshire, Scotland for planned vessel maintenance and minor repairs (**Figure 1**). On board were the skipper/co-owner (the skipper), the skipper's father, who co-owned the vessel (the co-owner) and two crew members – a watchkeeper and deckhand. The visibility was poor and, as it was dark and foggy, the co-owner took the first navigational watch alone in the wheelhouse. Once clear of Eyemouth Harbour, the skipper and crew watched television in the accommodation area two decks below the wheelhouse until 2100, after which the watchkeeper and deckhand went to their bunks to rest.

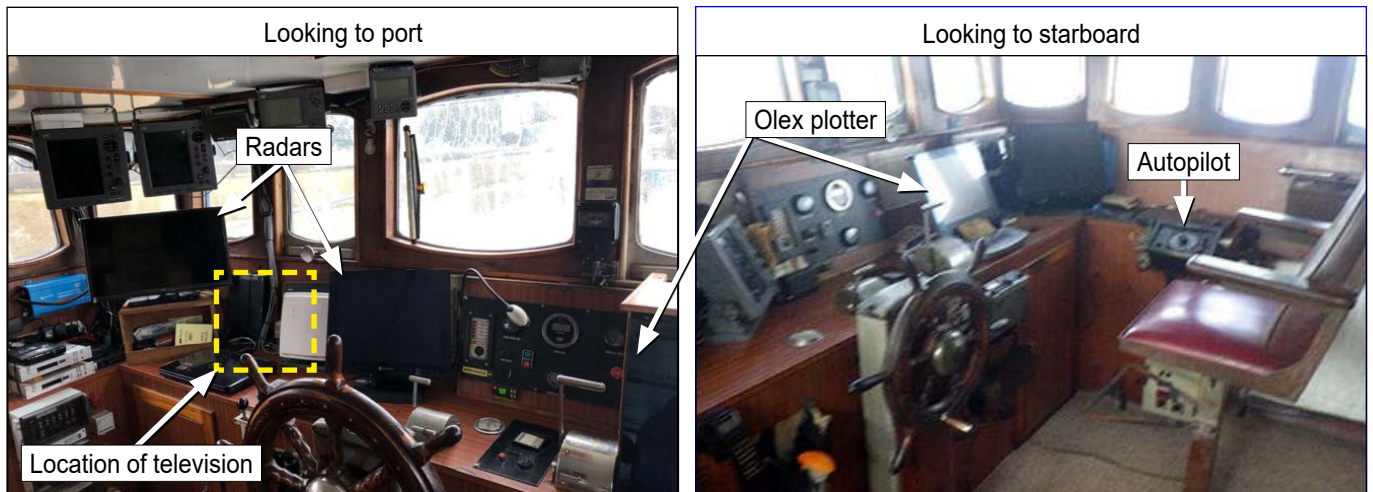
Figure 2: Wheelhouse equipment

The navigation equipment in the wheelhouse included one Sodena chart plotter, two Olex chart plotters, two radars (one was broken at the time of the accident) and one Navitron watch alarm connected to the autopilot. The instruments in operation were set to night mode during the transit to Fraserburgh. It was reported that the watch alarm had a 3-minute dormant period, after which a pre-alarm buzzer warning would sound in the wheelhouse. If not reset within 30 seconds, an alarm would then sound in the galley and accommodation. The reset button could be reached from the wheelhouse chair. The wheelhouse was also equipped with a television. At the time of the accident this was tuned to a music channel. No issues were raised during certification with respect to wheelhouse visibility.

The watchkeeper's two trips to the illuminated galley immediately before the grounding would have impaired their diminished night vision, if not removed it altogether. *Ocean Maid's* wheelhouse television would have emitted light that affected the watchkeepers night vision as it did not have a night mode and was tuned to a music channel. The worsening visibility caused by the weather conditions combined with light exposure in the galley and the light levels due to the television would have impaired the watchkeeper's ability to identify anything but the nearest and most obvious lights and objects, and could explain why they did not clearly recognise the Cairnbulg Briggs beacon. MGN 313 (F) identified television sets and other domestic media devices as a source of distraction for watchkeepers and required these to be placed in the accommodation.

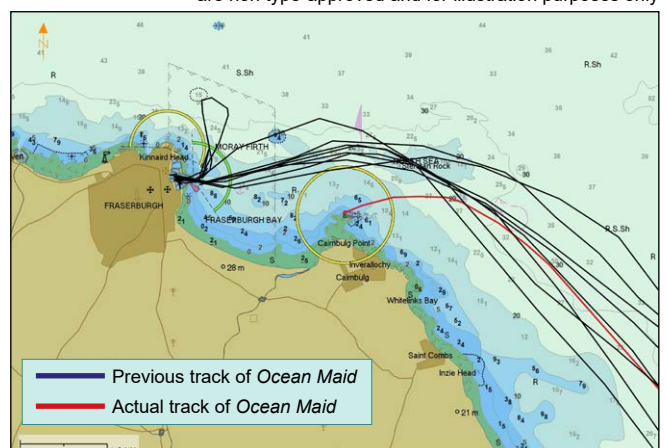
Figure 7: Summary of *Ocean Maid's* available AIS past tracks in the year leading up to the accident

Analysis of *Ocean Maid's* AIS track showed a series of small deliberate alterations to indicate when the watchkeeper was in the wheelhouse. The watchkeeper believed they were following the correct route into Fraserburgh Harbour and did not realise that their actions were beginning to turn *Ocean Maid* towards Cairnbulg Point when they started the series of small alterations from 0540 (see **Figure 2**). The reasons why the watchkeeper turned the vessel too early (see **Figure 7**), mimicking the previous tracks (see **Figure 7**) taken in previous passages to Fraserburgh, could not be

determined during the investigation due to the watchkeeper's recall of events. It is likely the watchkeeper was relying on external visual indicators rather than the electronic chart plotter to determine the vessel's position.

With no formal passage plan, the hazards to navigation were not identified and led to the watchkeeper's navigation being reactive and unplanned, increasing the risk of disorientation and the likelihood of grounding.
