SAFETY FLYER TO THE FISHING INDUSTRY

Fatal fall overboard from the fishing vessel *Eder Sands* (UL 257) approximately 150 nautical miles west of Ireland on 7 October 2022

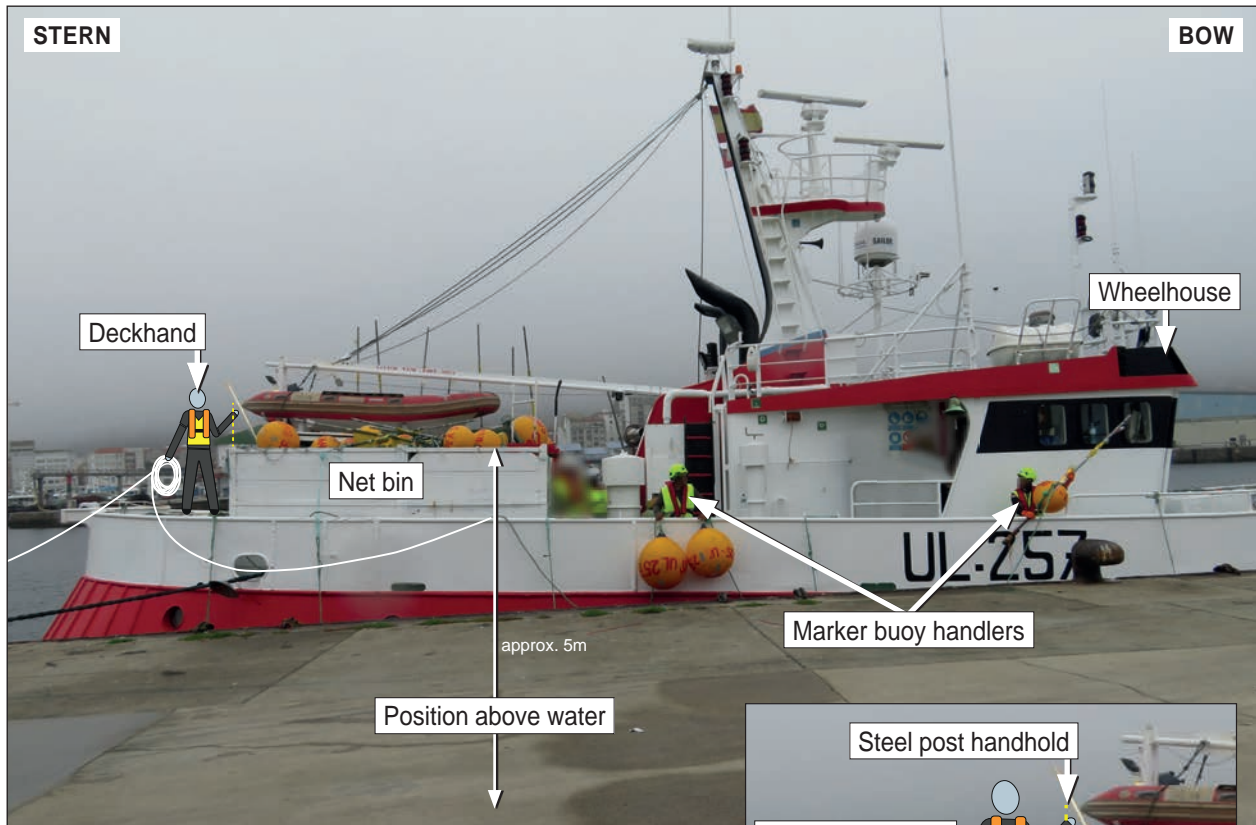
Reconstruction, showing the positions of the deckhands during the final phase of shooting the net

The onboard procedure for shooting the final part of the fishing gear required three deckhands, one standing close to the vessel's stern and the other two tending the net marker buoys next to the starboard wheelhouse door. All three deckhands were wearing foul weather dungarees, boots and an auto-inflate lifejacket. The deckhand at the stern was standing on the lid of a storage locker that aligned with the top of the bulwarks; he was holding on to a bight of the buoy line and might have been holding on to a steel post, which was subsequently found to have sheared off.

As the last of the net was about to be laid, the deckhand at the stern shouted to stop the vessel and call the bosun. The deckhand at the stern was seen to fall overboard 30 seconds later.

1. The procedure for shooting nets must be included in a fishing vessel's safety management system and properly risk assessed. *Eder Sands'* crew had developed an informal routine that required one of them to stand on the lid of a storage locker close to the stern while holding a bight of buoy line. This process had not been appropriately risk assessed, resulting in no guard rails or safety harness to prevent the crew member falling overboard. Additionally, the crew were routinely handling the fishing gear when shooting the nets, putting themselves at risk of becoming entangled and dragged overboard by the gear.
