## Collision between the pair trawlers *Guiding Light* (H 90) and *Guiding Star* (H 360) resulting in the flooding and sinking of *Guiding Star* 33 nautical miles south-east of Fair Isle, Scotland on 6 October 2022

### SUMMARY

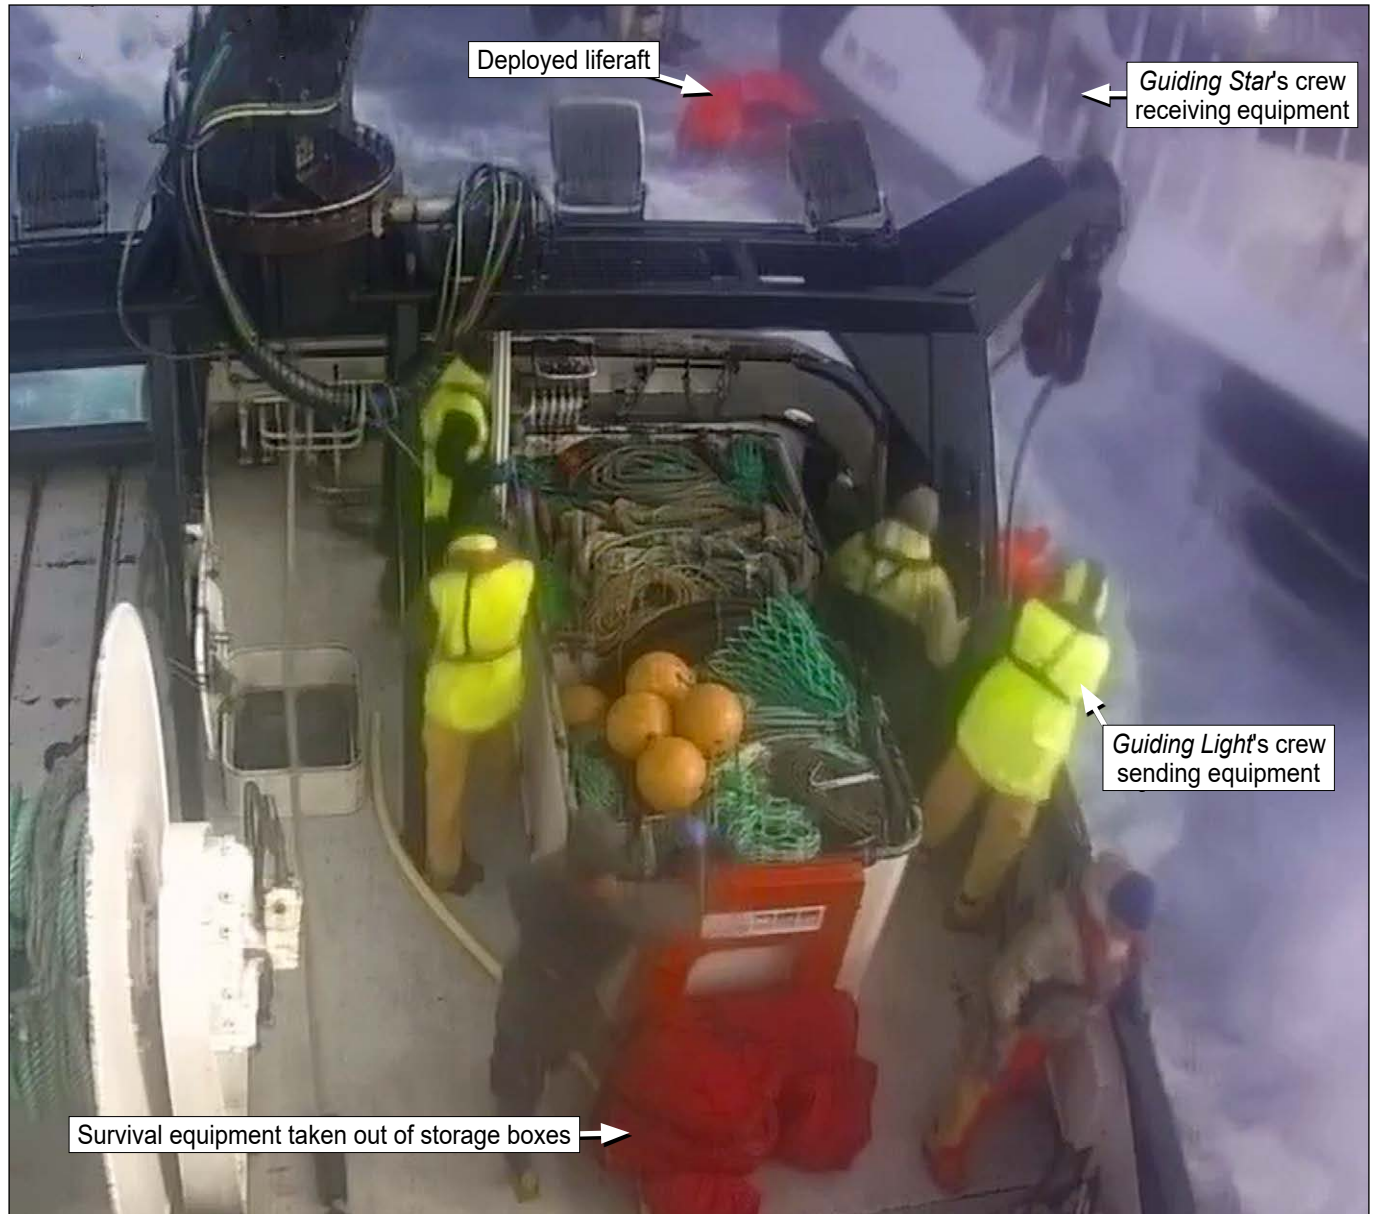
**Figure 1:** CCTV still, showing the transfer of survival equipment from *Guiding Light* to *Guiding Star*

upper deck. A heaving line was thrown across to *Guiding Star* and secured and the lifejackets were transferred at 1219, followed two minutes later by the immersion suits (**Figure 1**). *Guiding Star's* crew donned the gear as the quarterdeck became submerged. At 1234, with the vessel listed significantly to port, the crew jumped into the liferaft and cut the painter.

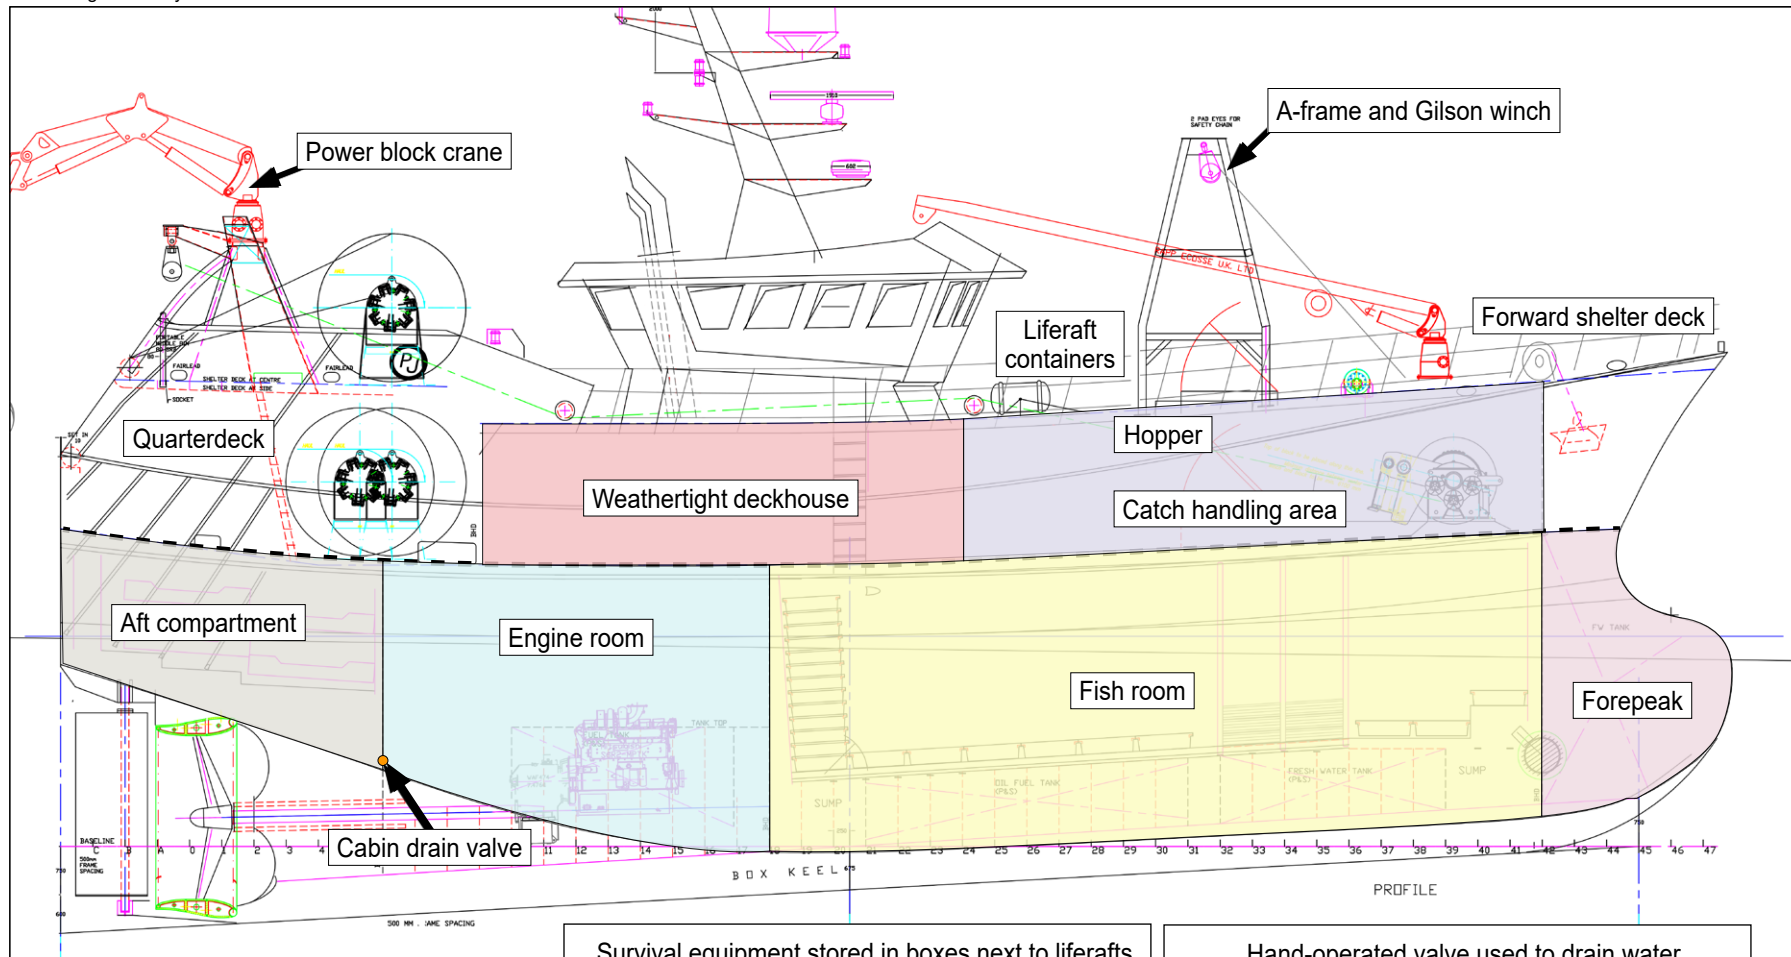
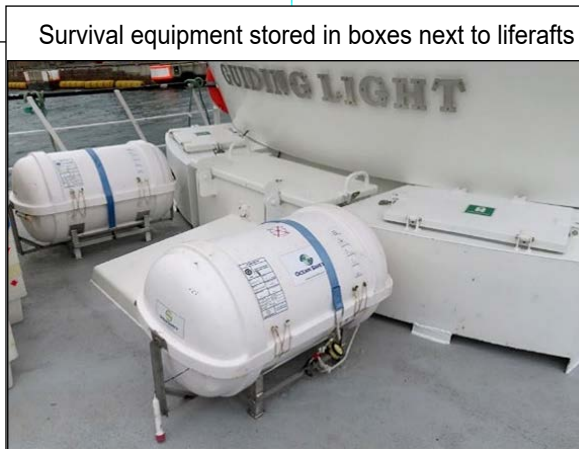
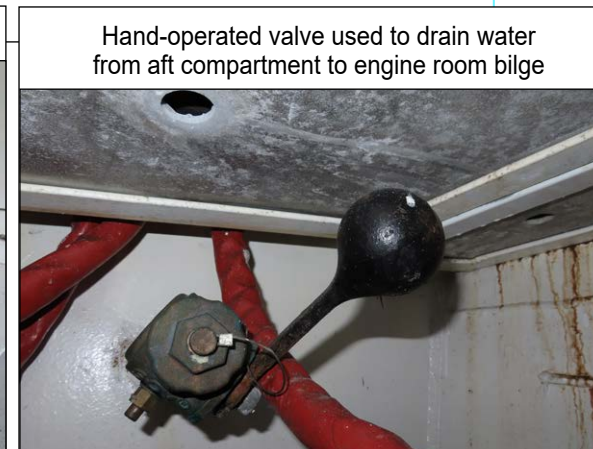
**Figure 3:** Vessel layout, showing watertight divisions and weathertight deckhouse and (insets) survival equipment and cabin drain valve

The engine room had three bilge pumps that provided suction for the engine and fish rooms. In line with Sea Fish Industry Authority (Seafish) Construction Standards<sup>4</sup> at the time of the vessels' builds there was no bilge suction inside the aft compartment. Instead, any accumulated water within the compartment could be drained into the engine room bilge through a 40mm diameter pipe fitted with a hand-operated valve<sup>5</sup> (**Figure 3**).

The lifejackets and immersion suits on board *Guiding Light* were stored in boxes next to the liferafts on the forward shelter deck (see **Figure 3**). The boxes had been custom-built following an MCA intermediate survey in October 2020, which recommended that the lifejackets be moved above the waterline. An MCA surveyor made a similar note during the intermediate survey of *Guiding Star* in December 2021, recommending *that life jackets are stowed above waterline at a designated space. It was found that the jackets were behind the clothes in crew cupboards in cabin and were not readily accessible* [sic]. This recommendation was not actioned, and the survival equipment remained in the same place at the time of the accident.

remained inside crew cabins. It is unfortunate that the vessels' manager did not intervene to ensure survival equipment locations were aligned across its vessels. It is fortunate that *Guiding Star's* crew were able to abandon ship with survival equipment due to the quick transfer of replacement gear from *Guiding Light*. Proper consideration must be given to the location of the survival equipment for timely use in an emergency.
