Report on the investigation of
a fall from height on the bulk carrier

Equinox Seas

resulting in one fatality

at ONEX Syros Shipyard, Ermoupoli, Syros, Greece

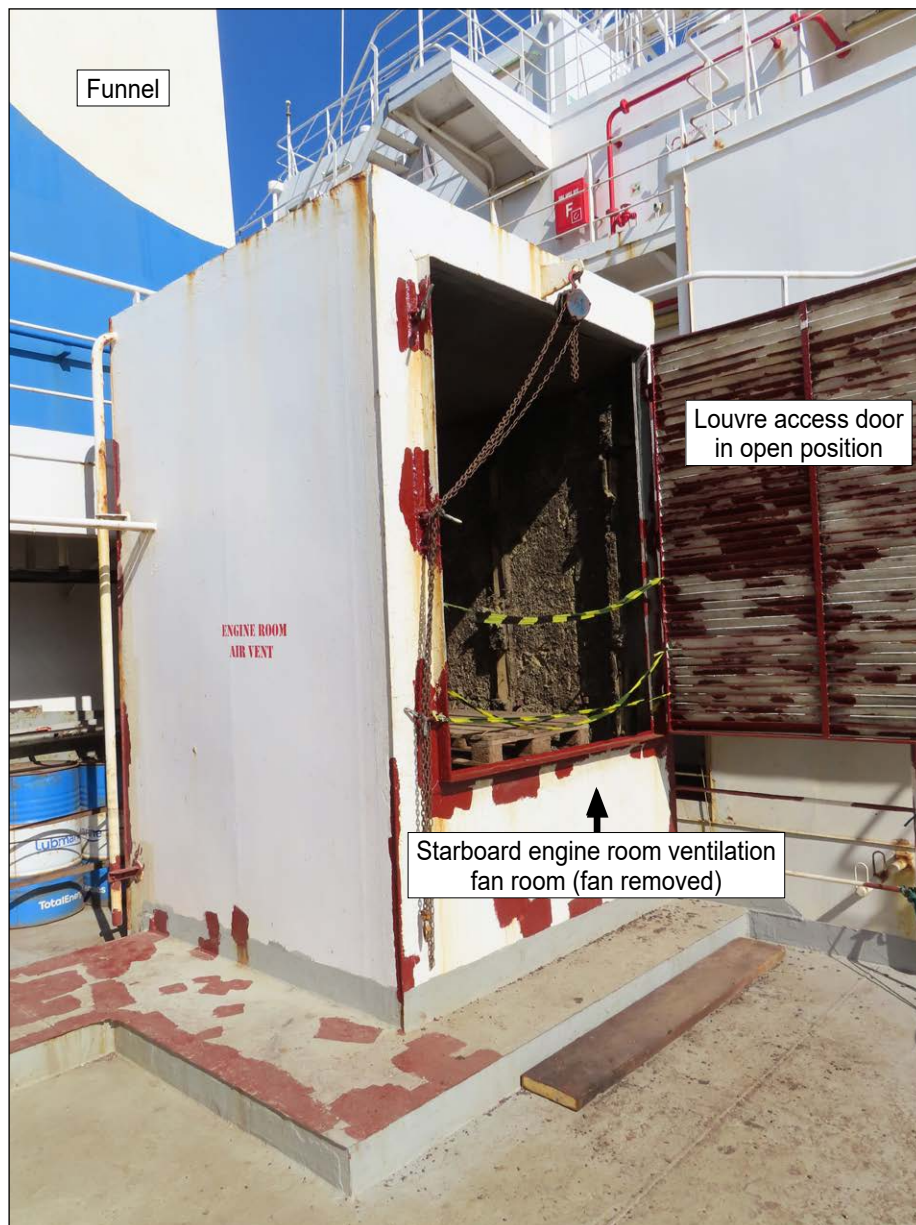
Figure 1: Access to the starboard engine room ventilation fan room

The fitter was fatally injured when he fell approximately 10m down the ventilation trunk leading from the starboard engine room fan to the plenum chamber at its base. To access the fan room the fitter passed hazard warning tape that shipyard staff had placed over the entrance to the fan room following removal of the fan for maintenance.

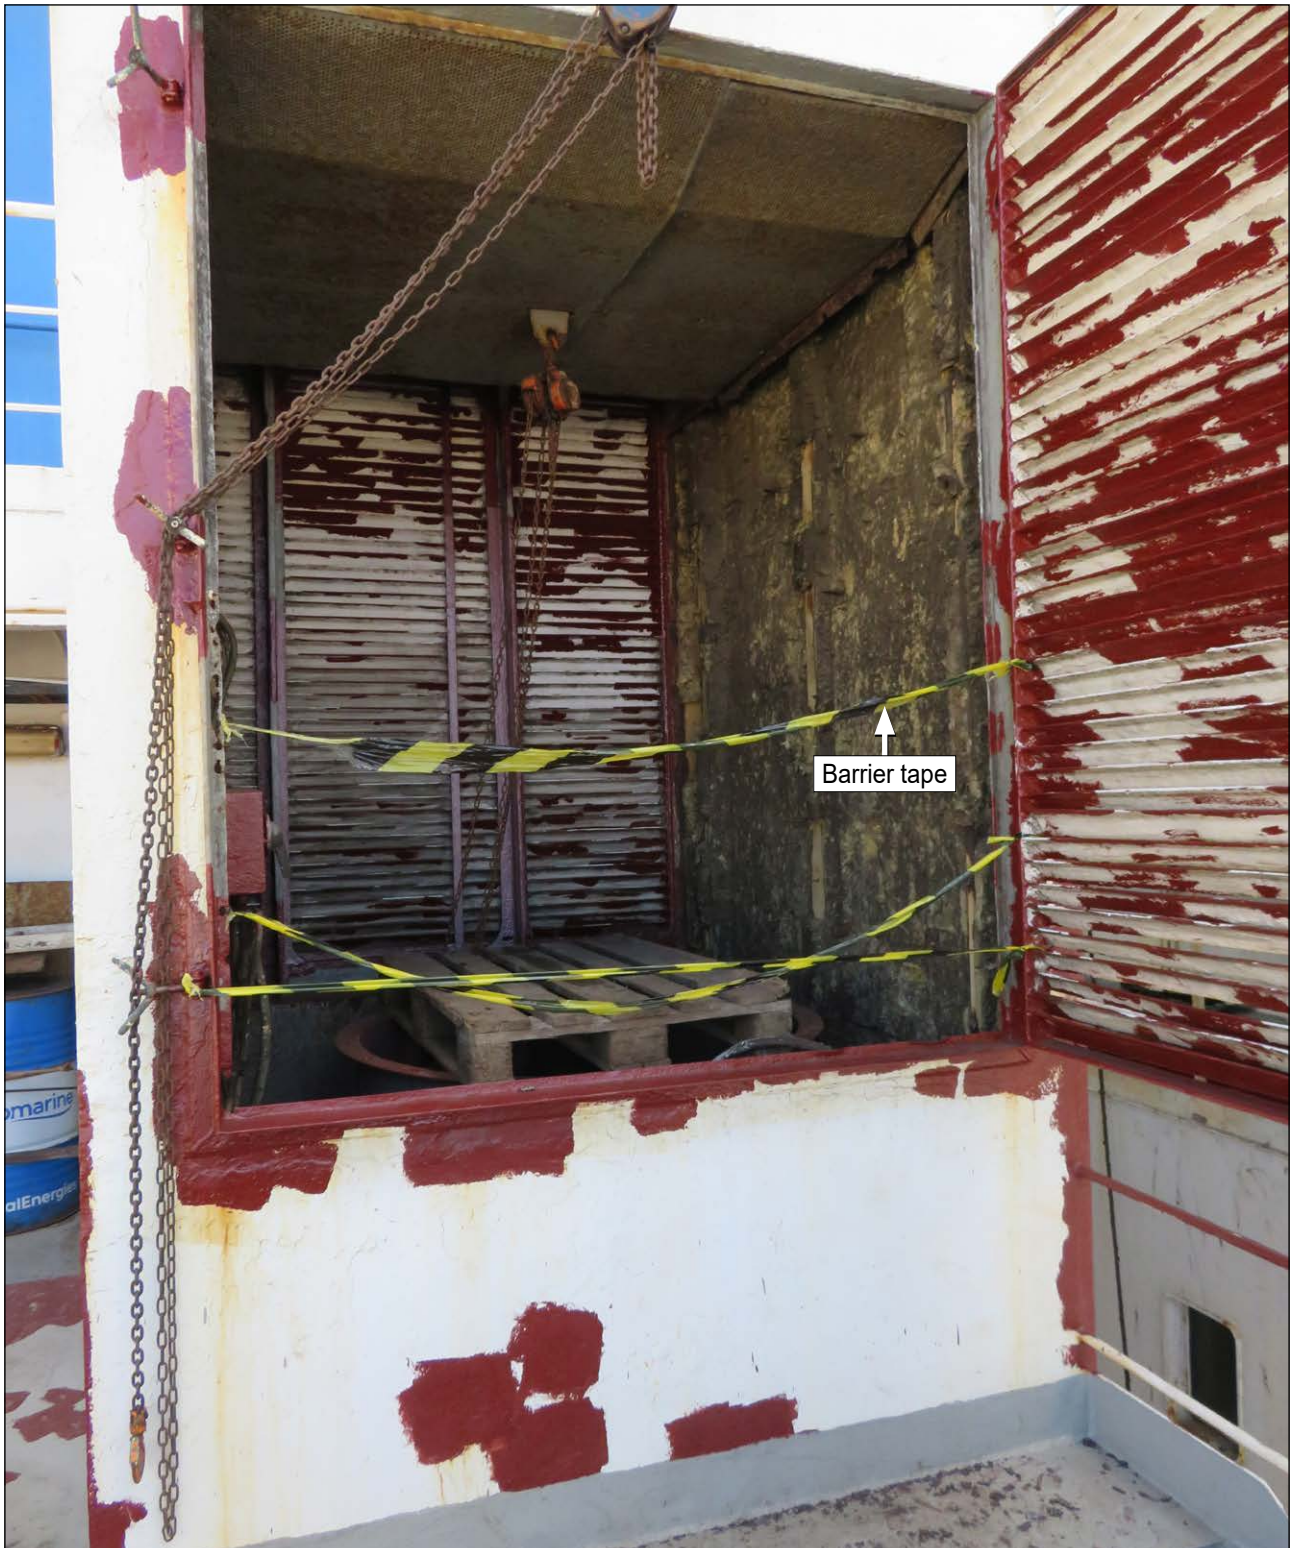
Figure 9: Barrier tape across the fan room access

Once the starboard fan was removed, the shipyard placed black and yellow striped tape across the entrance to the fan room to restrict access to the space (**Figure 9**). No steps or staging were provided outside the fan room to provide a means of access. There was no additional signage applied to indicate the nature of any hazards in the space.

The purpose of a barrier is to separate a person from a hazard. The shipyard workers had placed the black and yellow tape across the access to the starboard engine room fan room with the expectation that it would deter access. The use of such tape to warn of a hazard followed the EU directive requirements and national law; however, it did not specify the nature of the hazard it was indicating. By reference to MGN 556 (M+F), the COSWP identified that the use of black and yellow markings could be interpreted as warning of a dangerous location but did not necessarily identify the presence of a fall or electrical hazard. It is possible that the fitter might have taken the tape as denoting only the presence of the wet paint evident in the space.

Without additional signage to indicate the nature of the hazards present in the fan room, the tape alone was insufficient as a control to prevent the space being accessed.

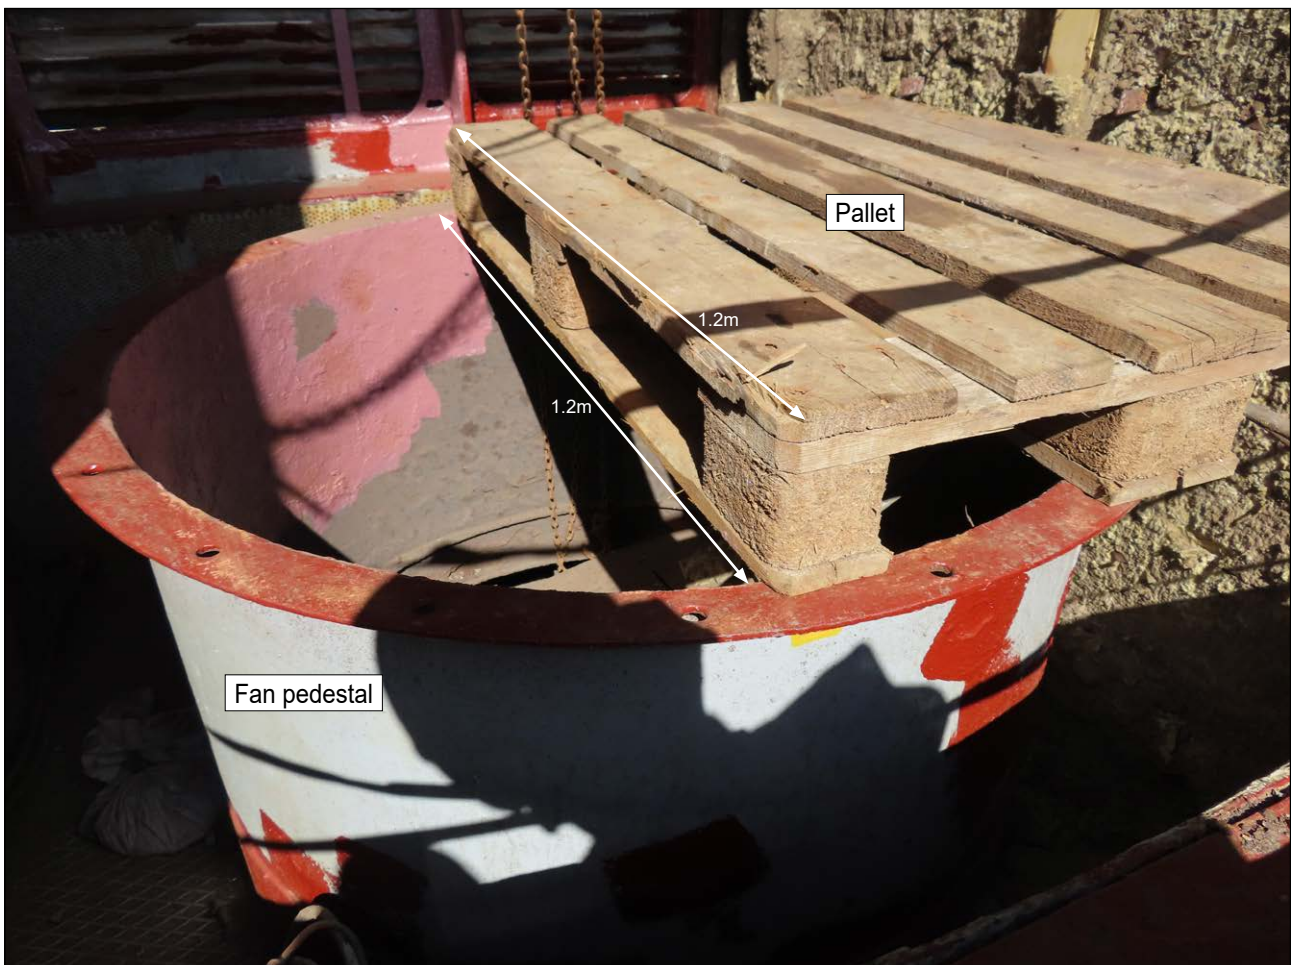
Figure 10: Pallet on the fan pedestal in the position it was reported to have been found

A standard wooden pallet⁵ was placed on the top of the pedestal, partially covering the opening. The pallet was not secured and was reported to have been positioned across the forward half of the pedestal opening (**Figure 10**). The length of the pallet was 1.2m, the same as the internal diameter of the pedestal opening.
