Serious injury to a crew member on board the survey and supply vessel *Kommandor Orca* at Portland, England on 16 August 2022

SUMMARY

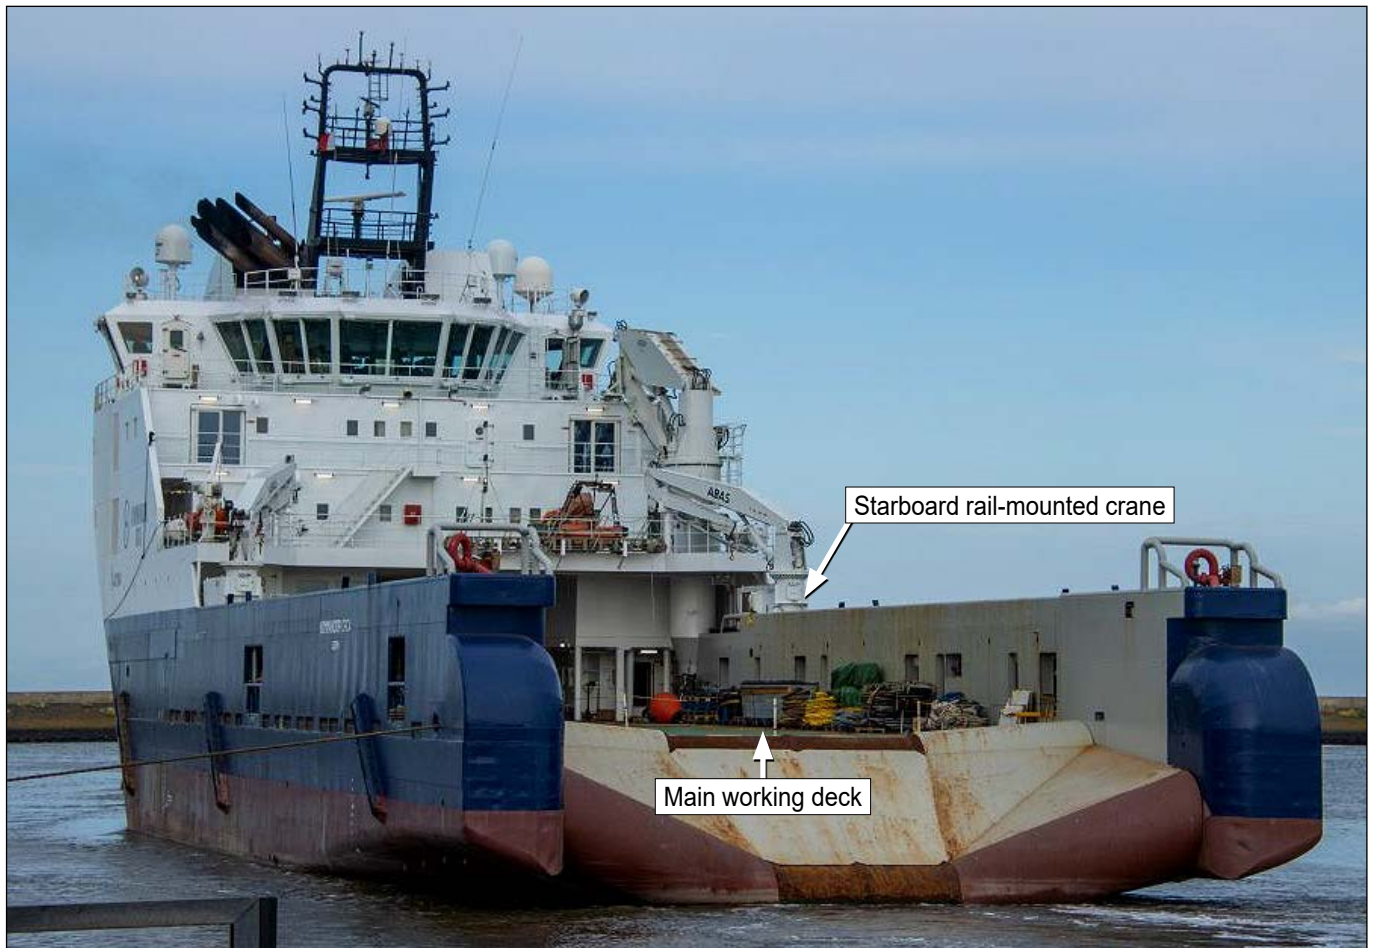
Figure 1: *Kommandor Orca*'s deck arrangement

At 0800¹ on 16 August 2022, *Kommandor Orca* was alongside at Portland, England preparing for a contract. The vessel's chief officer (C/O) held a toolbox talk with the vessel's second officer (2/O), fitter and a deck rating to plan the day's work. During the toolbox talk the C/O also completed the lifting plan and permit to work for moving several items of deck gear and machinery. The C/O returned to the bridge after the toolbox talk, while the 2/O and the fitter used a pallet truck to move equipment on the vessel's main deck. They decided to move heavier items using the starboard rail-mounted crane (**Figure 1**).

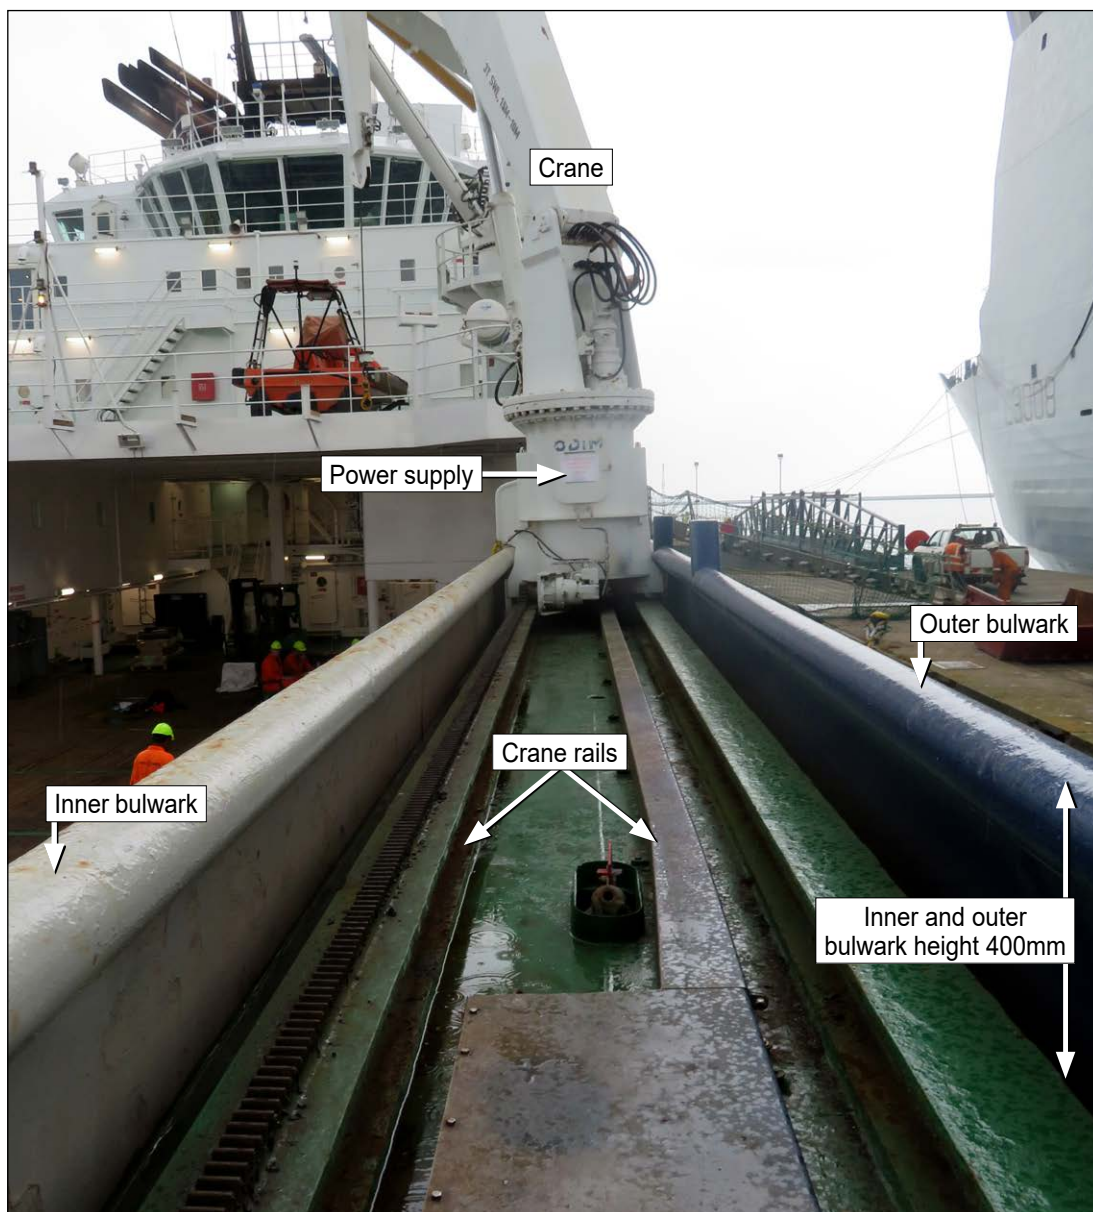
Figure 2: Starboard rail-mounted crane

The 2/O climbed up the ladder from the aft main deck and walked forward along the starboard crane rail to access the crane (**Figure 2**). The 2/O then used the local hydraulic valve controls in the pedestal (**Figure 3**) to manoeuvre the crane to reposition two loads on the main deck. While conducting a third lift, the 2/O stood with his left foot on the inboard bulwark and his right foot on the crane drive motor casing (**Figure 4a**); this enabled him to see both the fitter and the load positioned 4m below on the main deck.

The vessel had two rail-mounted cranes, each with a safe working load of 3 tonnes, which were fitted 4m above the main deck on platforms running the length of the deck, one on the port side and one on the starboard side. An outer and inner bulwark of 400mm in height was adjacent to each crane rail (see **Figure 2**).

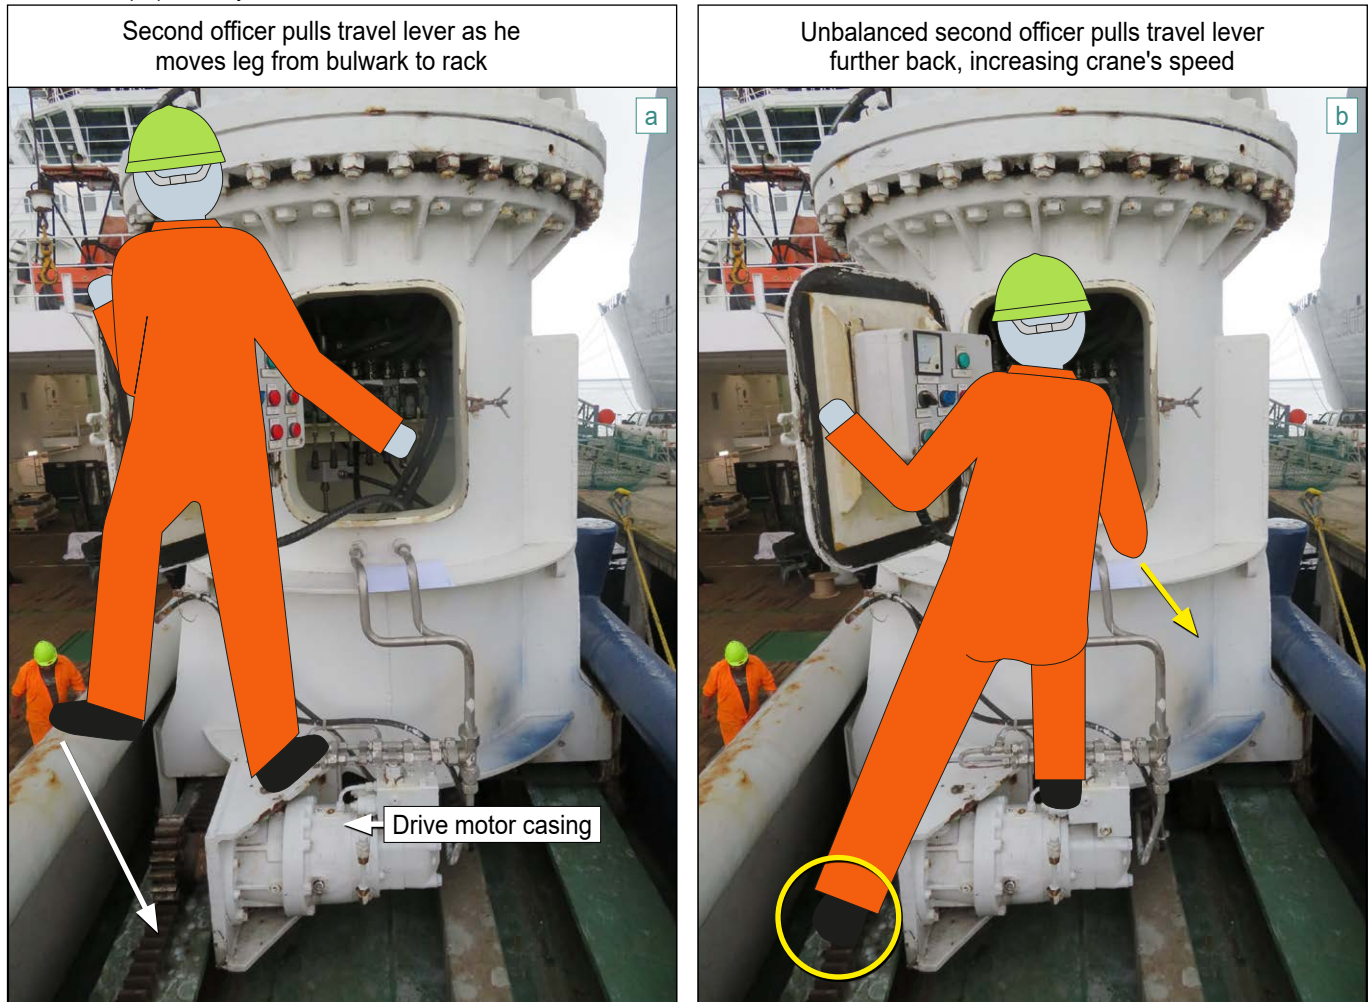
Figure 4: Positions and movements of the second officer

At 0841, *Kommandor Orca*'s 2/O pulled the travel control lever to move the crane a few metres aft. At the same time, he moved his left foot from the bulwark to the rack (**Figure 4b**). He then felt his left leg overalls being pulled, which unbalanced him and forced his right leg closer to his body. He held onto the

crane travel lever for balance, unintentionally pulling it further backwards, which increased the speed of the crane's traverse. As the 2/O's left foot and leg were dragged further into the rack and pinion drive, he let go of the travel lever, which stopped the crane, and then fell backwards.

Kommandor Orca's 2/O was following his training when he operated the crane's local controls from the exposed position at height and without safeguards. His position, with his left foot on the inboard bulwark and his right foot on the crane drive motor casing, was stable until he needed to step down from the bulwark as the crane moved aft. When the crane mechanism dragged his boilersuit into the unguarded rack and pinion gear, he lost his balance backwards and continued to hold on to the travel control lever. The added pressure that this applied to the lever was an automatic reaction, which in turn increased the crane's speed and dragged the 2/O's leg further into the pinion gear.

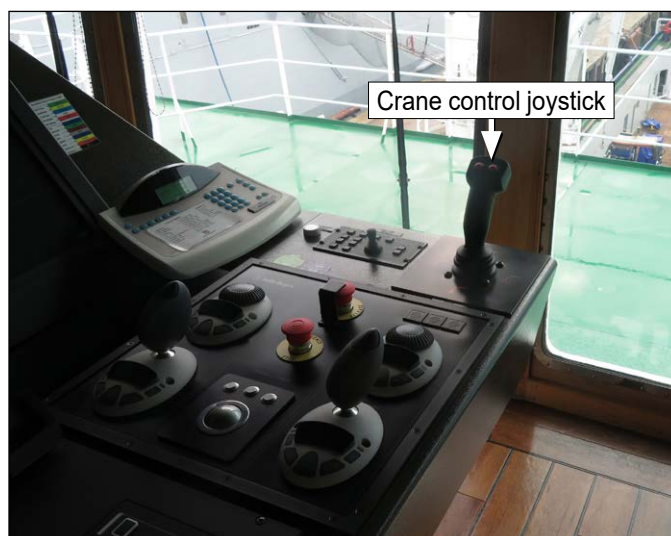
Figure 5: Bridge aft station, showing left-hand crane control joystick

The cranes could be controlled remotely, either from the bridge aft station overlooking the main deck (**Figure 5**) or by using a wireless remote control unit (**Figure 6**). A wireless remote control fault required that the port side crane could only be operated using the local emergency controls, or the bridge control. The starboard crane was operable with both remote and bridge controls.
