Fatal man overboard from the sail training vessel *Pelican of London* at Sharpness, England on 2 October 2023

SUMMARY

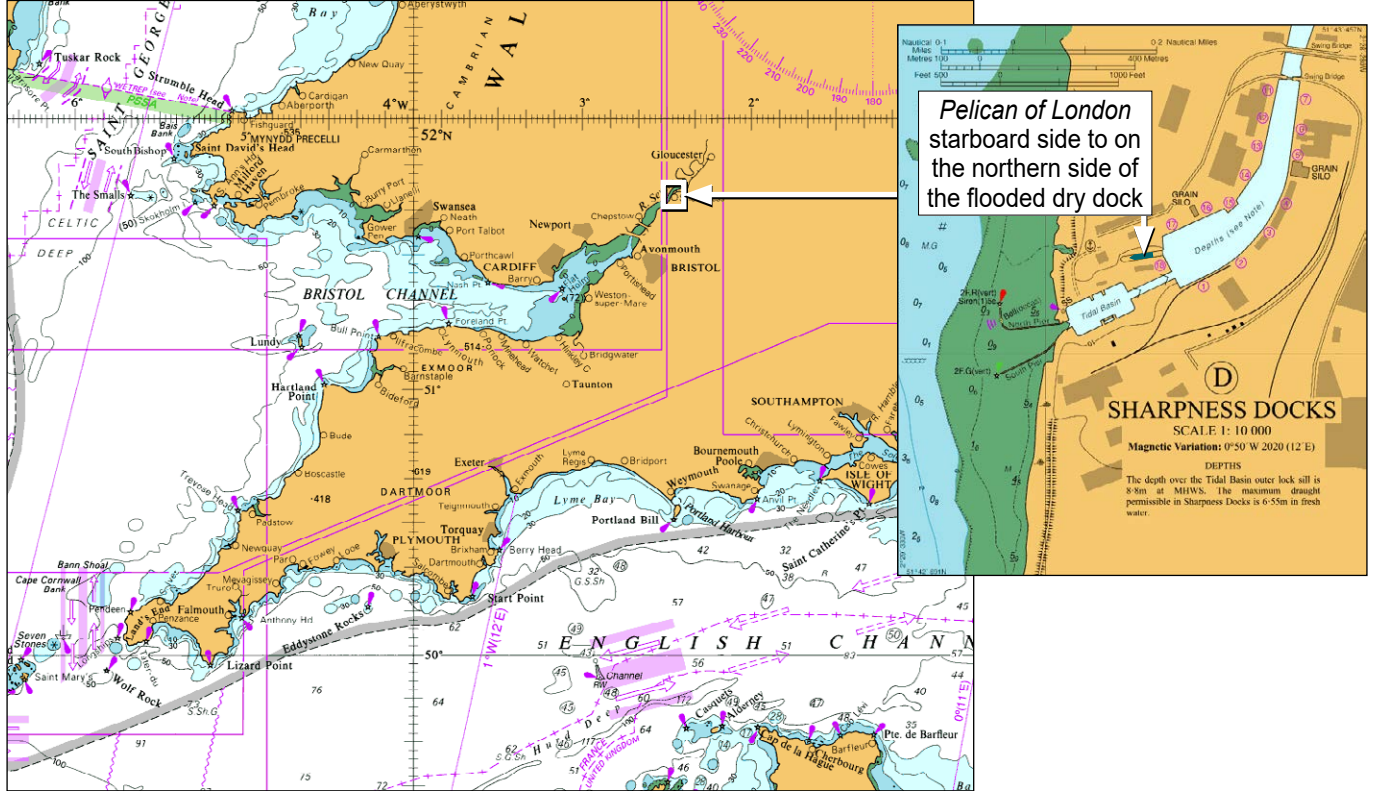
Figure 1: The accident location

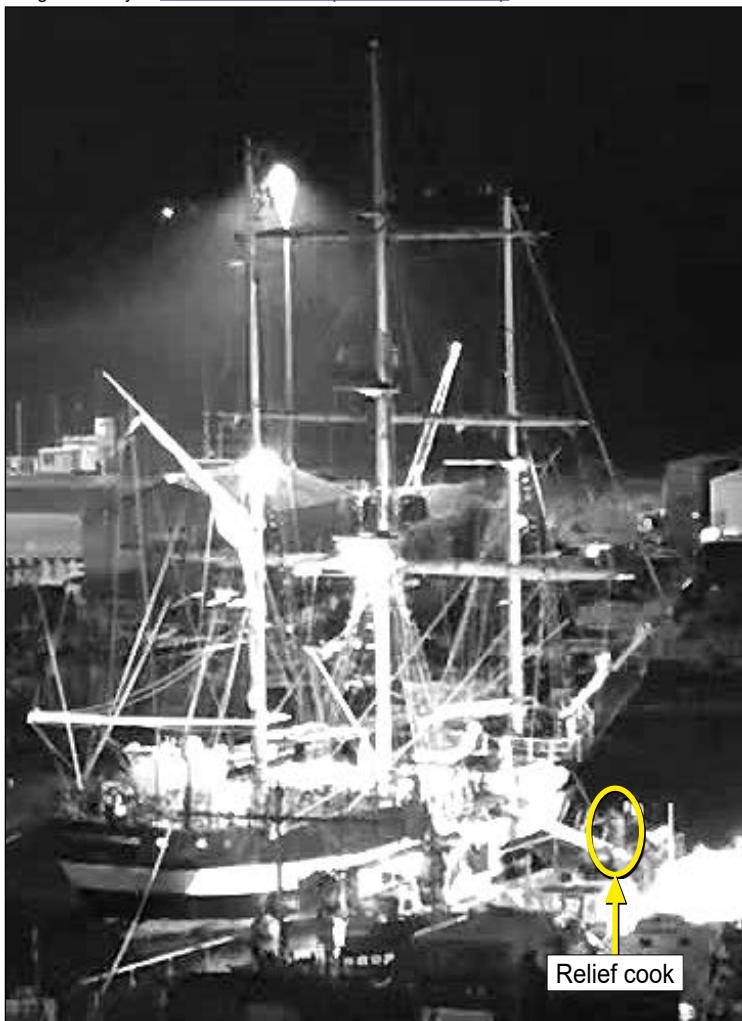
Figure 2: CCTV image of the relief cook ascending the gangway

At 2009 on 2 October, the relief cook joined his *Pelican of London* colleagues at the local bar where, over the next 2 hours and 42 minutes, he drank at least nine double whiskies and ice. The relief cook was the last customer in the bar when he left at 2251, walking back to *Pelican of London* alone. Arriving at the ship at 2307, the relief cook slowly ascended the gangway (Figure 2) and then paused for a few seconds to step down towards the deck via the bulwark ladder.

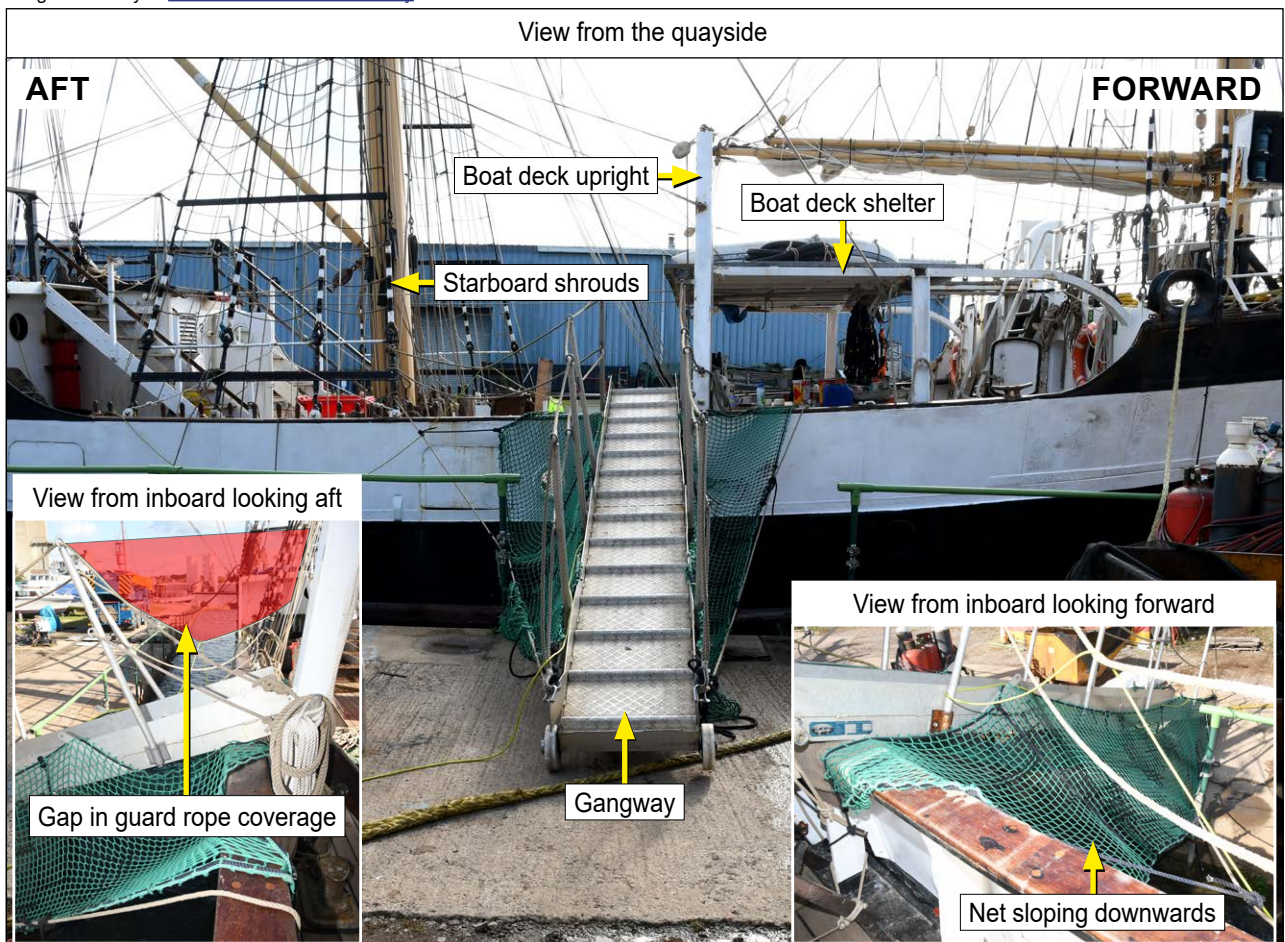
Figure 4: The gangway

At the top end of the gangway the aft side's guard ropes had been tied off slack on the forward shroud line at a height of approximately 0.5m above the top of the bulwark. An electric cable had been run over the top of the aft guard ropes and along the aft side of the gangway to a position on the quay. The electric cable served to depress the guard ropes such that they were roughly 0.3m high at their lowest point. The guard ropes at the inboard end of the forward side of the gangway had been tied off on a cleat on the aft upright of the boat deck (approximately 0.25m above the bulwark top) and at the base of the same upright.

The gangway net was rigged in two rectangular sections (approximately 1m x 5m). Each rectangular net section was arranged with its long edge lashed to the edge of the gangway; one forward and one aft. The outer long edges of the gangway net sections were lashed to lines run from the shore end of the gangway to points on board. On the forward side, this line was secured to the base of a bulwark stanchion about 2m forward of the gangway. Aft, this line was secured to the base of the forward starboard shroud. This meant that, on either side of the gangway, the nets sloped downwards away from the gangway edges by approximately 30° from the horizontal.

When the gangway was rerigged on 27 September the guard ropes from the stanchions on the inboard end of the gangway were tied off aft on the shrouds near the top of the bulwark, and forward low down on the starboard aft boat deck upright. This left significant gaps in the effective fencing between the top of the bulwark ladder and the inboard end of the gangway on both sides. These gaps were worsened by the electric cable that ran across the guard ropes and did not provide a sufficient barrier to prevent anyone from falling overboard from the top of the gangway.

The safety net, which should have arrested the fall of anyone toppling from the gangway, was rigged without a spreader bar. With the net's outer edges tied low onto the shrouds aft, and onto the bulwark forward, the net sloped downwards away from the gangway, creating a chute that did nothing to arrest the relief cook's fall.

- 2024/130** Review and amend fleet policy, procedures and training for rigging and approving the gangway arrangement to include guard ropes to prevent falls and gangway nets to arrest the fall of a person.
- 2024/131** Review and amend the onboard risk assessment procedure, as guided by the COSWP Annex 1.4, such that:
- operational risks can be mitigated to a level that is as low as reasonably practicable
 - local work instructions are produced that control the hazards.
- 2024/132** Review and amend the fleet policy and procedure on drugs and alcohol to include specific consideration of:
- individual responsibilities
 - alcohol testing
 - returning on board from recreational time ashore.
