Grounding and loss of the motor vessel *Channel Queen* near the Needles, Isle of Wight, England on 20 July 2023

SUMMARY

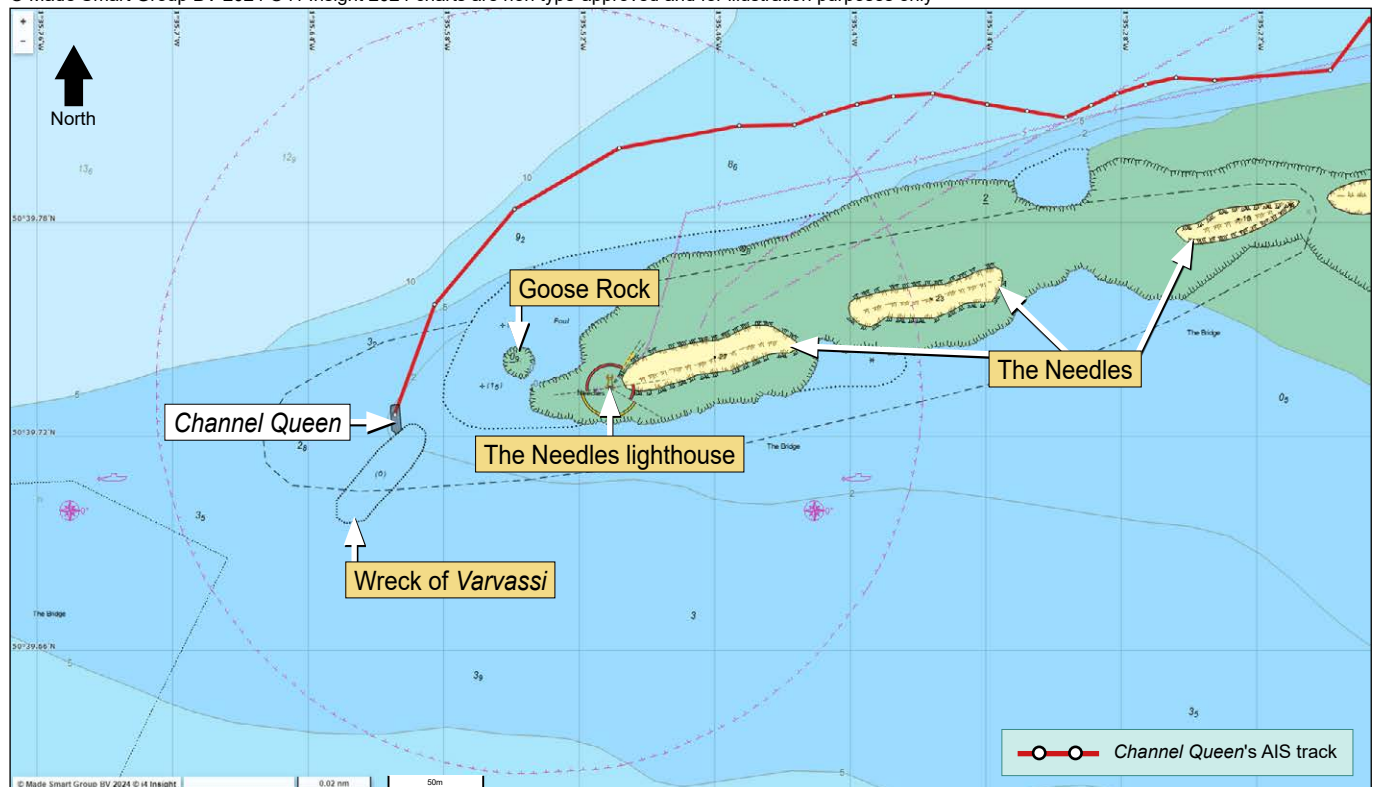
Figure 2: *Channel Queen's* AIS position as it approached the wreck of *Varvassi*

At 0559, *Channel Queen* shuddered noticeably as it passed over the charted wreck of *Varvassi* at a speed of less than 5kts and the port engine stopped (**Figure 2**). The owner immediately contacted the skipper by VHF radio to report that the vessel had struck an object. The deckhand who had been resting in the forward cabin alerted the owner that the hull had been breached and the vessel was flooding. Aware of the loss of power in the port engine, the owner immediately requested the skipper to return to *Channel Queen* for assistance. The skipper promptly reboarded the vessel, assessed the damage and decided to beach *Channel Queen* in Scratchell's Bay to prevent it from foundering.

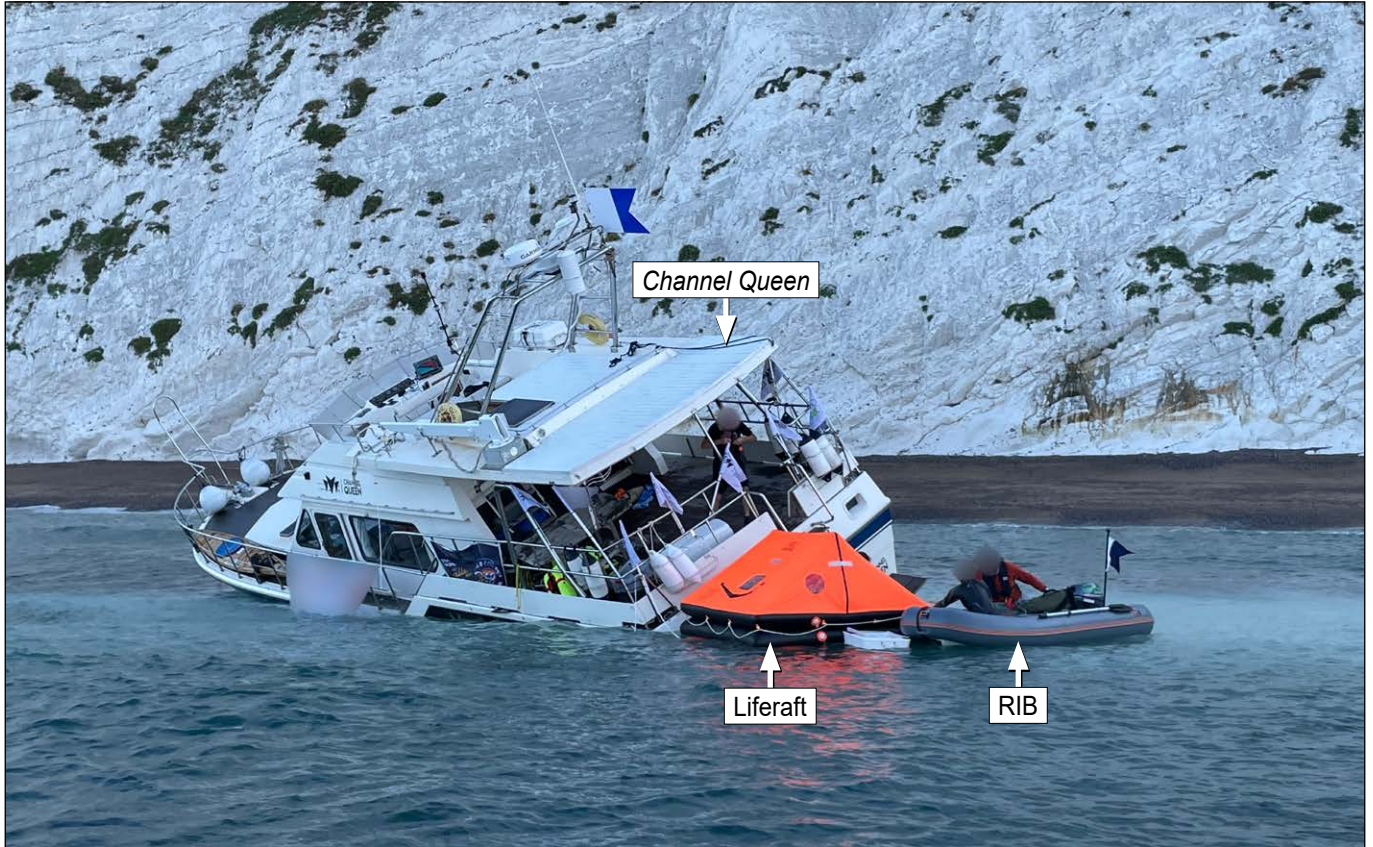
Figure 3: *Channel Queen* beached in Scratchell's Bay

At 0559¹ on 20 July 2023, the UK registered motor vessel *Channel Queen* grounded while passing over the wreck of the steam ship *Varvassi* near the Needles lighthouse, Isle of Wight, England, while escorting a relay swim event around the island. *Channel Queen* was then deliberately beached in nearby Scratchell's Bay.

The passengers and crew abandoned *Channel Queen* to its rigid inflatable boat and a liferaft and were then transferred to a Royal National Lifeboat Institution lifeboat. *Channel Queen* was subsequently declared a total loss.

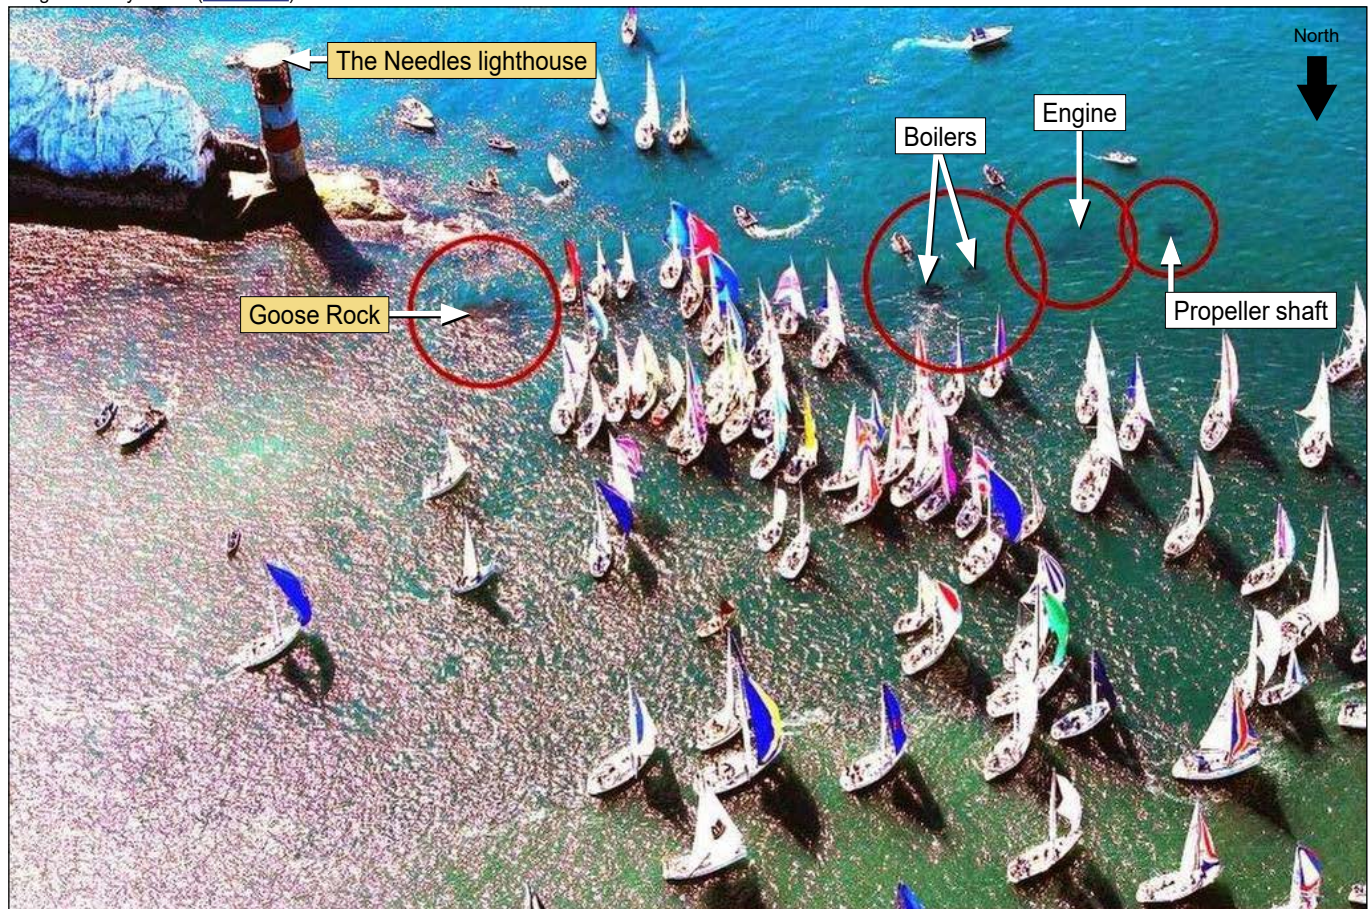
Figure 4: Round the Island Race competitors passing the remains of *Varvassi*

A high volume of inshore traffic frequently passed the *Varvassi* wreck (**Figure 4**).

There have been numerous groundings on the wreck of *Varvassi*. These have frequently occurred during the Round the Island Race⁶, when competitors have attempted to make the passage between the wreck and the Needles lighthouse (**Figure 4**).
