Report on the investigation of
the capsizing and sinking of the tug

Biter

with the loss of two lives,
while assisting the passenger vessel

off Greenock, Scotland
on 24 February 2023

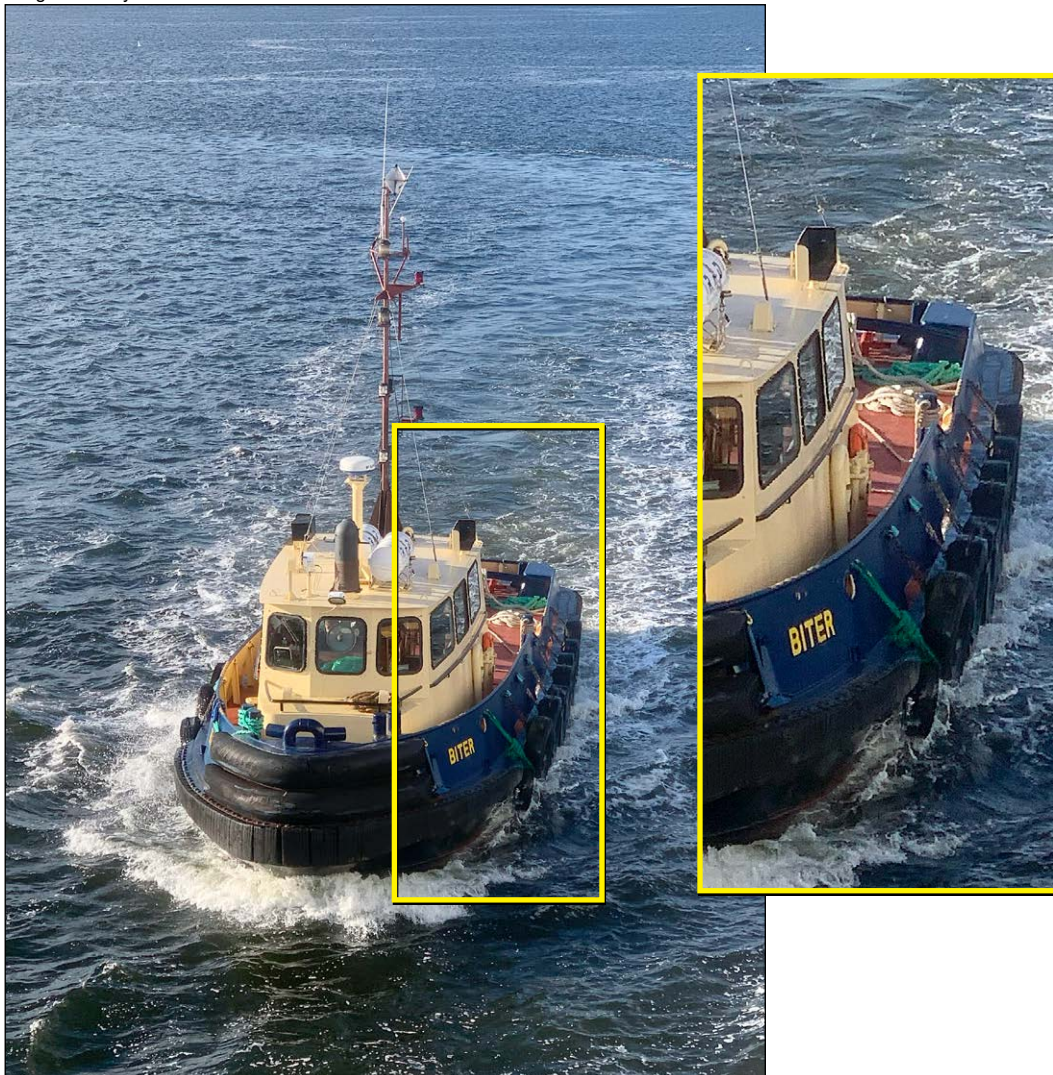
Figure 4: *Biter* running alongside *Hebridean Princess's* starboard quarter, before the lines were passed, showing the tug's gob rope secured to the port side samson post

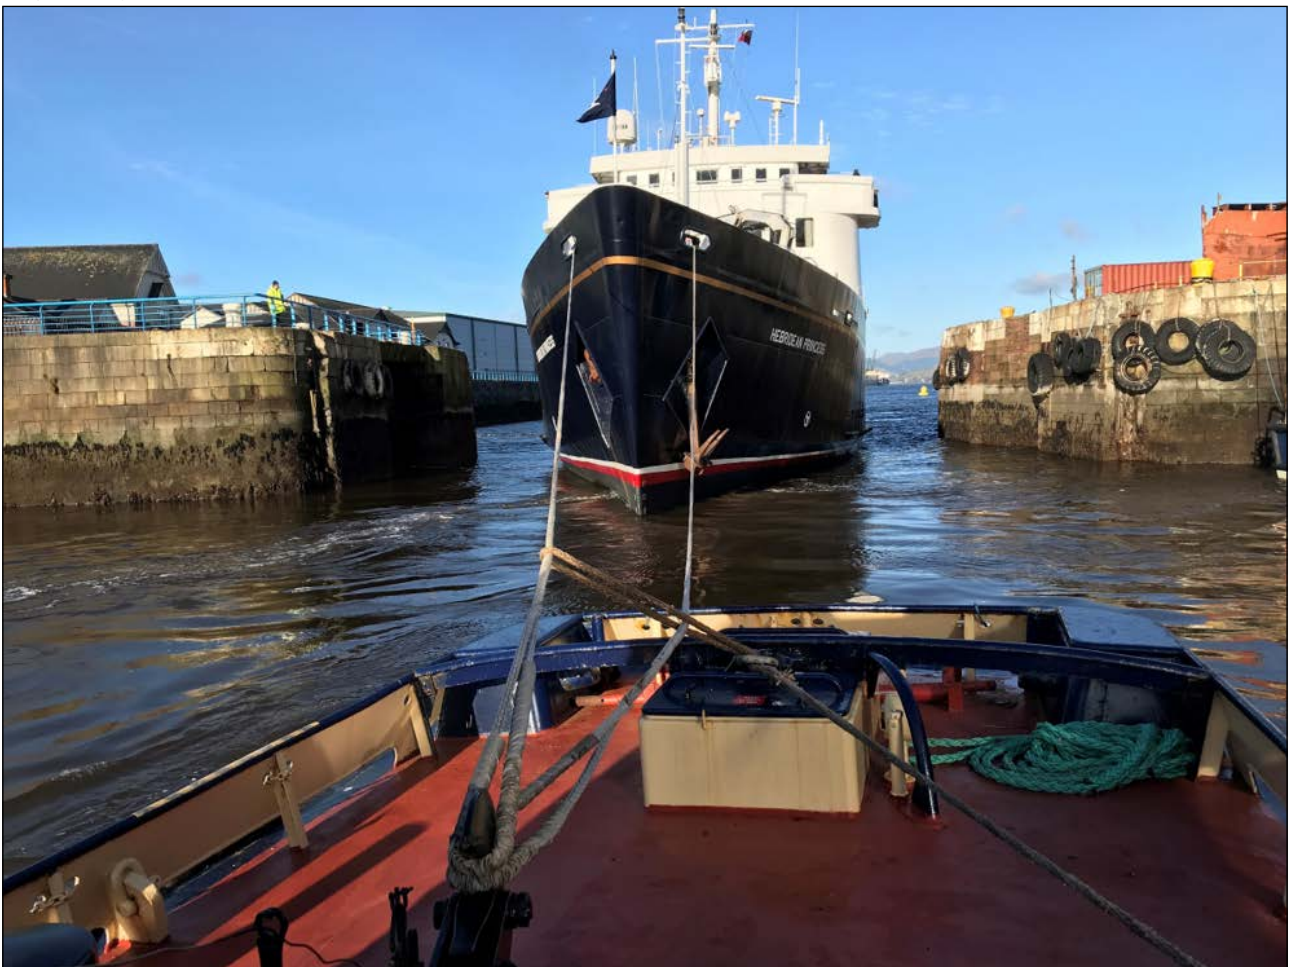
Photographs of *Biter* in operation indicate that the preferred option for securing the gob rope was for it to be turned up four or five times around the port side samson post before locking turns were placed on the post's two stag horns. The gob rope could be manually loosened or tightened when secured around the samson post; when secured using figure of eights around the towing hook frame the increased friction made the arrangement more secure and harder to adjust. There had been no reported issues with the securing arrangements for the gob rope in CMS's conventional tugs and these methods of securing the gob rope had been in use for many years and were decided on by the tug master. In common with other tug operators, neither method of securing the gob rope had been formally tested or evaluated. Further, neither method allowed the gob rope to be adjusted when the towline or bridle was under tension.

Figure 13: *Biter*'s gob rope while assisting *Hebridean Princess* to leave James Watt Dock on the morning of 24 February 2023

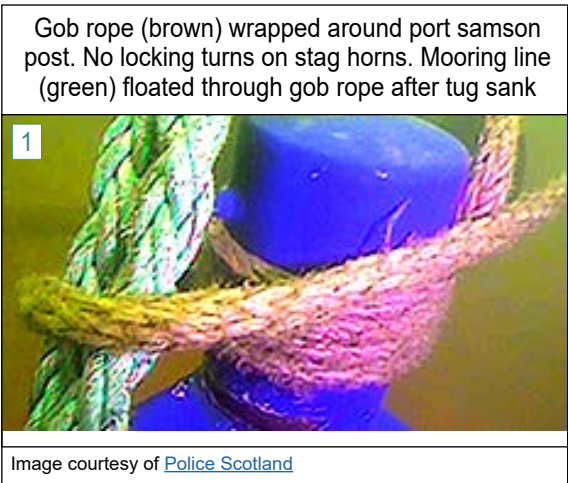
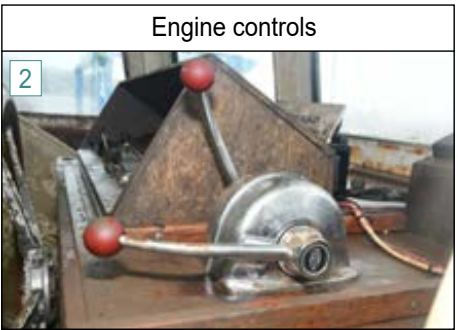
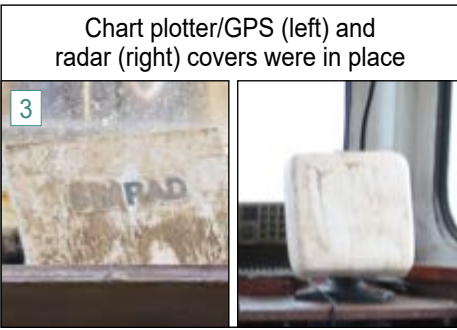
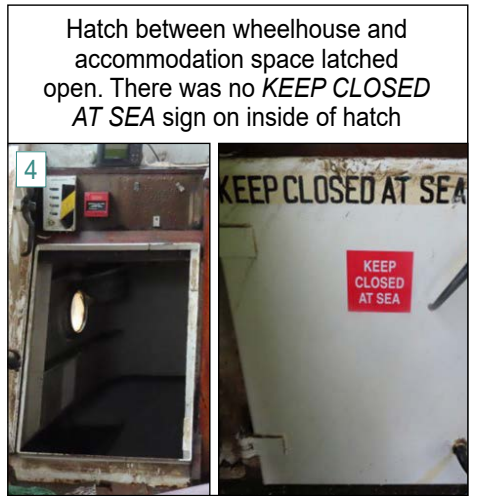
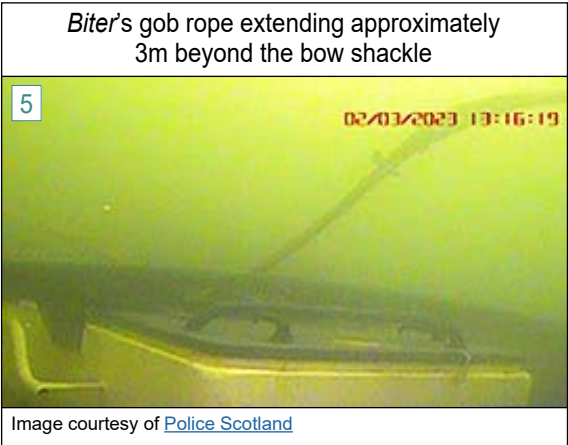
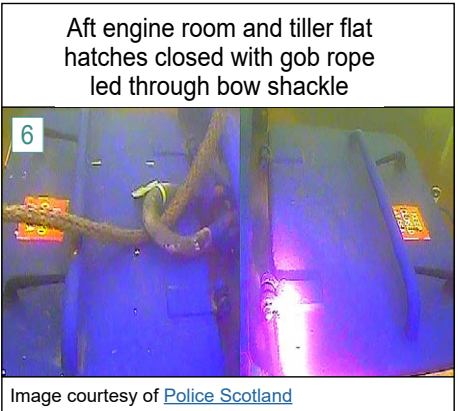
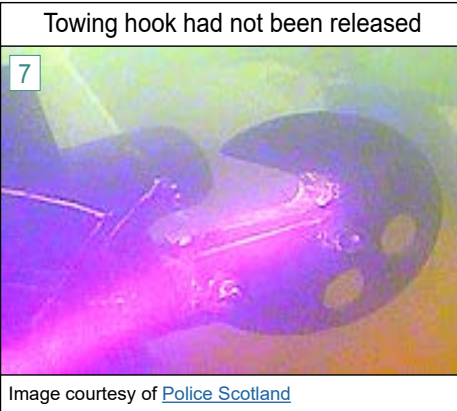
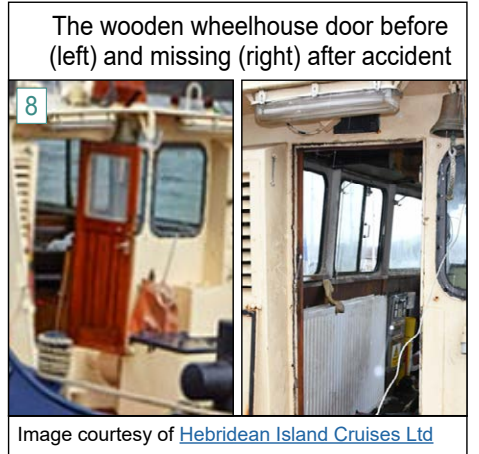
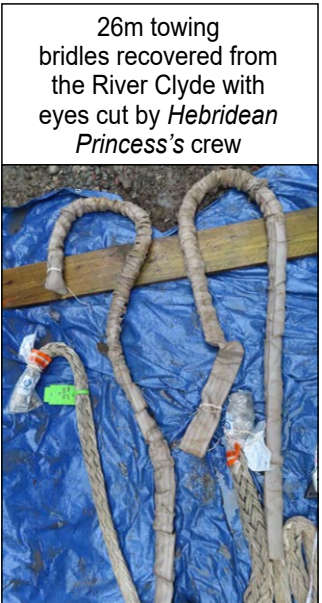
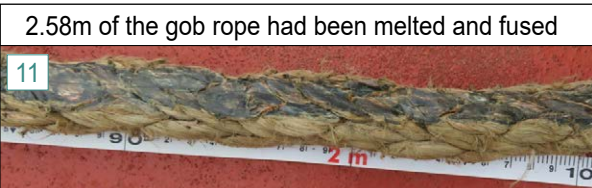
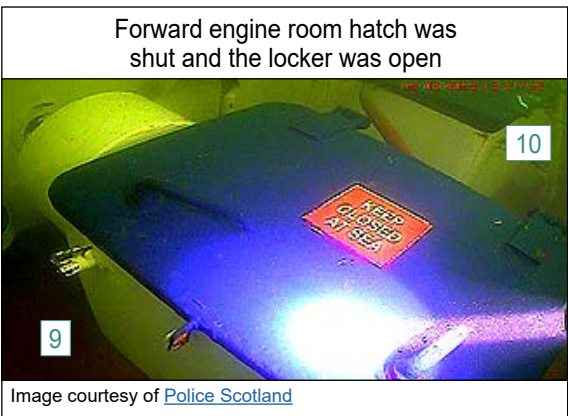
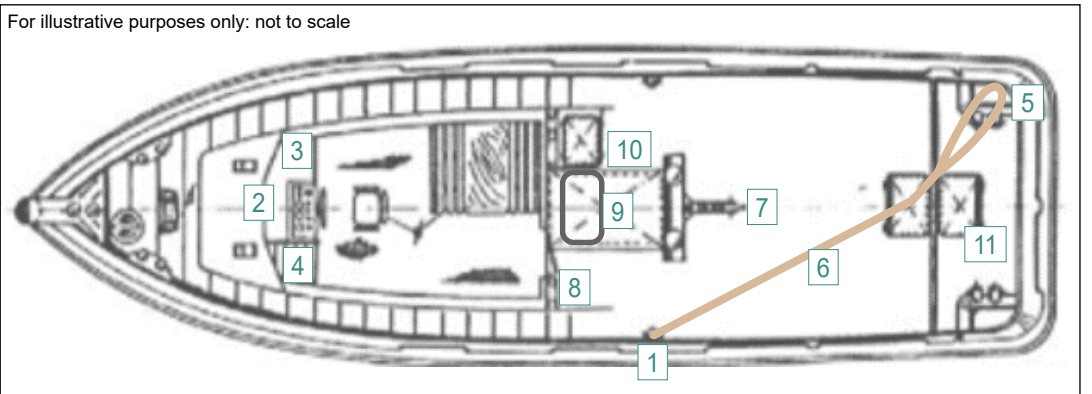
Figure 16: *Biter* post-accident inspection

Biter was inspected ashore after its salvage. The post-salvage inspection and photographs taken after the accident and during a Police Scotland dive inspection on 2 March 2023 resulted in the following observations (**Figure 16**):

- *Biter's* wooden external wheelhouse door was missing and the internal hatch between the wheelhouse and accommodation space was open. All other compartment doors and hatches were shut.
- Only one side of some of the doors and hatches was marked with *KEEP CLOSED AT SEA*. This warning sign was therefore obscured when the hatch between the wheelhouse and accommodation space was open.
- The chart plotter/GPS and radar displays in the wheelhouse were covered.

- The tow hook had not been released. When the tow hook was tested post-salvage, the local release mechanism at the hook and the emergency release wire located in the wheelhouse operated correctly.

- During the dive survey the gob line was seen to be wrapped around the port samson post and had been led aft through a bow shackle mounted between the engine room and aft peak hatches. There were no locking turns on the samson post. Close inspection of the gob line after salvage found that 2.58m of the 25m rope had been melted and fused. The location of the fused area was coincident with the section of the rope that would have been wrapped around the samson post.
