## Serious Incident

| <b>Aircraft Type and Registration:</b> | Spitfire IXT, G-BMSB | |

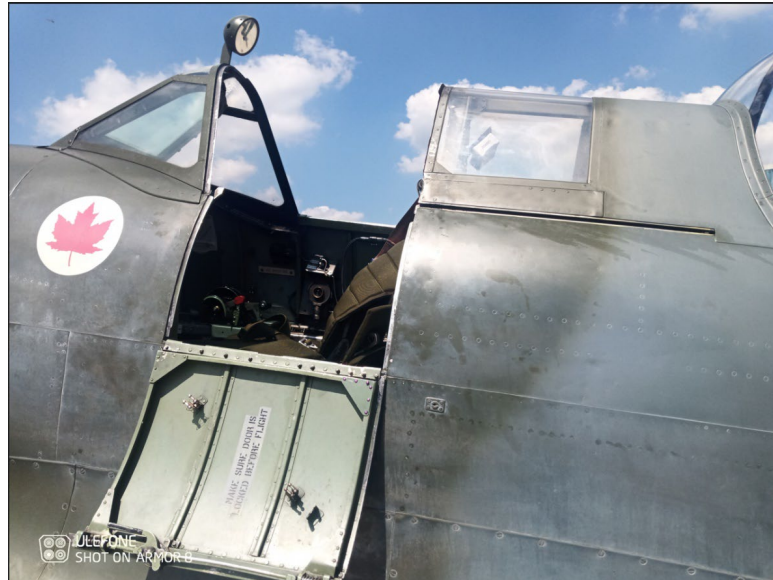
**Figure 1**

G-BMSB after landing showing absent front canopy and open cockpit side door

On the Spitfire IXT, the forward part of the left side canopy rail is on the top edge of the cockpit side door. With the door open, the canopy was not engaged in the rail and the air flow was able to get underneath the canopy causing it to detach.

The front cockpit canopy detached in flight as the cockpit side door had not been closed prior to departure. Contributory factors included the pilot's level of familiarity with the aircraft, being relatively new to the type and distractions due the pre-departure phase of flight.

The pilot considered that the safety lesson learned is to close the door before engine start and have the ground crew confirm that it is properly latched. The operator issued a crew notice instructing its pilots that the cockpit door must be closed prior to engine start. On subsequent passenger flights, the pilot has requested passengers to observe a sterile cockpit approach until the aircraft is airborne and clear of the Aerodrome Traffic Zone.
